| RE: <b>Recall Campaign Launch Notification – 2019030017 Takata PG5 DRIVER and PASSENGER AIRBAG Zone A</b><br>Certain MY11 W204 (C-Class), MY12 X204 (GLK-Class), and MY 2011-2015 SLS Coupes and Roadsters vehicles | DATE: March 26, 2019 |

SUBJECT: **Model 204, X204 and 197**  
**Model Years 2011 – 2015**  
**Replace Driver-Side and Front Passenger-side Airbag**

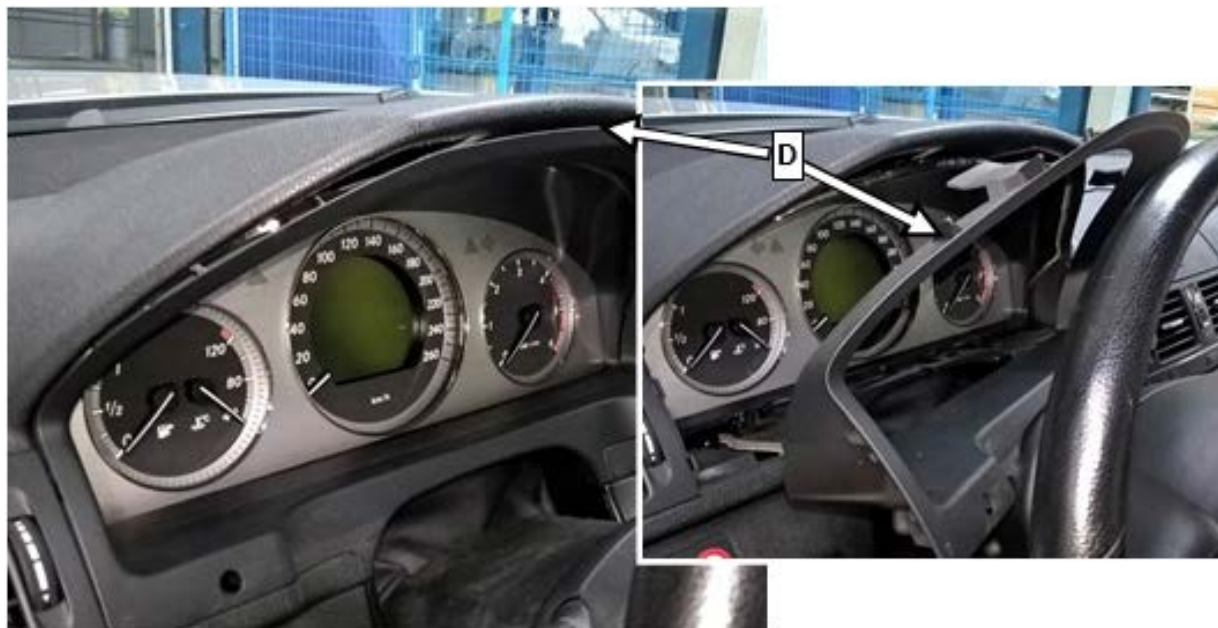
Figure 7

7. Remove center console (**AR68.20-P-2000CW**).
8. Remove automatic climate control and operating unit.
  - i For basic data of model 204, see **AR83.40-P-6350CW**
9. Remove trim (**D, figure 7**) around the instrument cluster.
  - i For basic data of model 204, see **AR54.30-P-6015CW**.

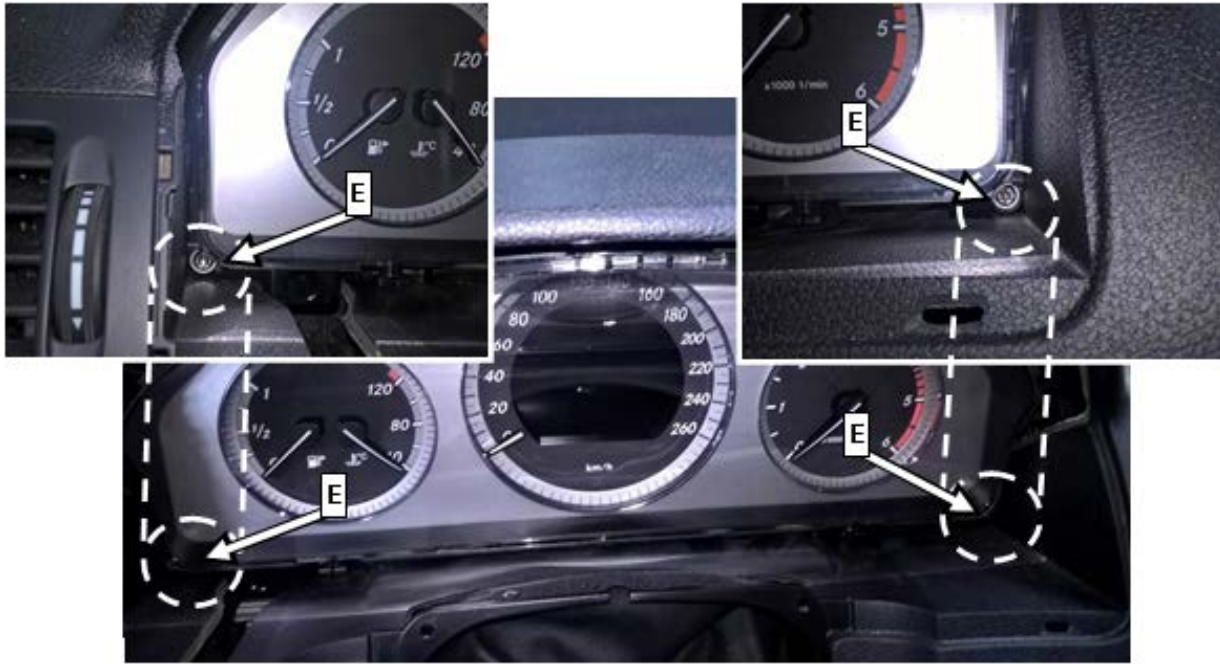
**Figure 8**

10. Remove the two bottom threaded connections (**E**, **figure 8**) of the instrument cluster.

**i** These screws are simultaneously fasteners for the instrument panel.

**i** The upper two screws do not need to be removed.

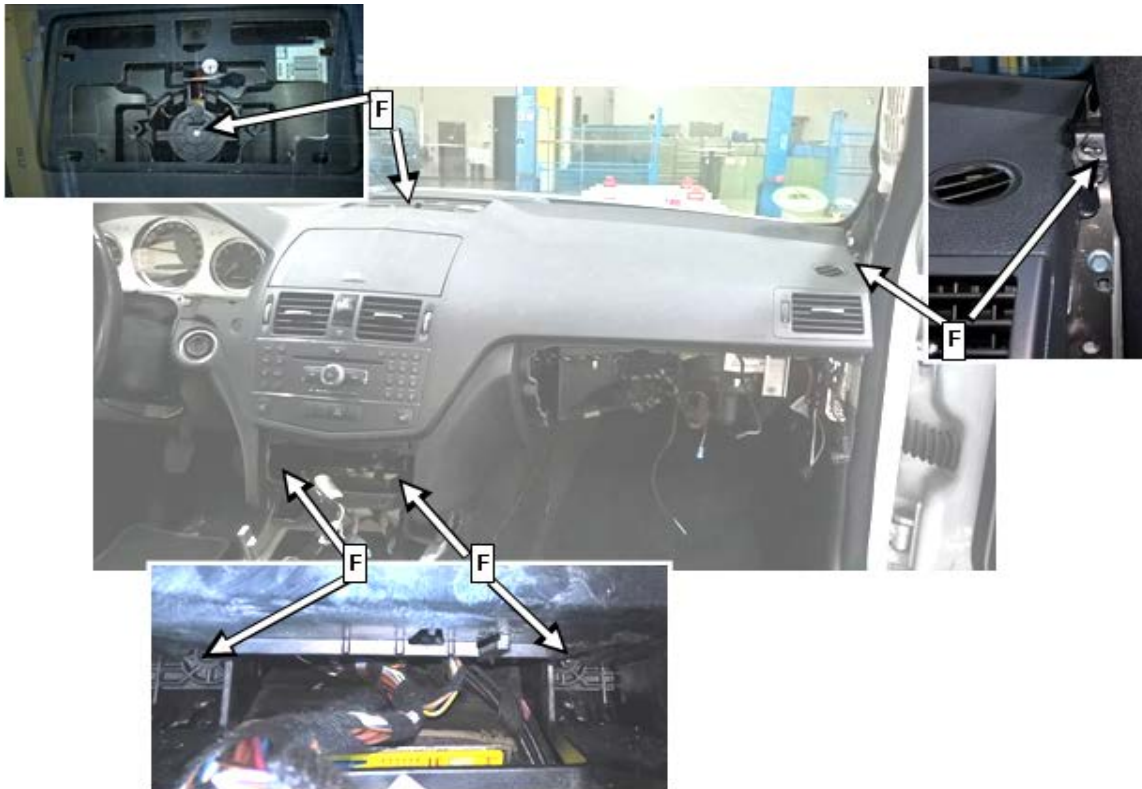
**Figure 9**

11. Remove four screws (**F**, **figure 9**) for fastening the instrument panel

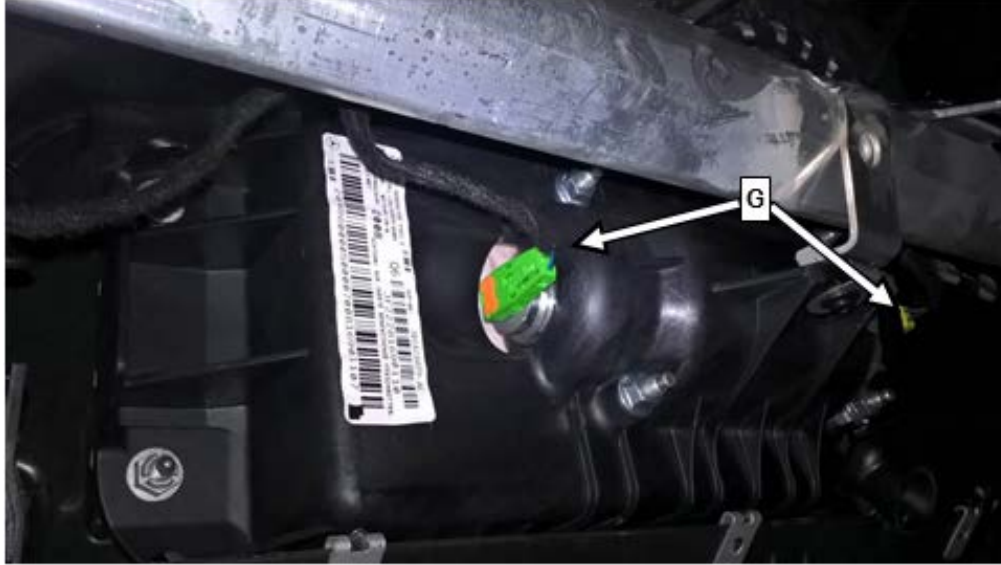
Figure 10

12. Disconnect electrical contacts (**G**, **figure 10**) at the front passenger airbag.

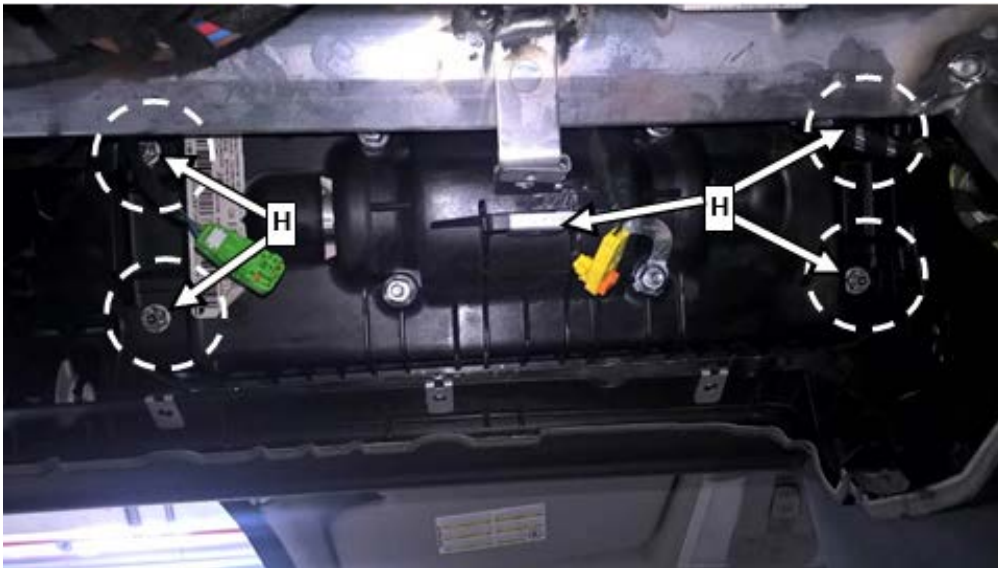
Figure 11

13. Remove lock nuts (**H**, **figure 11**) for the front the passenger airbag.

**i** Lock nuts should only be replaced if they are damaged. For more info see: **AH00.00-N-0001-01A / Modification notes 27.10.2016**

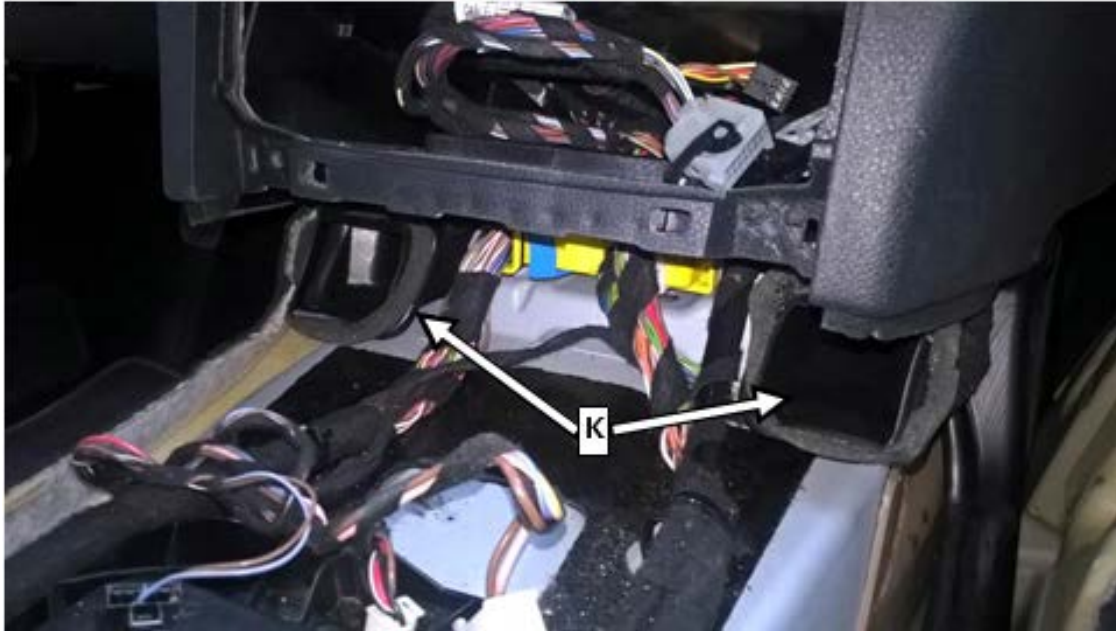
Figure 17

22. Place instrument panel back into position and install the air ducts (**K**, **figure 17**) correctly.

**i** The air ducts are pulled out when the instrument panel is raised.

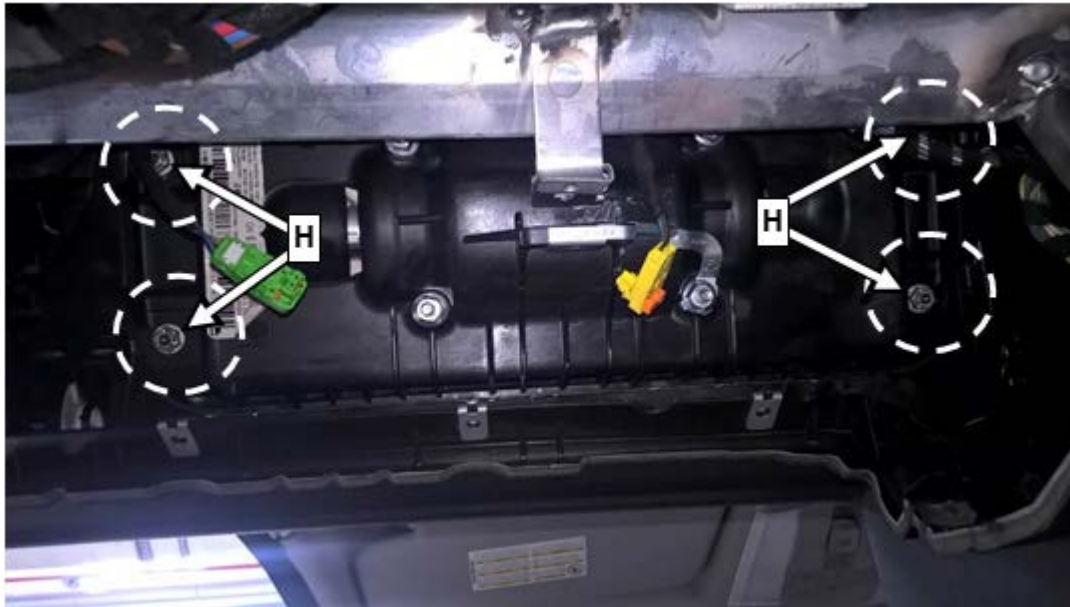
Figure 3

6. Remove threaded connections (**H**, figure 3) for the front the passenger airbag.

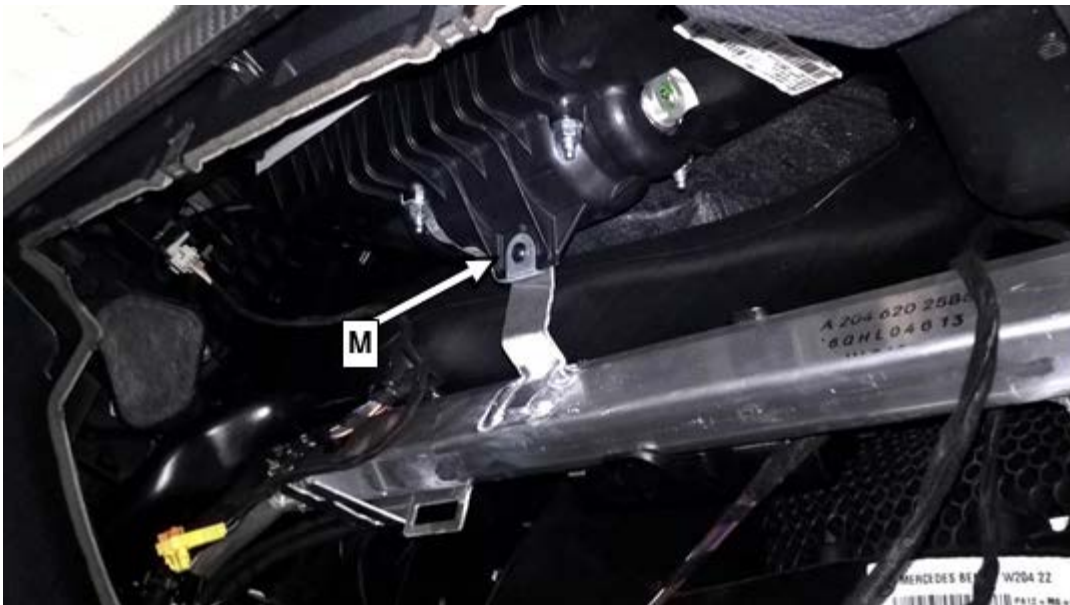
Figure 4

7. Remove Screw (**M**, figure 4) for the front passenger airbag.

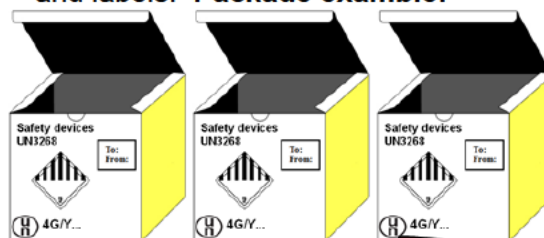
- Package each airbag in a separate UN spec box prepared with the labels/markings described above.
- Place each individual airbag box inside a larger non-UN spec box to keep the shipment together.
- This larger box is called an "OVERPACK."

- The OVERPACK must have the identical markings and label as the boxes contained inside.
- The OVERPACK must have the "OVERPACK" statement on the same face as the hazard markings and labels. **Package example:**
