July 2016  
FL705A  
NHTSA #16V-206  
Transport Canada #16-176  
REVISED NOTICE

## Subject: Bendix Rear Brake Calipers

**Models Affected: Specific Freightliner 108SD, 114SD, Business Class M2, and Columbia vehicles manufactured January 6, 2010, through February 29, 2016, equipped with Bendix rear brake calipers.**

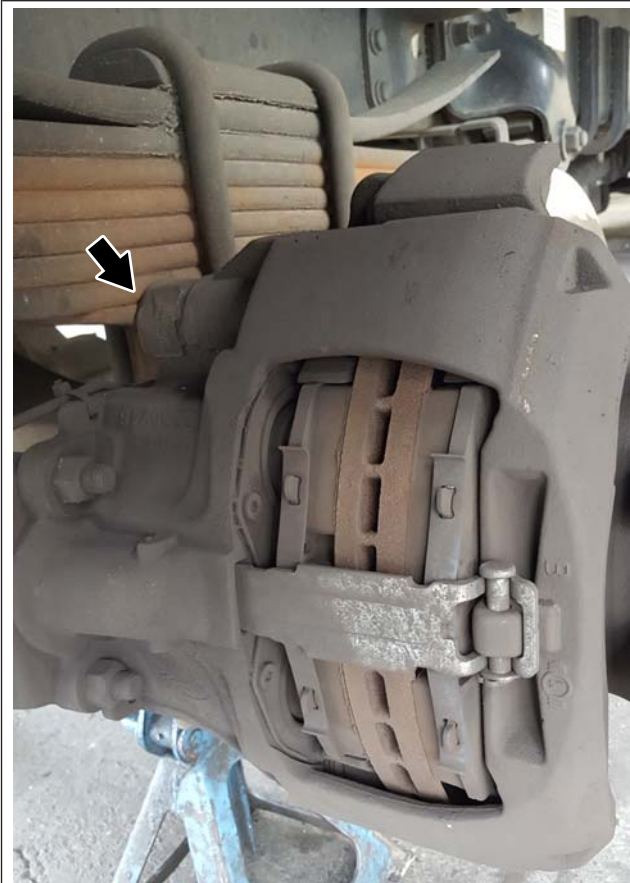
**Fig. 2, Contact Area**

4. On each axle end, inspect the spring and caliper for evidence of contact. See **Fig. 2**, **Fig. 3**, and **Fig. 4**, then go to "Caliper Orientation Procedure" on page 10.

Look for contact here.

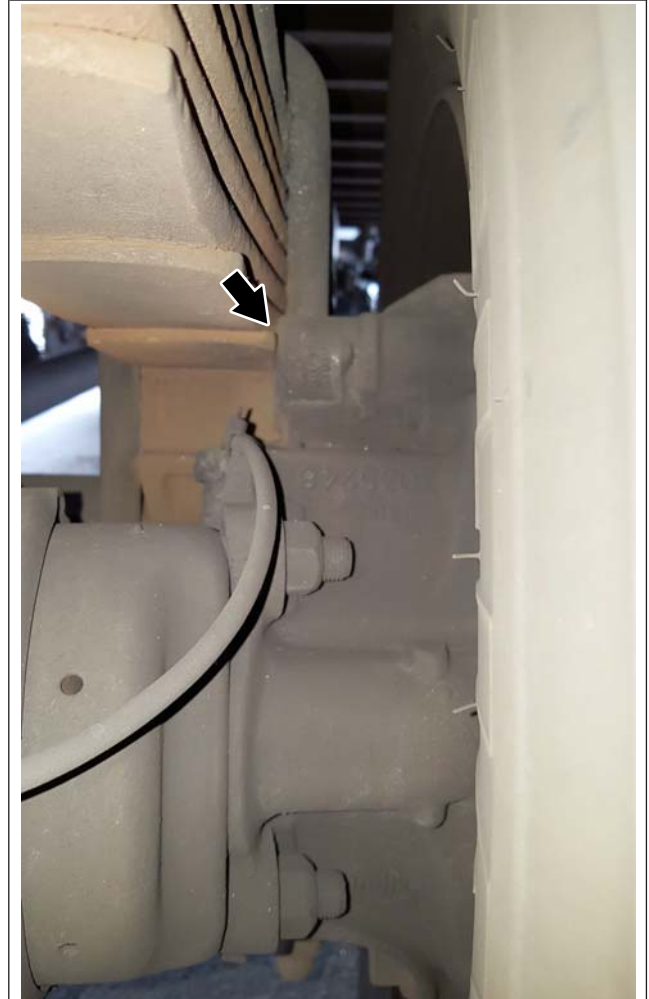
**Fig. 3, Contact Area**

Look for contact here.

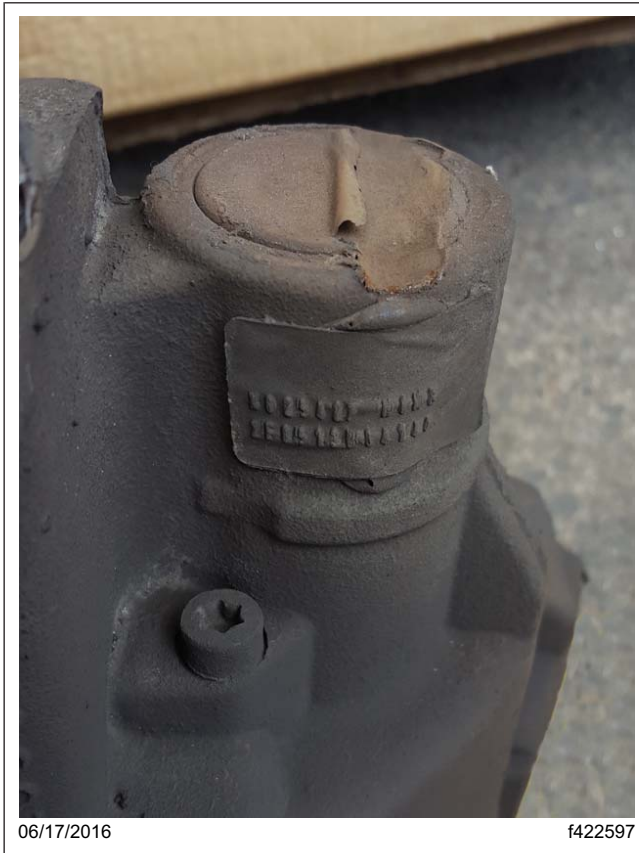
**Fig. 5, Caliper Damage**

4. Cage the rear brake chambers so that the springs cannot actuate during disassembly.
5. Disconnect the supply and return air lines from the brake chamber.
6. Back off the manual brake adjuster 1/4 turn.
7. Remove the brake pads.
8. With the caliper/carrier assembly securely supported, remove and discard the six bolts attaching the carrier to the anchor plate. Remove the caliper/carrier assembly.
9. If contact between the caliper and spring was noted during the inspection procedure, and the caliper shows evidence of contact similar to that shown in [Fig. 5](#) and [Fig. 6](#), replace both sets of brake calipers, rotors, and brake pads on both ends of the affected axle. Follow the procedure in "Caliper and Rotor Replacement" on page 14. Refer to PartsPro for the appropriate part numbers.
