## TECHNICAL INSTRUCTIONS FOR SAFETY RECALL G0R FRONT PASSENGER AIRBAG INFLATOR MODULE CERTAIN 2010 MY 4RUNNER

### UPDATE 9-5-18

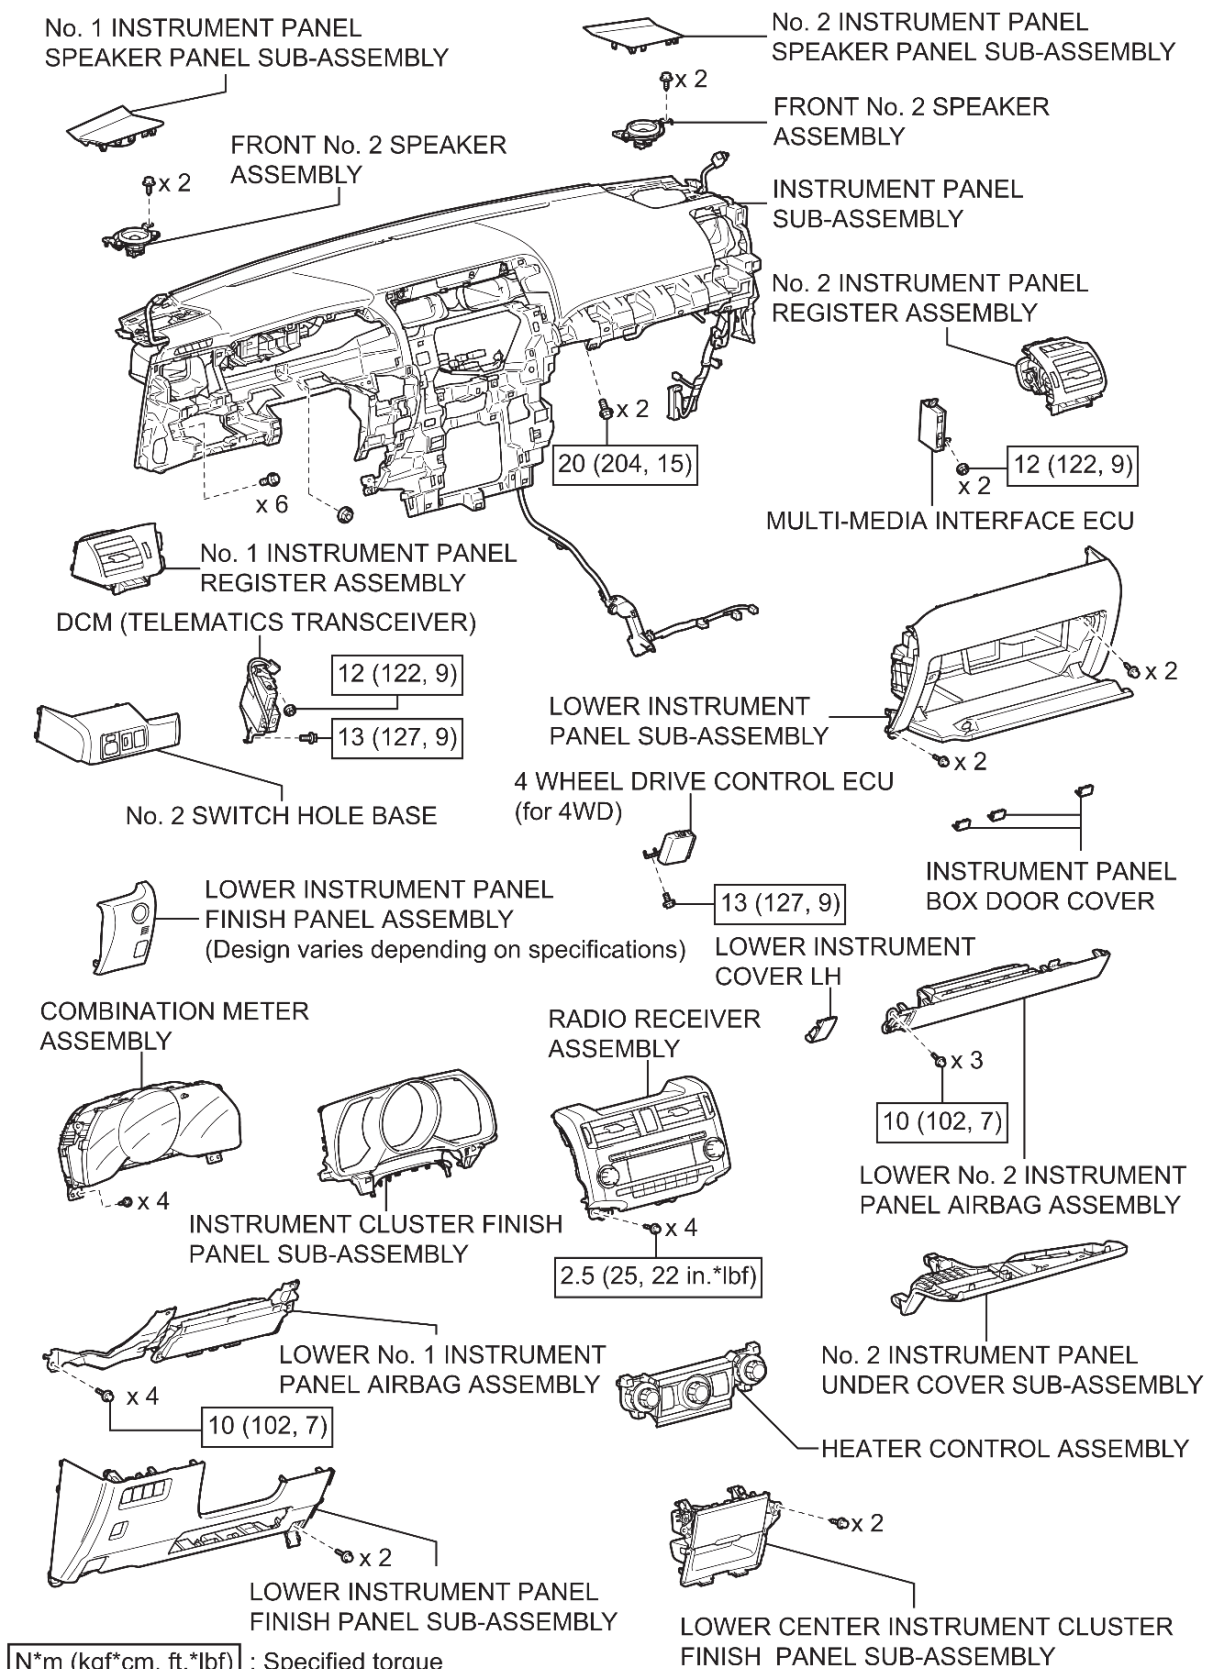
R1703160012

**CAUTION-PLASTIC RETAINING CLIPS ARE FRAGILE. REMOVE WITH CARE**

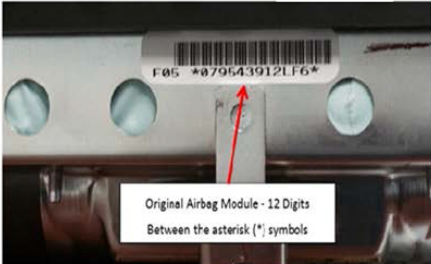
#### Airbag Serial Number Label Example

- The airbag serial number is **ALWAYS** the **12 DIGITS** located between the asterisks.
- The 3 digits before the asterisk **ARE NOT** part of the serial number, and **SHOULD NOT** be entered or an inaccurate response may be returned.

Original Airbag Module - 12 Digits Between the asterisk (\*) symbols

The Airbag module Assembly serial number is a 12 digit code. It can be found along with a bar code on opening the Airbag assembly unit. To manually enter these details into the application, the technician has to identify the 12 digit code between two Asterisks (\*) inside the Airbag assembly unit. The first seven characters of this 12 digit code are numbers and the 10<sup>th</sup> digit is either 'K' or 'L' always.

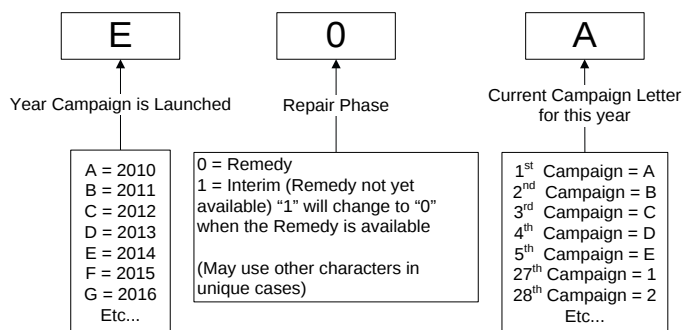
### A. CAMPAIGN DESIGNATION DECODER

Examples:

A0D = Launched in 2010, Remedy Phase, 4<sup>th</sup> Campaign Launched in 2010

B1E = Launched in 2011, Interim Phase, 5<sup>th</sup> Campaign Launched in 2011

C1C = Launched in 2012, Interim Phase, 3<sup>rd</sup> Campaign Launched in 2012
