### TECHNICAL INSTRUCTIONS FOR SAFETY RECALL G0P FRONT PASSENGER AIRBAG INFLATOR MODULE CERTAIN 2010-2013 MY 4Runner

#### UPDATE 9-5-18

The subject vehicles are equipped with front passenger airbag inflators produced by Takata. According to Takata, the propellant in these inflators may degrade after prolonged exposure to high absolute humidity and fluctuating high temperatures. Degraded propellant can cause inflator rupture during airbag deployment. In the event of an inflator rupture, metal fragments could pass through the airbag cushion material, striking the vehicle occupants, and result in serious injury or death.

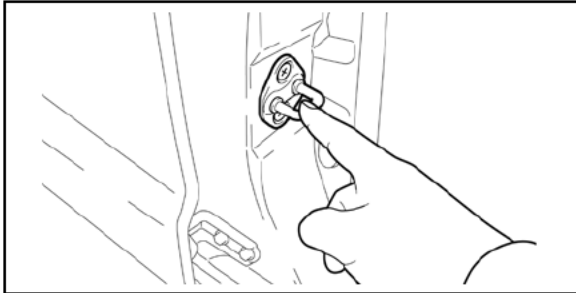
#### 1. ELIMINATE STATIC ELECTRICITY

- Before starting work and periodically while working on the vehicle, touch a metallic part of the vehicle to discharge static electricity in the body.

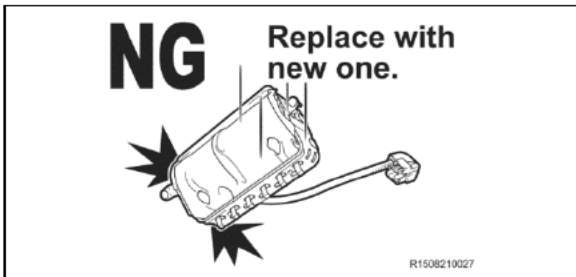
#### 3. HANDLE THE AIRBAG CAREFULLY

- If an airbag is dropped, replace it with a **NEW** one.

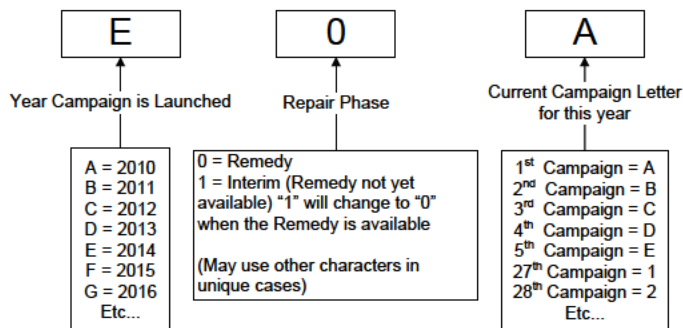
### A. CAMPAIGN DESIGNATION DECODER

Examples:

A0D = Launched in 2010, Remedy Phase, 4<sup>th</sup> Campaign Launched in 2010

B1E = Launched in 2011, Interim Phase, 5<sup>th</sup> Campaign Launched in 2011

C1C = Launched in 2012, Interim Phase, 3<sup>rd</sup> Campaign Launched in 2012
