Subject	07-11 CR-V Passenger's Airbag Inflator Kit-INSPECT BEFORE INSTALLATION-UPDATE
----------------	---

Subject: 2007-11 CR-V Front Passenger's Airbag Inflator Kit – INSPECT BEFORE INSTALLATION-**UPDATE**Yesterday, May 15th, American Honda identified a concern with the following airbag inflator kit:

Part Number	Part Description	Action
04790-SWA-407	2007-11 CR-V Front Passenger's Airbag Inflator Kit	Inspect Before Installation

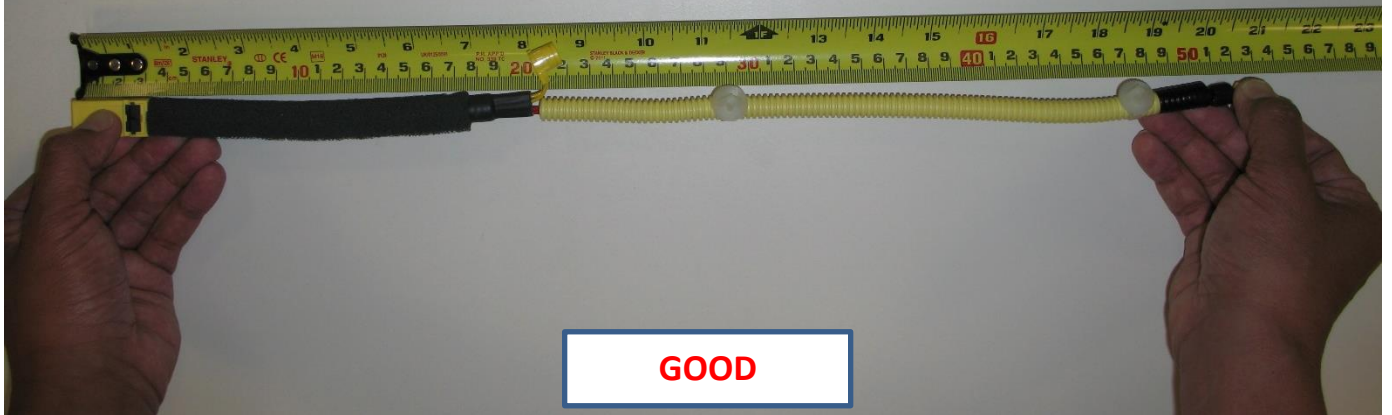
GOOD

The RED wire should measure 530 mm which runs the entire length of the harness (from the 4 pin prong to the 2 pin prong at the end)

- The yellow wire should measure 225mm and the red wire should be 530mm (image attached).
- The incorrect wire harness will also have a black felt tape around the red wire near the 2 pin prong that is in the center of the wire harness (image attached).

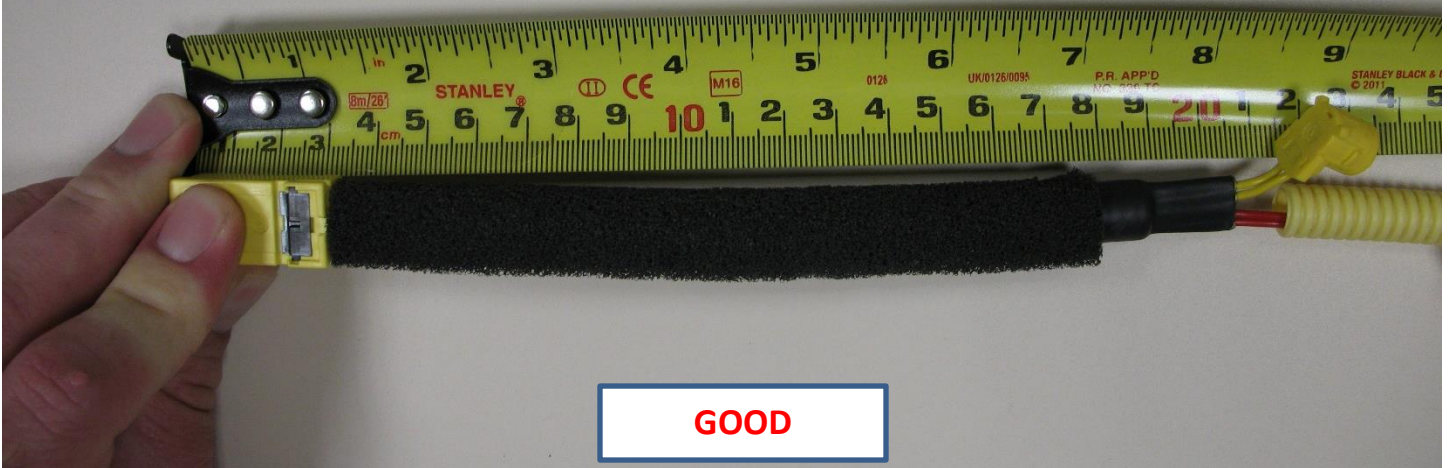
GOOD

The YELLOW wire should measure 225 mm (from the 4 pin prong to the center 2 pin prong)

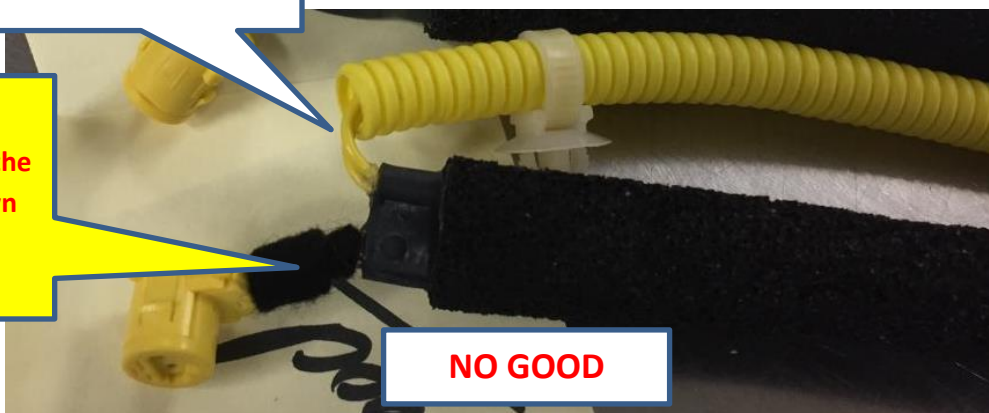
NO GOOD

This is the incorrect wiring harness. The yellow wire was INCORRECTLY installed. (DO NOT USE!)

Black felt tape should not cover the red wire as shown here

- Do **not** replace the incorrect harness with a harness from another kit; you **must** keep the incorrect harness within the inflator kit packaging that it was originally shipped.

- If the harness does not match the correct images, keep the kit separate from your other stock and email the following information to ahm_inflator_swap@ahm.honda.com with the subject line "PN 04790-SWA-407 Harness Issue":

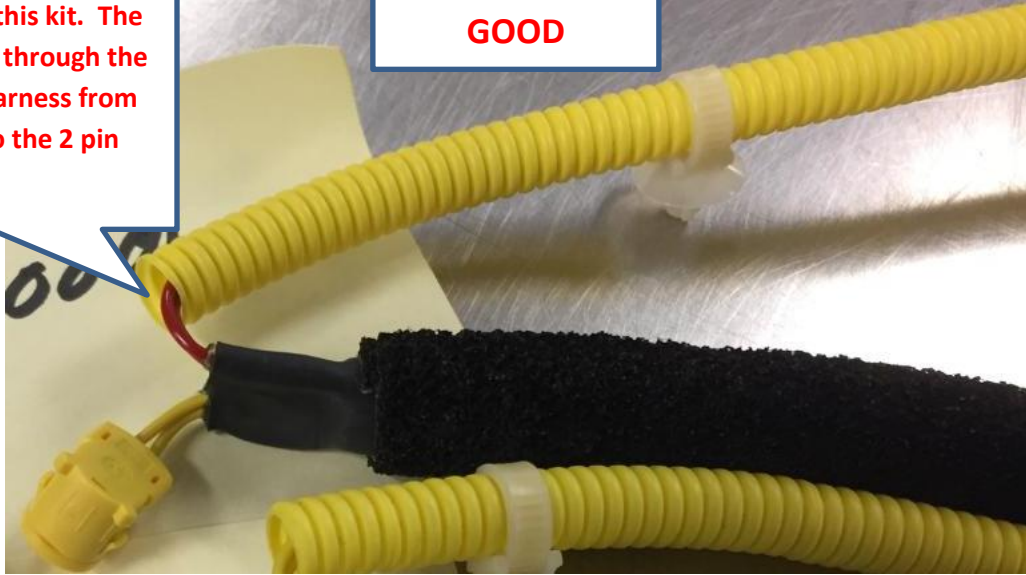
GOOD

This is the correct wiring harness you should see for this kit. The red wire should run through the full length of the harness from the 4 pin prong to the 2 pin prong.

- If the wire harness is correct, you may proceed accordingly and install the inflator kit per the applicable service

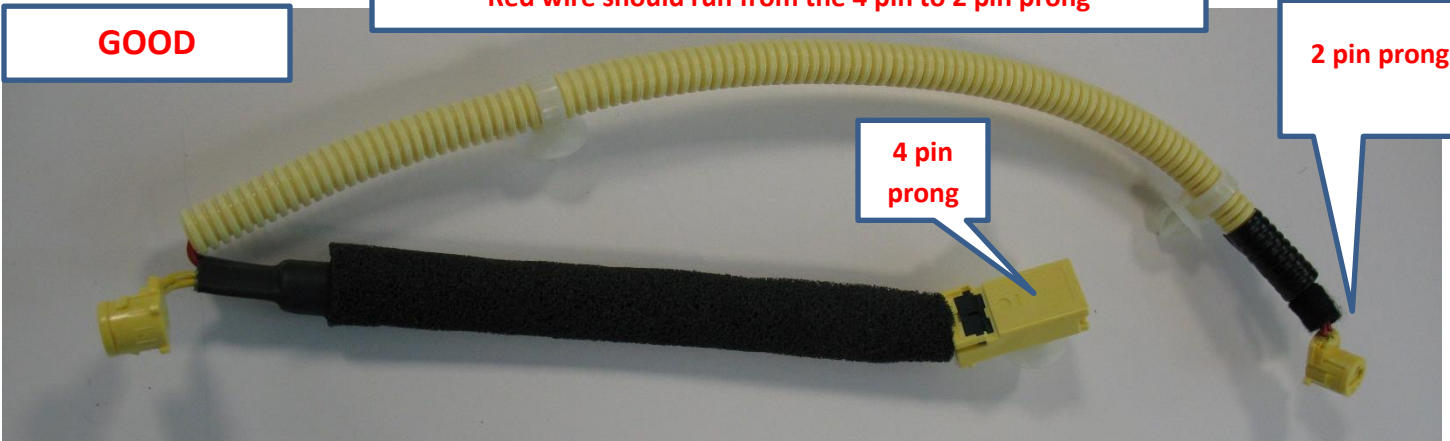
Red wire should run from the 4 pin to 2 pin prong

4 pin prong

2 pin prong
