| RE: <b>Recall Campaign Launch Notification – 2019030017 Takata PG5 DRIVER and PASSENGER AIRBAG Zone A</b><br>Certain MY11 W204 (C-Class), MY12 X204 (GLK-Class), and MY 2011-2015 SLS Coupes and Roadsters vehicles | DATE: March 26, 2019 |

| Recall Campaign Launch Notification | | | March 26, 2019 |
|---|---|---|---|
| Campaign No. : | NHTSA ID: 16V081<br>16V363/17V017<br>18V043/19V010 | Campaign Desc. : | Takata Recall – PG 5<br>Driver and Passenger Airbag |

SUBJECT: **Model 204, X204 and 197**  
**Model Years 2011 – 2015**  
**Replace Driver-Side and Front Passenger-side Airbag**

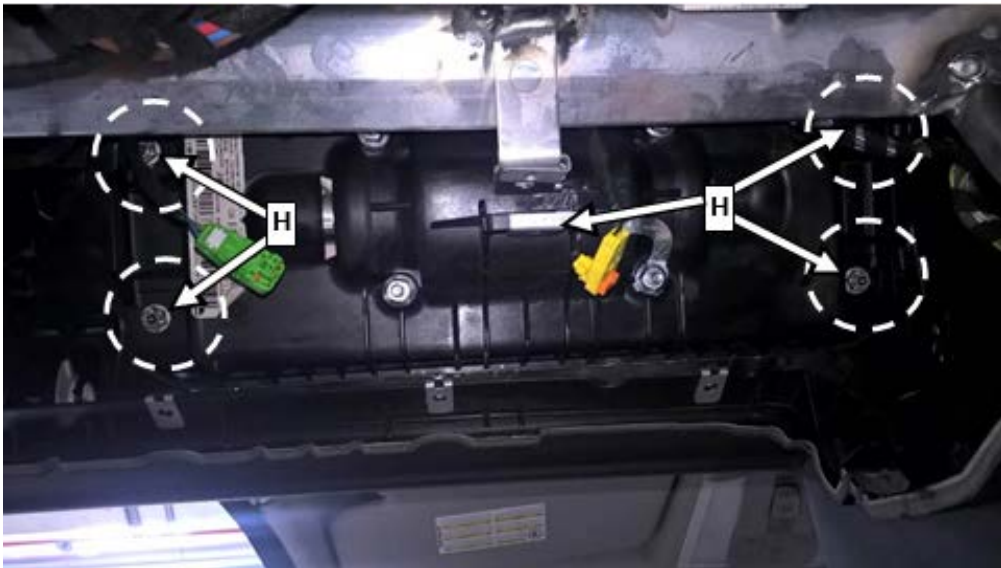
Figure 11

13. Remove lock nuts (**H**, **figure 11**) for the front the passenger airbag.

**i** Lock nuts should only be replaced if they are damaged. For more info see: **AH00.00-N-0001-01A / Modification notes 27.10.2016**
