| RE: <b>Recall Campaign 2018070014 Takata- Priority Group 4++ Ever-Registered in Zone A Replace Driver-side Airbags – Certain MY08-09 W204 (C-Class)</b> | DATE: August 28, 2018 |

# RECALL CAMPAIGN LAUNCH

SUBJECT: **Model 204 Model Years 2008 and 2009**  
**Replace Driver-Side and Front Passenger-side Airbag**

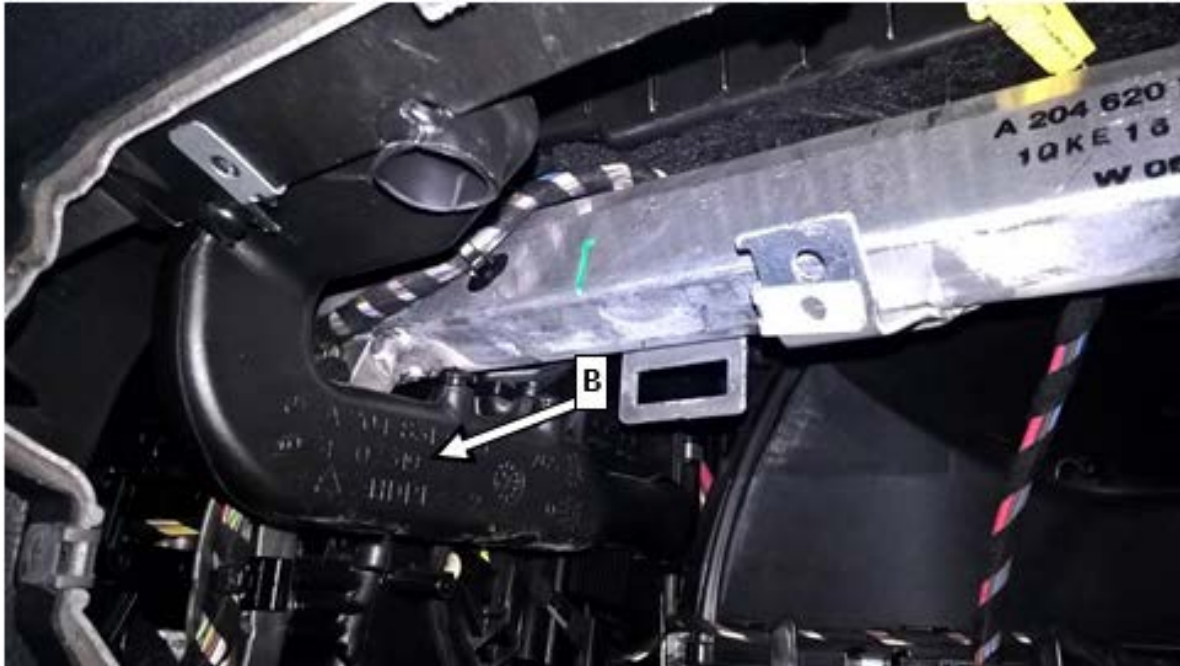
Figure 5

5. Remove air duct (**B**, **figure 5**) above the glove compartment.

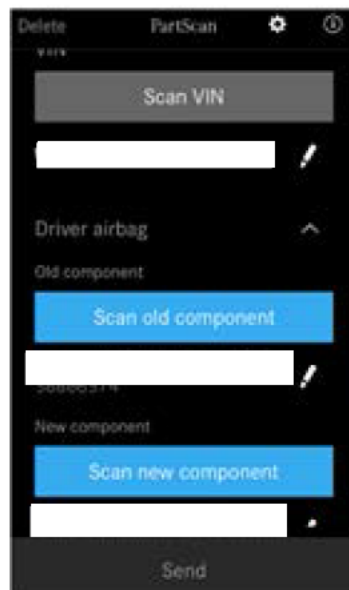
**Figure 13**

16. Scan barcodes of the removed driver airbag using the button "Scan old component" (figure 13).
  -

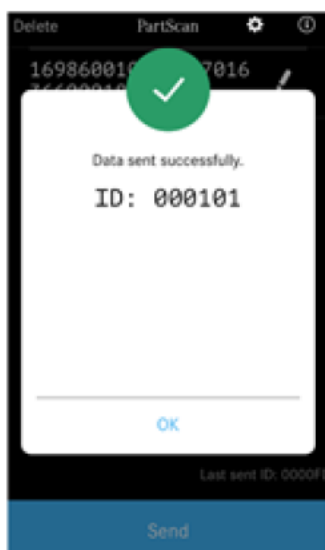
Figure 16

The generated scan ID (figure 16) must be recorded in writing in the workshop order and then stored in a tamper-proof manner.

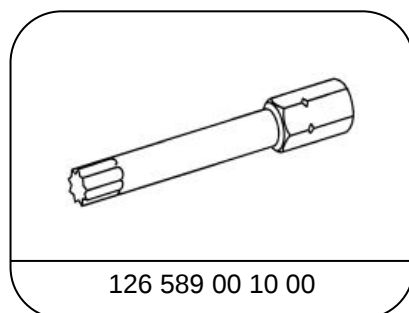
Screwdriver bit

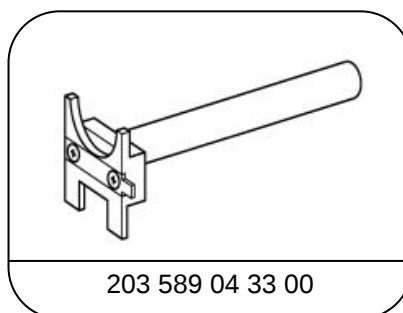
Removal lever (or locally sourced equivalent)

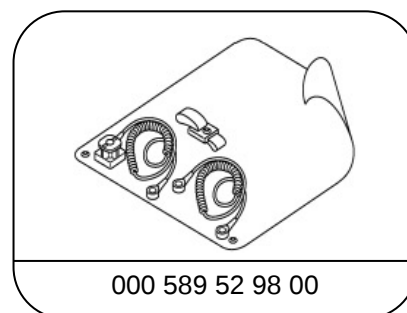
Electro Static Discharge (ESD) kit (or locally sourced equivalent)

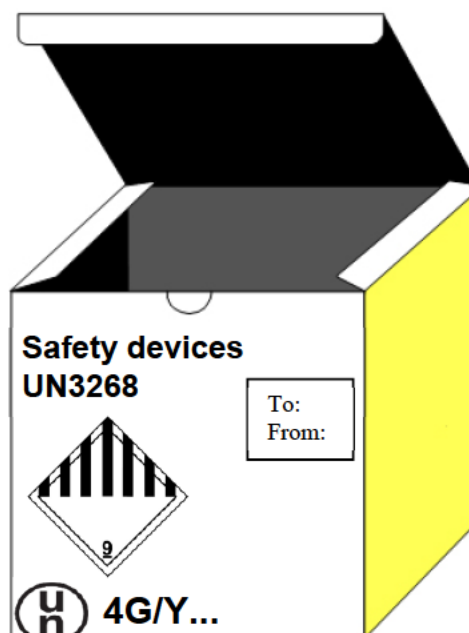
- The following words ("marking") must also be clearly visible on the same side of the box as the Class 9 label:  
**Safety devices**  
**UN3268** (font size must be  $\geq \frac{1}{2}$  inch)
- Affix "To/From" address label to same or adjacent packaging face as the hazardous markings/labels.
- The UN 4G code preprinted near the bottom edge of the box must also be clearly visible.

- Note:** The Packing Group and the EX# are no longer required to be printed on the HAZMAT bill of lading.
- Package example:**
