June 2016
FL712AB
NHTSA #16V-366

Subject: ZF IFS Front Axle Steering Gears

Models Affected: Specific Freightliner Custom Chassis motor-home chassis manufactured May 1, 2014, through June 16, 2015, with certain ZF North America front axles.

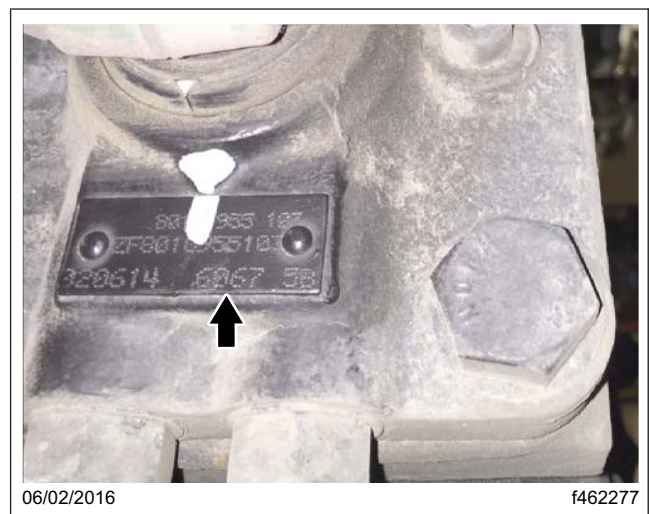
Fig. 2, Steering Gear Type Plate, Four-Digit Serial Number

2. Park the vehicle on a level surface, shut down the engine, and set the park brake. Using lifts, raise the vehicle.
NOTE: Due to the location of the type plate, it may be easier to maneuver a camera within the frame and take a picture of the type plate.
3. Locate the steering gear type plate on the input side near the intermediate shaft. See [Fig. 1](#). Record the four-digit serial number on the bottom right of the type plate. See [Fig. 2](#). Also record the axle serial number. (Both serial numbers are required on the claim.)

If the steering gear serial number is **not** 5545-5789, the steering gear does not need to be replaced. Clean a spot on the base label (Form WAR259), write the recall number, FL712, on a completion sticker (Form WAR260), and attach it to the base label.

If the serial number **is** within the suspect range of 5545-5789, the steering gear must be replaced. Go to *Steering Gear Replacement*.

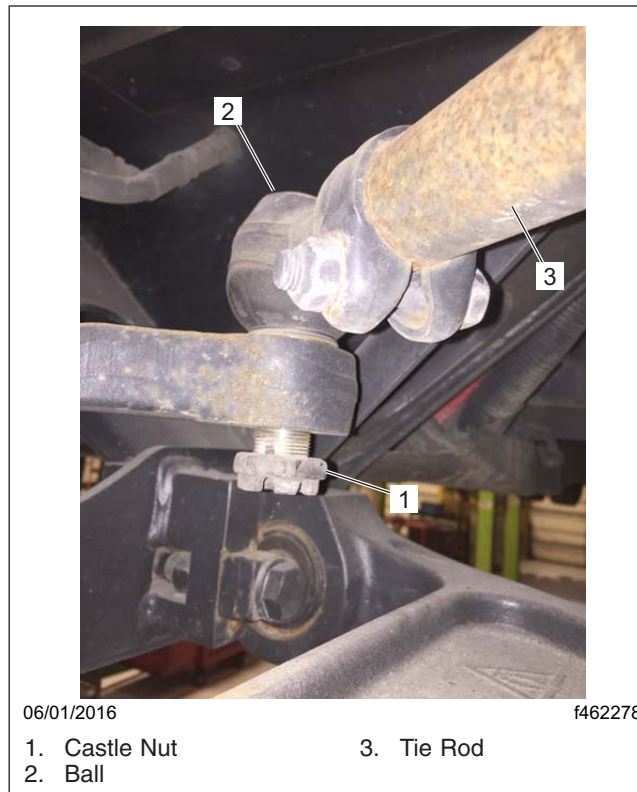
Fig. 3, Tie Rod Assembly

1. Disassemble the left and right tie rods from the pitman arm. See **Fig. 3**.

- 1.1 Remove the cotter pin.
- 1.2 Loosen the castle nut on the tie rod end.
- 1.3 Using an air/steel hammer or two arm puller, pop the joint from the pitman arm.
- 1.4 Using tie straps, secure the tie rods to the frame so they are out of the way.

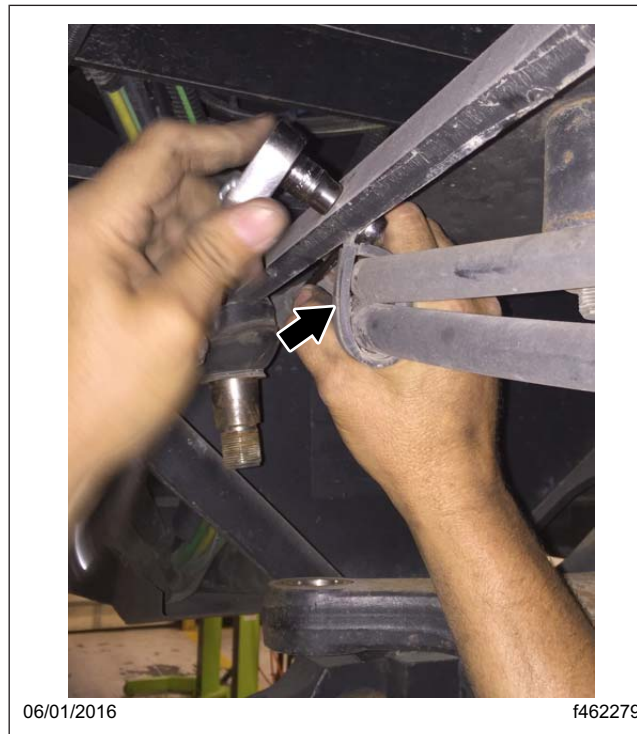
Fig. 4, Removing the P-Clip

2. Remove the P-clip that secures the hydraulic hoses to the frame. See [Fig. 4](#).

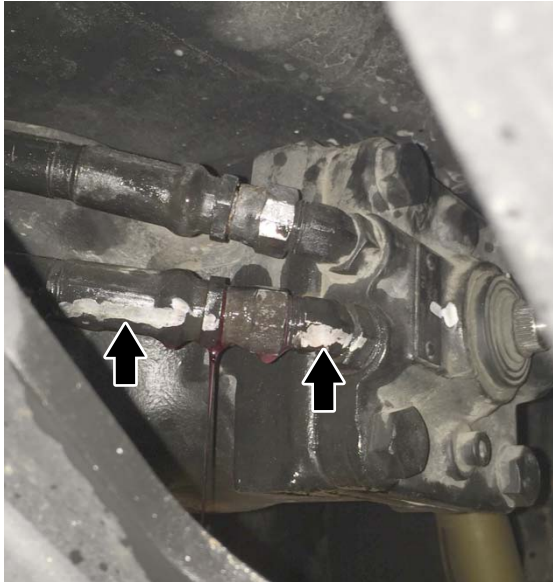
Fig. 5, Steering Gear Hydraulic Hoses

3. Place a drain pan under the hydraulic lines of the steering gear.
4. Mark the hydraulic hoses and the fittings at the steering gear for identification later. See [Fig. 5](#). Disconnect the hoses and remove the fittings from the steering gear. Put the fittings aside in a clean area free of dust and debris.
 - 4.1 Plug the connectors on the hoses and steering gear with caps to prevent fluid from bleeding out. See [Fig. 6](#). If caps are not available, drain the system according to shop practice.
 - 4.2 Using tie straps, secure the hoses to the frame so they are out of the way.

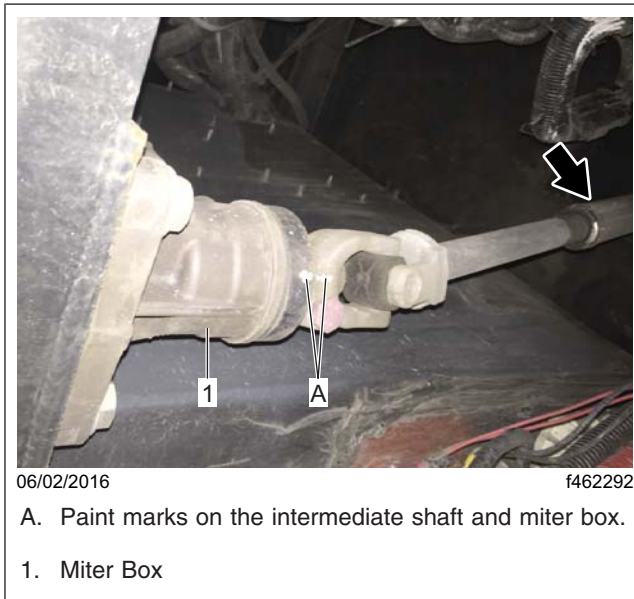
Fig. 7, 90-Degree Miter Box and Intermediate Shaft

IMPORTANT: Ensure that the steering wheel is centered before marking the intermediate shaft and the 90-degree miter box.

NOTE: It will help to mark the position of the intermediate shaft at the 90-degree miter box before removal. This will make it easier to align during installation. See [Fig. 7](#).

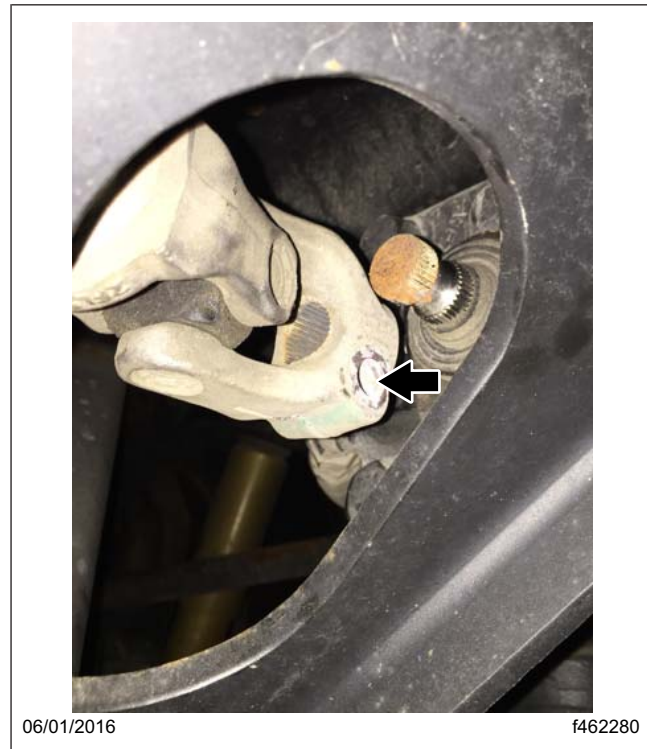
Fig. 8, Intermediate Shaft Disconnected (pinch bolt removed)

5. Disconnect the intermediate shaft. See [Fig. 8](#).
 - 5.1 Remove and discard the pinch bolt from the U-joint of the intermediate shaft.
 - 5.2 Spread the joint slight using a pry bar in the slot to increase the gap.
 - 5.3 Slide the U-joint forward and out of the way.

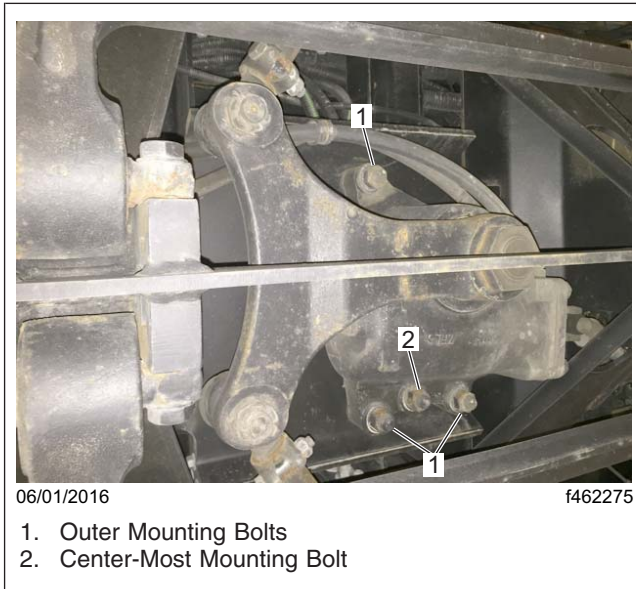
Fig. 9, Steering Gear Mounting Bolts

6. Remove the steering gear.
 - 6.1 Loosen, but do not remove, the four mounting bolts.
 - 6.2 Leaving the center-most mounting bolt assembled to prevent the steering gear from falling, remove the other three bolts. See [Fig. 9](#).
 - 6.3 Position shims across the lower control arms and use a jack to support the steering gear when disconnected. See [Fig. 10](#)

- 9.1 Using a jack and shims, position the new steering gear in the proper installation position. See [Fig. 14](#). and [Fig. 15](#).
- 9.2 Using the four mounting bolts, secure the steering gear. Tighten the bolts 361 lbf·ft (490 N·m). See [Fig. 9](#).

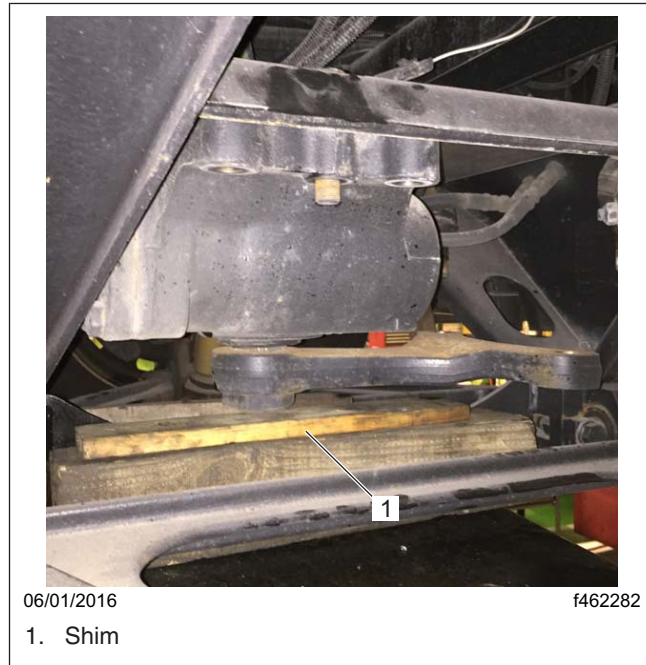
Fig. 10, Positioning the Shims

NOTE: Remove the steer box through the passenger side of the axle (by the pitman arm), while rotating the the steering gear down onto the shims.

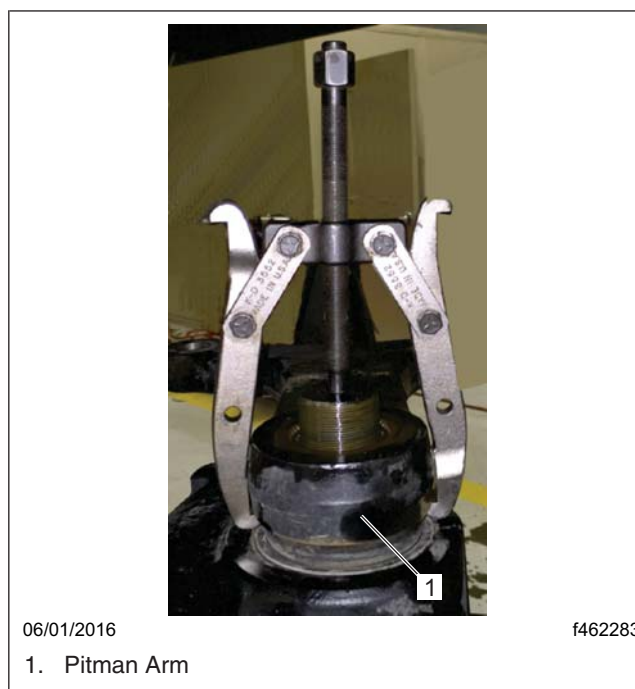
Fig. 11, Removing the Pitman Arm with a Two-Arm Puller

NOTE: The pitman arm-to-steer gear is a press fit, so the two-arm puller will need to be large enough so that an impact gun can run down.

- 7.1 Loosen the locknut securing the pitman arm to the box.
- 7.2 Using a two-arm puller, remove the pitman arm from the box. See [Fig. 11](#). If necessary, hit it with a steel hammer to loosen and break free.

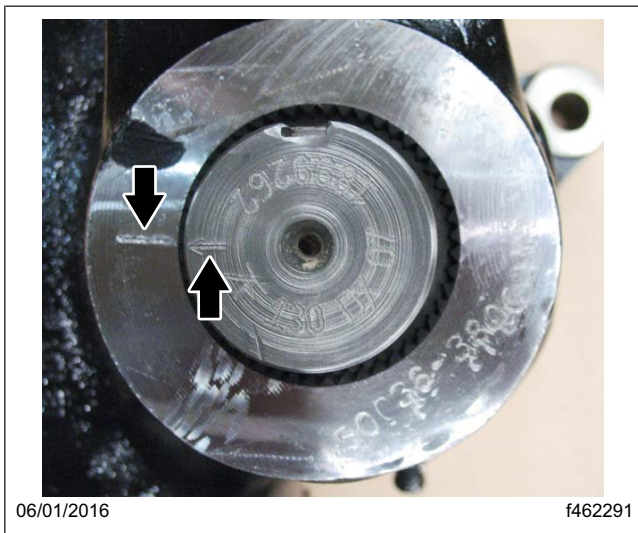
Fig. 12, Alignment Marks on the Shaft of the Steering Gear and Pitman Arm

IMPORTANT: During the installation process, take care to minimize the rotation of the pitman shaft as much as possible while removed in order to avoid changing the steering wheel alignment.

8. Install the pitman arm on the new steering gear. Make sure the alignment marks on the shaft of the box and the pitman arm match up. See [Fig. 12](#) .
 - 8.1 Line up the splines on the pitman arm with the correct steering position of the box.
 - 8.2 Using an impact gun, tighten the locknut until the pitman arm is pressed all the way onto the shaft. Tighten 420 lbf·ft (570 N·m).
 - 8.3 Using a punch, stake the locknut. See [Fig. 13](#).

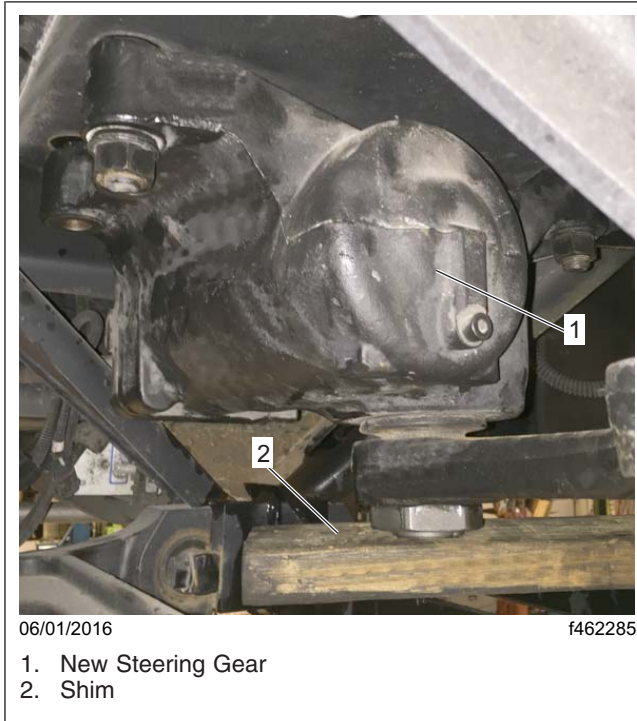
Fig. 14, New Steering Gear Installation

NOTE: Install the steer box through the passenger side of the axle (pitman arm first), while rotating the steering gear up and into position.

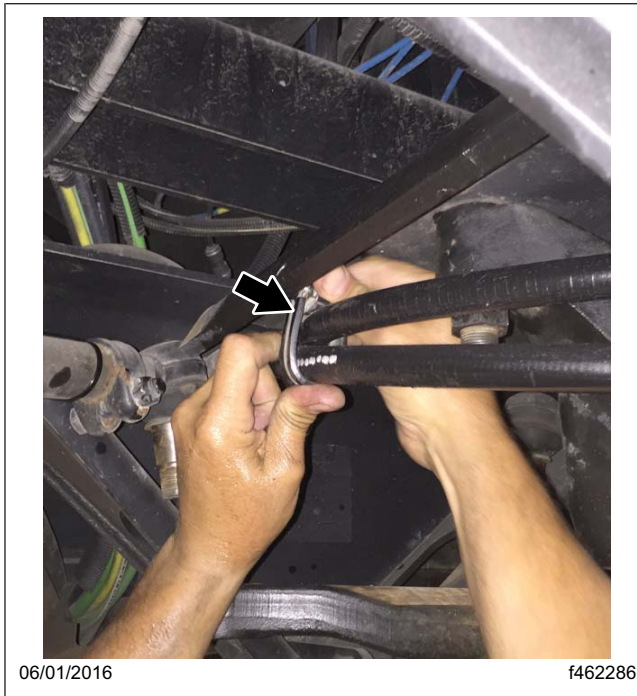
Fig. 16, Mounting the Hydraulic Hoses to the Frame

10. Place a drain pan under the steering gear and hydraulic hoses.
 11. Using the identification marks made earlier, install the hydraulic fittings removed earlier. Orient and tighten the hydraulic hoses to the steering gear. Tighten the hoses 60 lbf·ft (80 N·m). See
 12. Using a P-clip, mount the hydraulic hoses to the frame. See [Fig. 16](#)
 13. Connect the intermediate shaft onto the steering gear.
- NOTE: Ensure that the intermediate shaft is properly aligned by aligning the marks on the 90-degree miter box. See [Fig. 7](#).
- 13.1 Slide the intermediate shaft U-joint onto the steering gear input shaft. See [Fig. 17](#).
 - 13.2 Install a new pinch bolt in the U-joint and tighten with a new locknut. Tighten 35 lbf·ft (48 N·m).
 - 13.3 Apply white Torque Seal F-900 on the exposed pinch bolt threads and locknut.

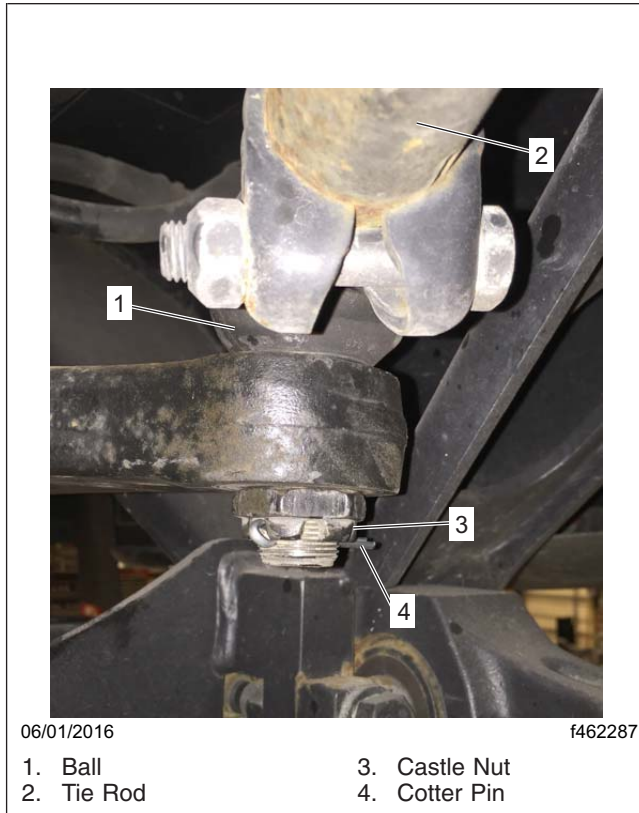
Fig. 18, Tie Rod Installation

NOTE: Coat the tie rod end ball with 15/40 oil before tightening the tie rod end fasteners.

- 14.1 Insert the tie rod end in the pitman arm taper. Connect the tie rod end. See [Fig. 18](#).
- 14.2 Tighten the castle nuts on the left and right sides 184 lbf-ft (250 N·m).
- 14.3 Install the cotter pins. See [Fig. 19](#).
