# Recall Campaign

Daimler Trucks  
North America LLC

FL713AB

## Subject: TBB Emergency and Non-Emergency Door Handle Stems

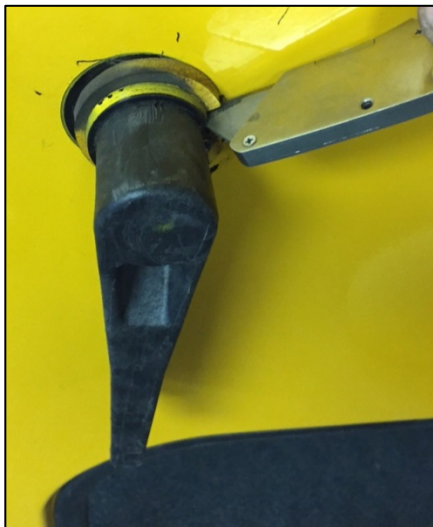
Figure 1, Cutting Washers

1. Chock the wheels, set the parking brake, make sure the shifter is in Park or Neutral. Disconnect the battery and the ignition switch is off.
2. Remove the washers between the external door handle and the door facing. Use a razor knife to slice through the large washer and then the smaller diameter plastic washer. Slide something under the washers to keep from damaging the paint on the door. See **Figure 1**.
3. Pull the washers off with needle nose pliers and discard the washers. See **Figure 2**.

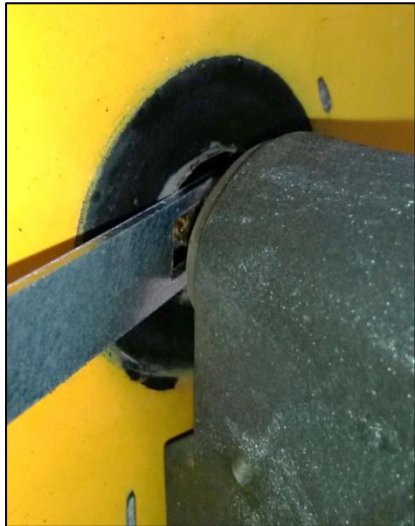
Figure 3, Using the Go/No Go Gauge

4. Once the washers are removed, use the go/no go gauge (TBB 204666 from kit TBB 204971) to verify the stem material is of sufficient thickness for operation. Try to slide the gauge over the smallest thickness of the stem on each of the four sides. See **Figure 3**. If the gauge is able to slide completely on at any point of the stem, go to "Replacement of Interior and Exterior Door Handles." See **Figure 3** for use of the gauge.
5. After verifying the gauge will not slide over the stem, apply a liberal amount of protectant over the entire stem (inside and outside the door cavity). Use an approved corrosion protectant such as WD-40 purchased locally. If any of the protectant liquid gets on the paint or exterior handle, remove it as quickly as possible with an alcohol-based wipe. See **Figure 4**.

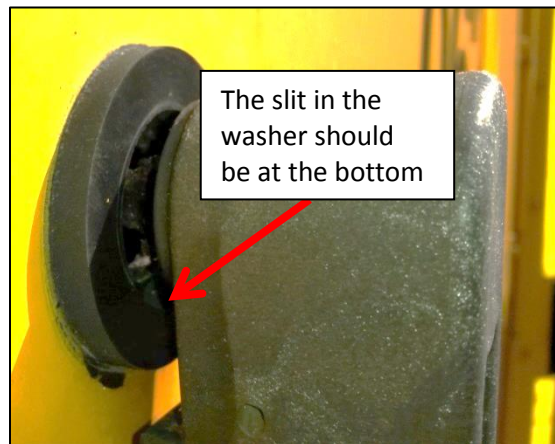
Figure 5, Position of Slit in Washer

7. Make sure the painted surface around the stem opening is clean and dry. Remove the paper backing from the washer and place the adhesive side on the door around the external handle. Make sure the washer slit is installed on the bottom side of the opening. There will be an opening between the exterior washer and the door handle. See **Figure 5**.

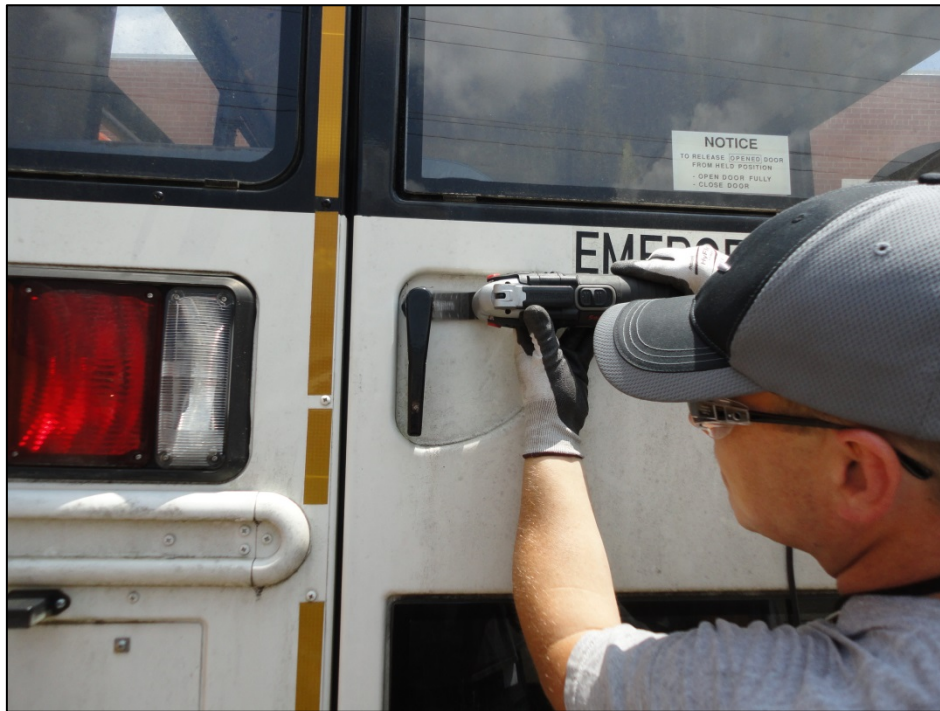
**Figure 6, Cutting Off the Stem and Exterior Door Handle**

1. Close and lock the door to keep it steady while performing next step.
2. Cut the stem and exterior door handle off. This can be performed with an oscillating tool or similar. See **Figure 6**.

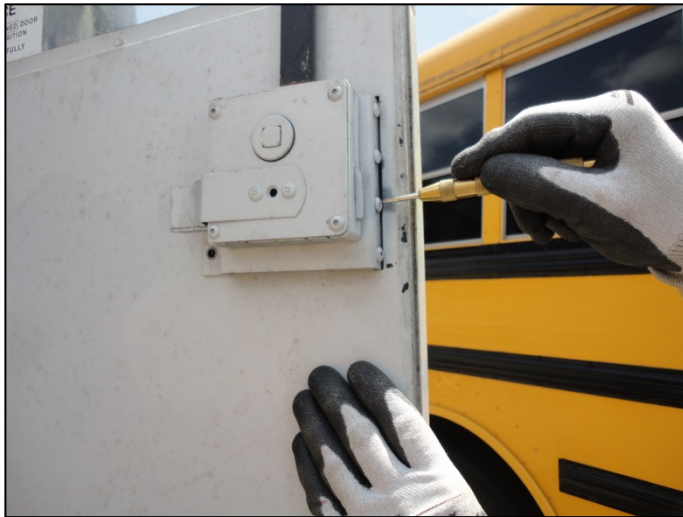
**Figure 7, C2 Mounting**

3. Enter the bus and open the emergency door. Return to the back of the bus.
4. Remove the fasteners on the interior locking mechanism using a punch and/or drill bit.  
C2 rear emergency doors will have four (4) rivets used for mounting the mechanism to the door bracket. Included in kit TBB 204987 are four (4) #12 screws to be used as replacement fasteners for the rivets. See **Figure 7**.

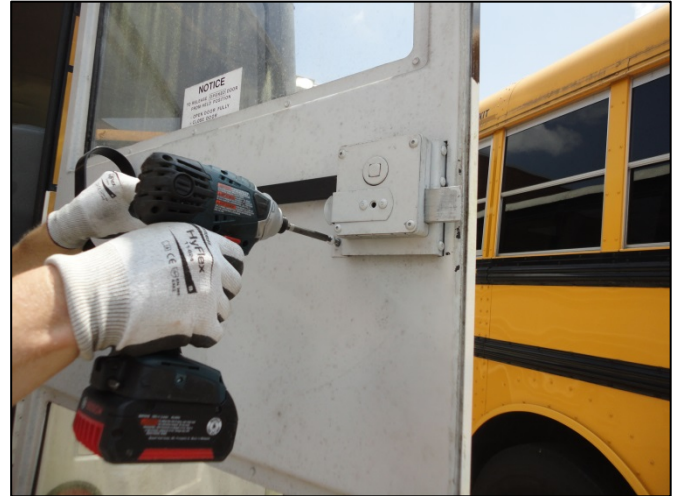
**Figure 8, Legacy Mounting**

Legacy products will have screws used for mounting the mechanism to the door. Remove and retain these screws for replacement. See **Figure 8**.

5. Remove the two screws on the left side of the locking mechanism and retain them for replacement.  
See **Figure 8**

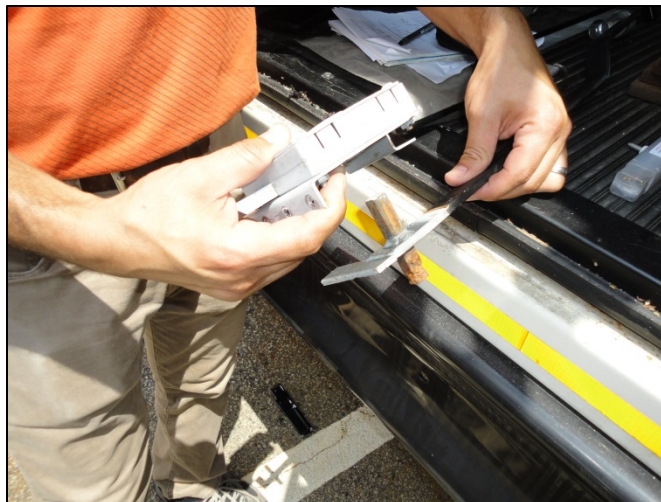
**Figure 9, Removing the Locking Mechanism**

6. Pull the locking mechanism and handle off the door. Lay the locking mechanism on the side the handle is not on and pull the handle shaft out of the locking mechanism. See **Figure 9**.

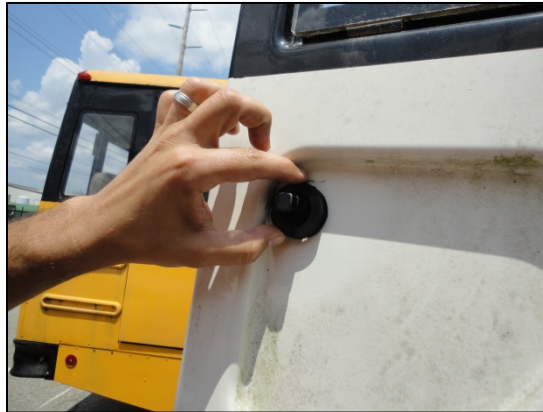
**Figure 10, Installing the New Washer**

9. Remove the paper covering the adhesive off back of the new washer and install it around stem. Make sure the washer slit is installed on the bottom side of opening. See **Figure 10**.

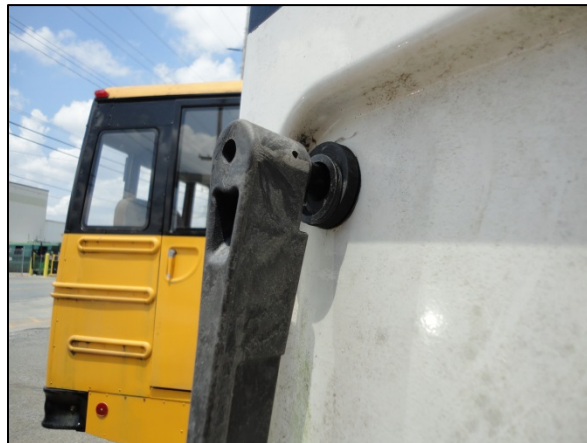
**Figure 11, Position of Newly Installed Exterior Handle**

10. Close the emergency door using the interior door handle. Make sure the interior handle is in the closed position. The closed position is when the interior handle is pushed all the way down to a horizontal position.
11. The exterior door handle must be installed in a vertical orientation. See **Figure 11**.

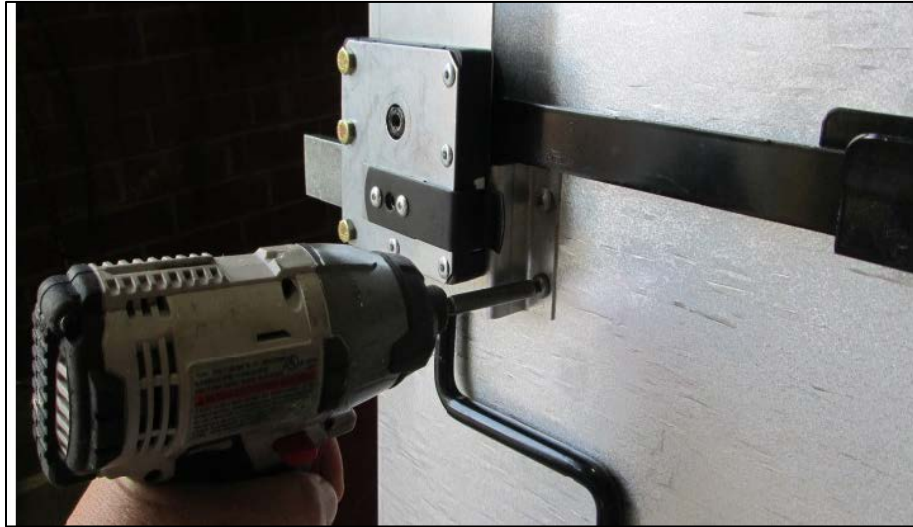
Two Screws from the Latch Assembly

2. Using an impact driver with a #3 Roberson bit, remove the two #12 screws from the door latch assembly. See **Figure 14**.

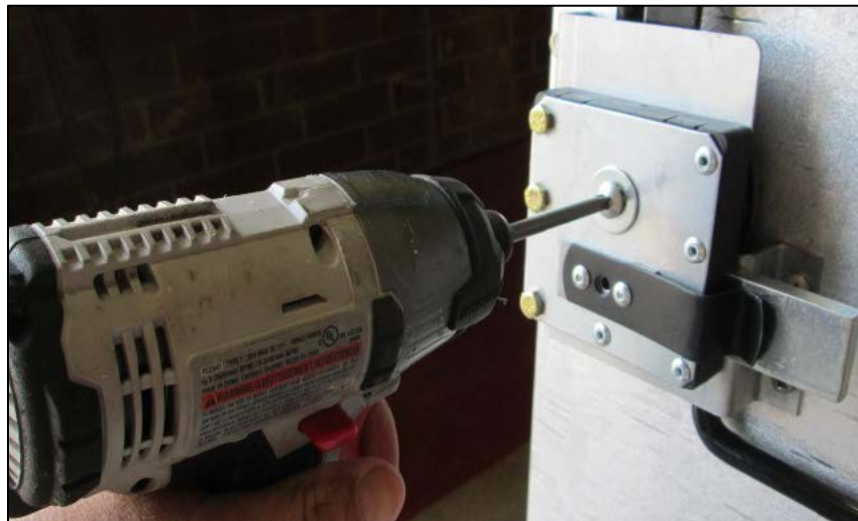
Figure 15, Removing the Bolt and Washers from the End of the Shaft

3. Changing to the Phillips P3 hex shank bit, remove the bolt, lock washer, and fender washer from the end of handle stem. Retain for reinstallation. See **Figure 15**.

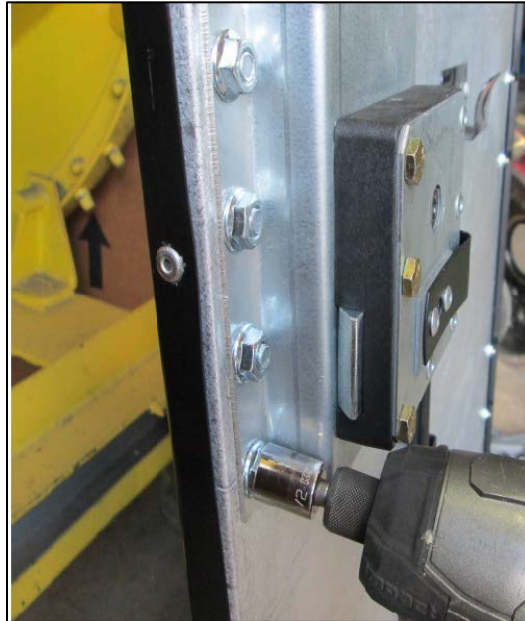
Figure 16, Removing 4 Nuts from the Door

4. Using a 1/2 inch socket, remove the 4 nuts on other side of mechanism. Retain for reinstallation. See **Figure 16**.

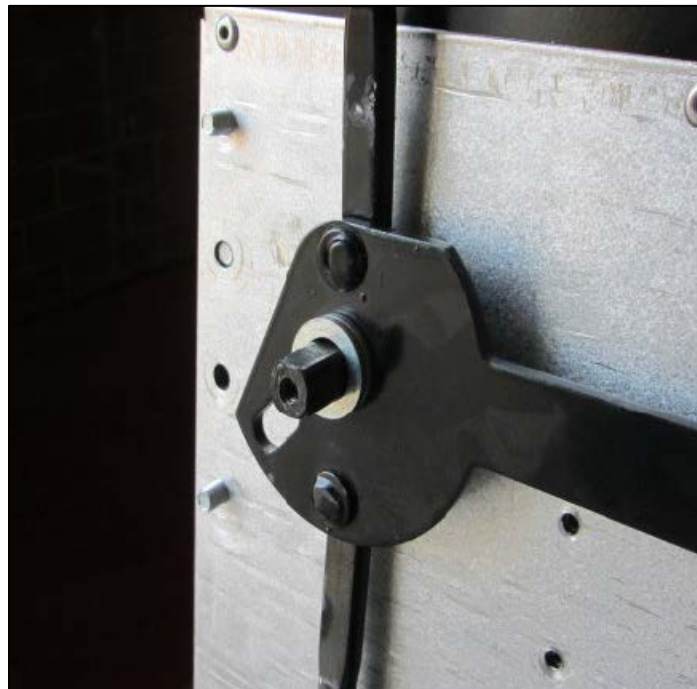
Figure 17, Handle and Shaft Mechanism Without the Latch Assembly

5. Remove the latch assembly. The handle and the rod assembly will still be on the stem. Use a dead blow hammer to separate the latch assembly from the stem and handle if needed. See **Figure 17**.

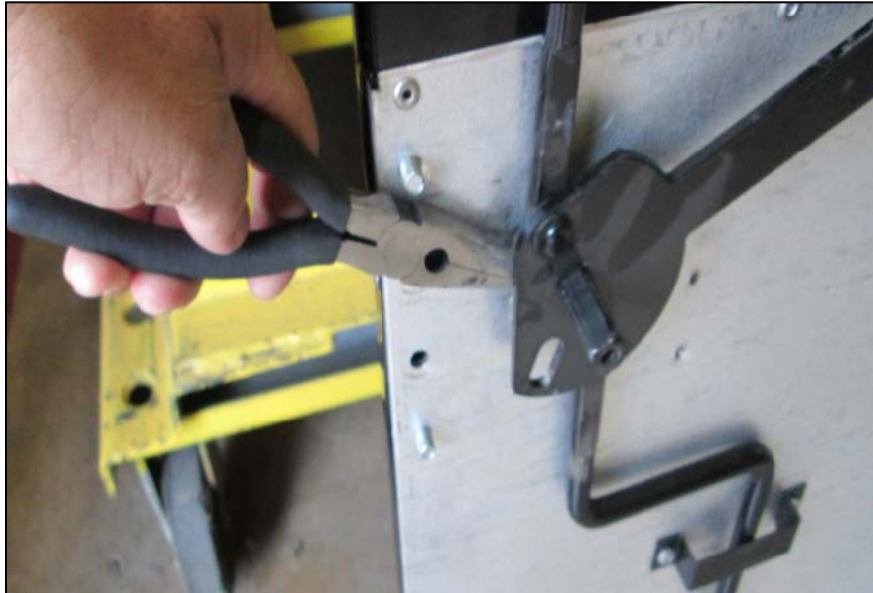
**Figure 18, Bending the Roll Pin**

- Using a pair of large needle nose pliers, grab the roll pin (previously hammered flush) and bend back and forth until it breaks off. See **Figure 18**.

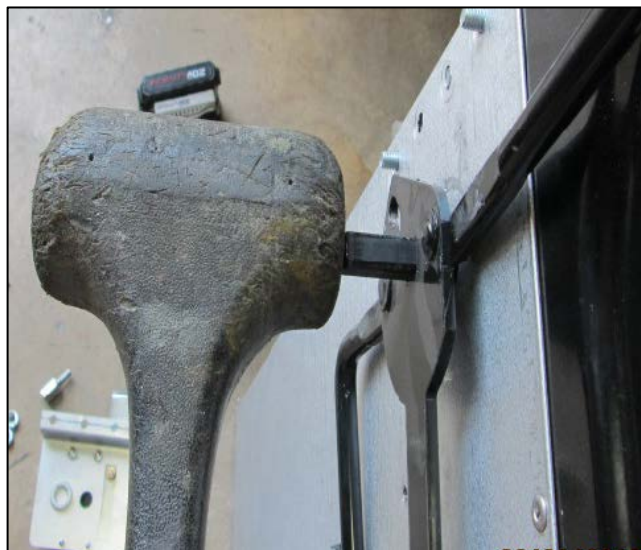
**Figure 19, Tapping Out the Stem**

- Using a dead blow hammer, tap the stem until the handle and stem come out of the exterior side of the door. Prevent the handle and stem from falling and damaging the exterior of bus.

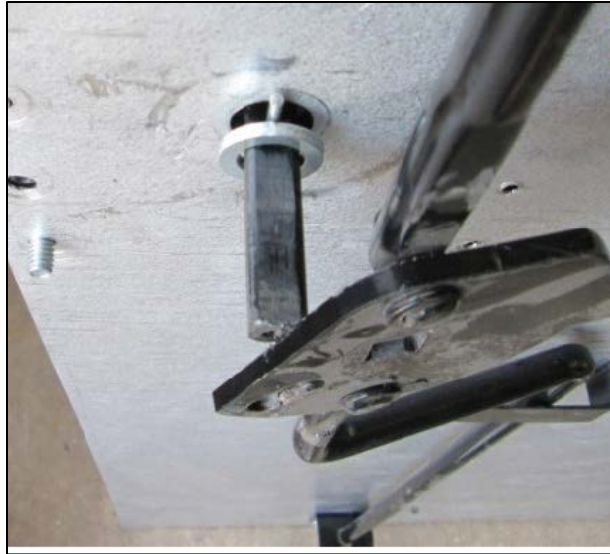
**Figure 20, Inserted Pin and Washer**

1. Put the new stem through the hole in the door, install the new roll pin (TBB 69006223) in new stem and put a washer on opposite side. See **Figure 20**.

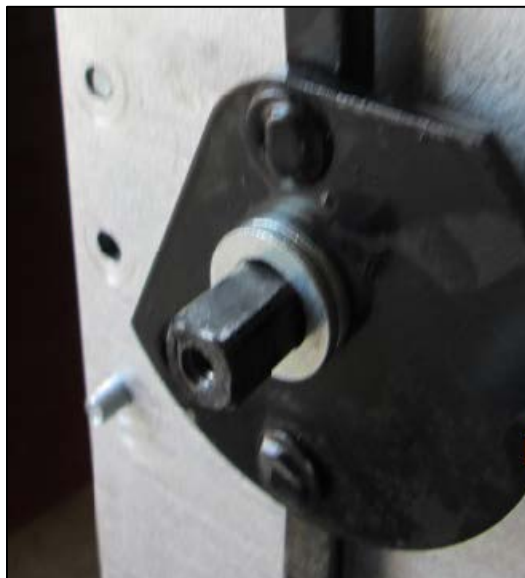
**Figure 21, Handle and Rod Assembly on the Door Handle Stem**

2. Put the handle and rod assembly over door handle stem. Place the two remaining washers on the door handle stems. See **Figure 21**.

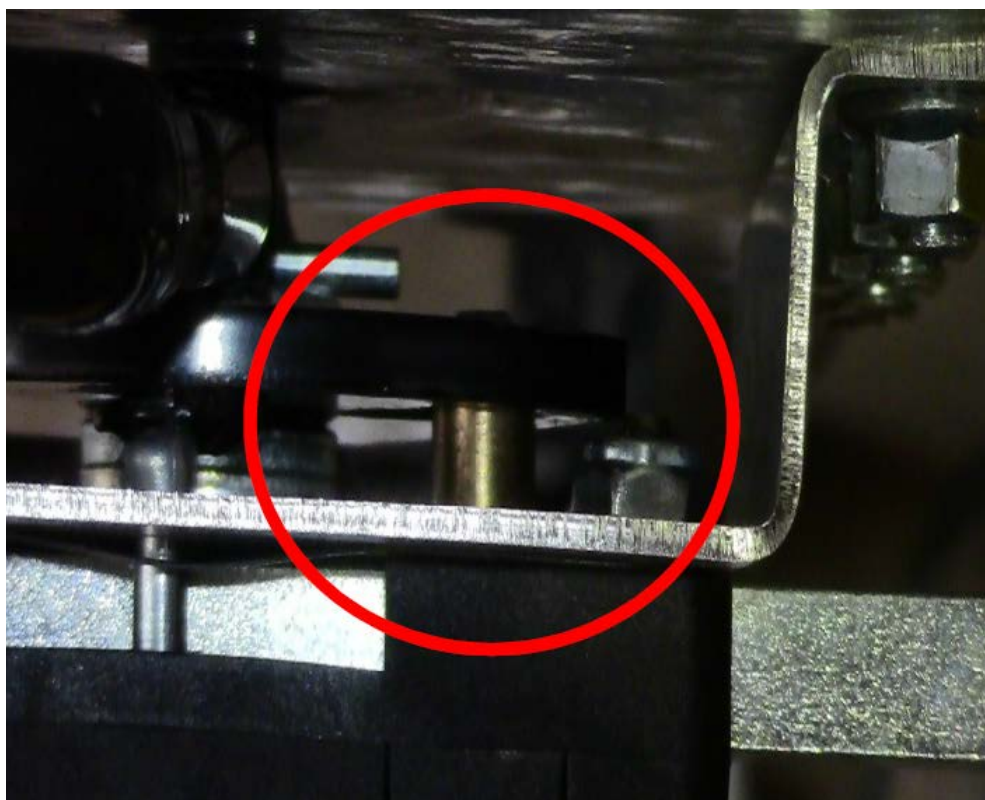
**Figure 22, Guide Bushing Inserted in the Handle Slot**

3. Install the latch assembly with the guide bushing inserted in the handle slot on the handle assembly.  
See **Figure 10**.

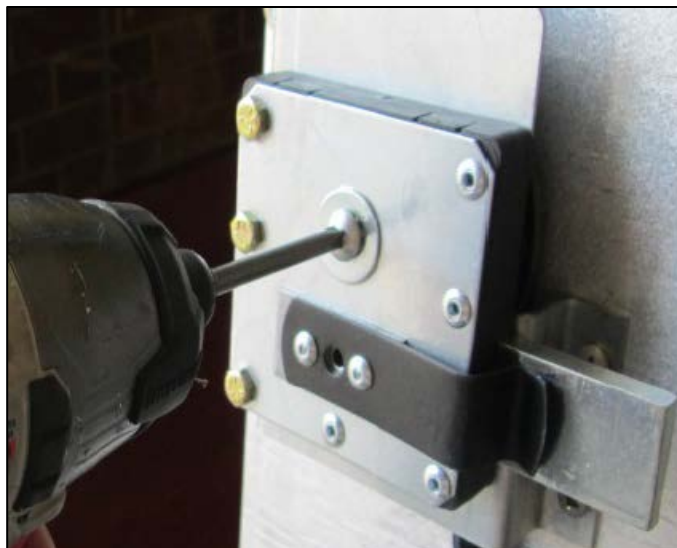
**Figure 24, Reinstallation of Bolt, Lock Washer, and Fender Washer**

5. Reinstall the bolt, lock washer, and fender washer. See **Figure 24.**

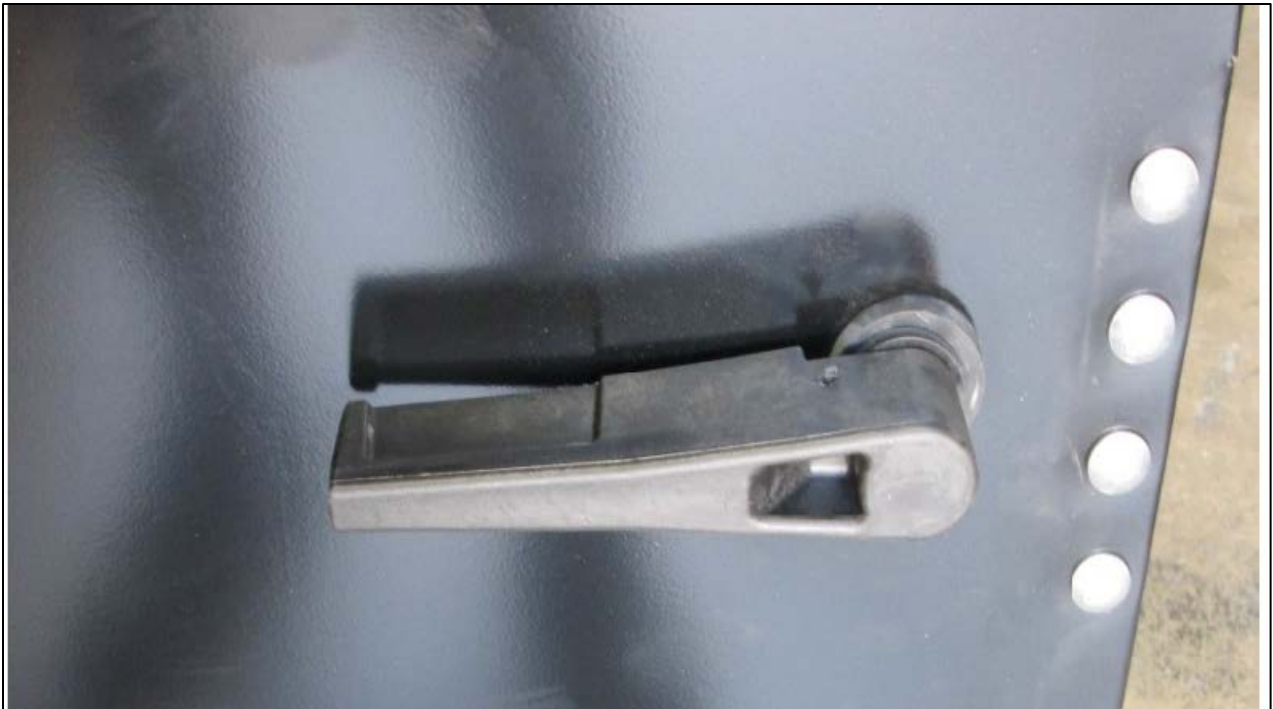
**Figure 25, Exterior Handle Installation**

6. Install the washer from the inspection kit (TBB 204971). Tap the outside handle (TBB 204988) onto the stem. Insert the roll pin in the handle and tap into place. Use a 1/8" pin punch to position roll pin. The exterior handle orientation and interior handle orientation must match. See **Figure 25**.
