MAZDA DEALER EMAIL

To: Dealer Principals, GMs, Sales Managers, Service Managers and Used Car Managers Subject: Certifying and Reporting CPO Sales on vehicles subject to Recall 9916H.

Certified Pre-Owned (CPO) Vehicles With Open Recall 9916H Limited Exception Process if Remedy Not Yet Available

Attachment 1 - Vehicle Corrosion Inspection Procedure Instructions

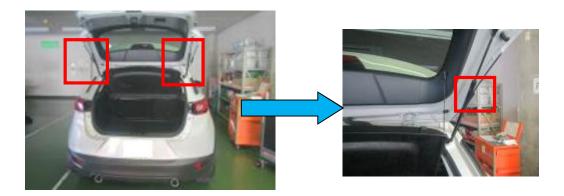
<u>Liftgate Stay Damper Visual Inspection:</u>

- 1. Open the liftgate.
- 2. Check for crack(s) and/or rust/corrosion on the liftgate stay damper covers.

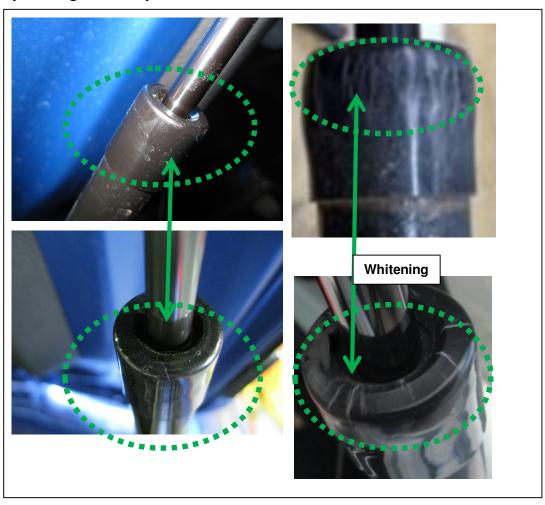
Examples of good dampers:

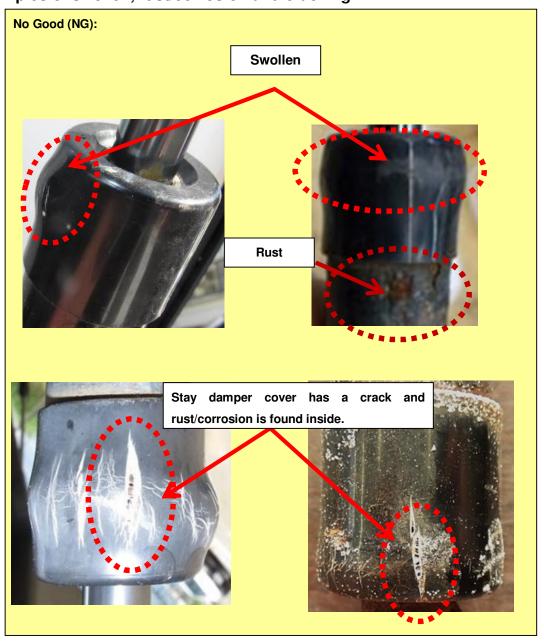
Examples of swollen, rust/corrosion and cracking:

Result	Next Step	
NO swollen, rust/corrosion, cracking conditions found on either side: Note: Slight white discoloration (no cracks) on end cap is OK.	 Do not perform any repairs at this time. Customer will be asked to bring their vehicle back to the dealer when replacement parts are available. CPO vehicle(s) can be sold and will be repaired when replacement parts are available. 	
Swollen, rust/corrosion, cracking conditions found on one or both sides:	Parts are not available. Parts are available.	 Rental car offered to customer until the replacement parts are available and repair is completed. CPO vehicles cannot be sold and cannot be certified as CPO. Send VIN to DSM. Replace both stay dampers with modified parts.
