SUBJECT: 2013-2016 CX-5, 2010-2013 Mazda3, 2012-2015 Mazda5 and 2016 CX-3
Lift Gate Stay Damper Concern - Safety Recall 9916H

MULTI-MODEL - LIFTGATE STAY DAMPER SAFETY RECALL 9916H REPAIR PROCEDURE

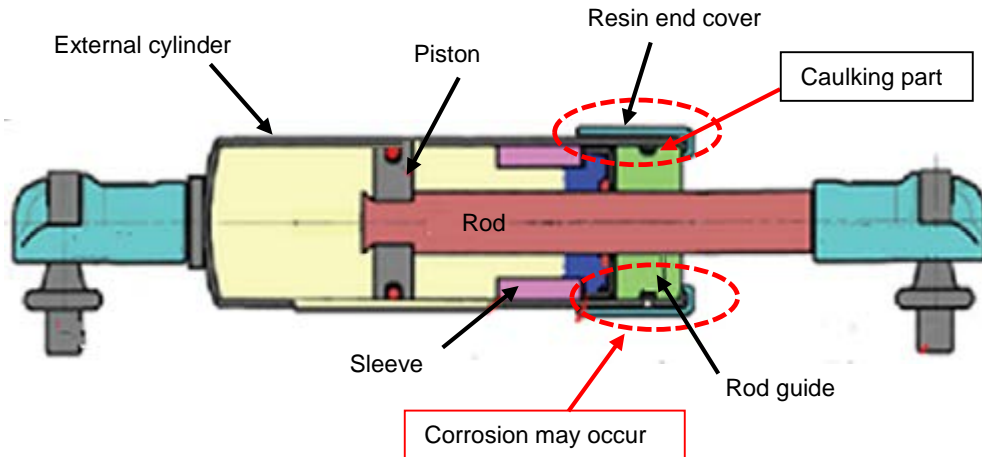
Lift gate Stay Damper

The rustproof coating on the lift gate stay dampers of the subject vehicles, applied to the end of the external cylinder, may not provide sufficient protection from corrosion. Salt water intrusion may cause the end of the cylinder to become corroded. Over time, increased corrosion may cause it to break as the lift gate is operated. The lift gate could drop suddenly, and the broken parts may injure people near the vehicle.

The purpose of this recall is to replace the lift gate stay dampers with modified ones. Please refer to Repair Procedure document on MS3.

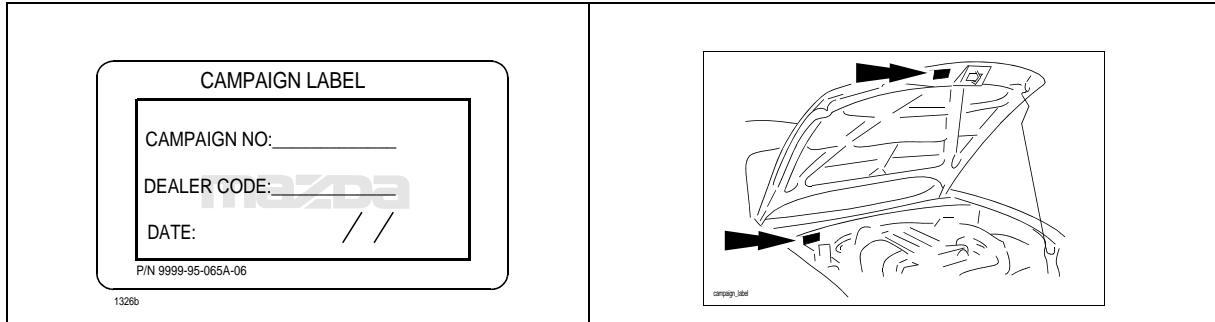
- Perform a Warranty Vehicle Inquiry using your eMDCS System and inspect vehicle for Campaign Labels **Recall 9916H** attached to the vehicle's hood or bulkhead. Refer to eMDCS System - Warranty Vehicle Inquiry Results table below.

NOTE: Be sure to verify Recall number as the vehicle may have multiple Recall labels.

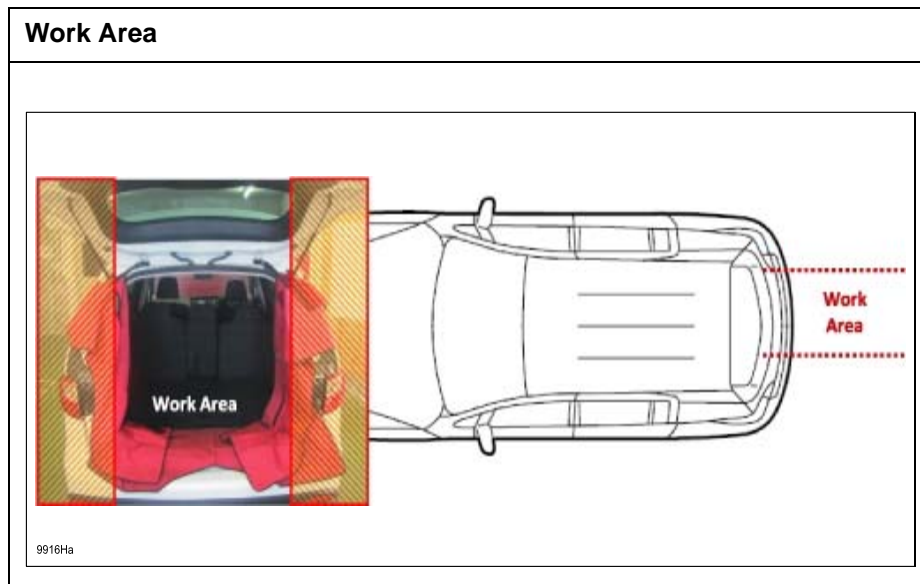
CAUTION: Mount fender covers (as shown below) onto the vehicle to avoid scratching the painted surface of the body, bumper cover and lift gate.

- Avoid working directly in front of the stay damper(s). Work from the center of the vehicle in the work area (as shown below).
- Work in an area where there are no other vehicles parked behind the subject vehicle.
- **Do not work on both side stay damper at the same time.**
- **Replace one stay damper at a time.**

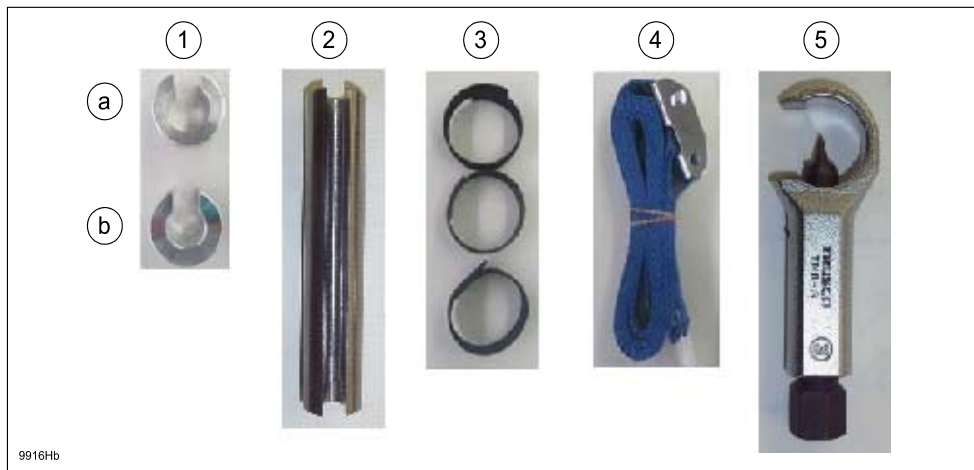
Tool Kit

1a	Gauge Tool - Large Inner Diameter (Mazda5, and CX-5)	3	Bands
1b	Gauge Tool - Small Inner Diameter (Mazda3 and CX-3)	4	Tie-Down Strap
2	Support Cylinder	5	Degassing Tool

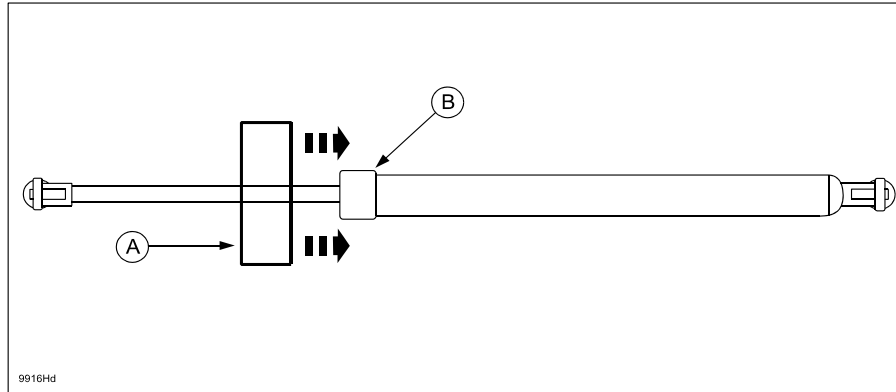
- From the rod side of the stay damper, use the gauge tool (A) to pass over the resin cover (B) of the stay damper (as shown below).

NOTE: In order to confirm a small bulge in the resin cover, (that may not be confirmed by visual inspection), always be sure to use the gauge tool.

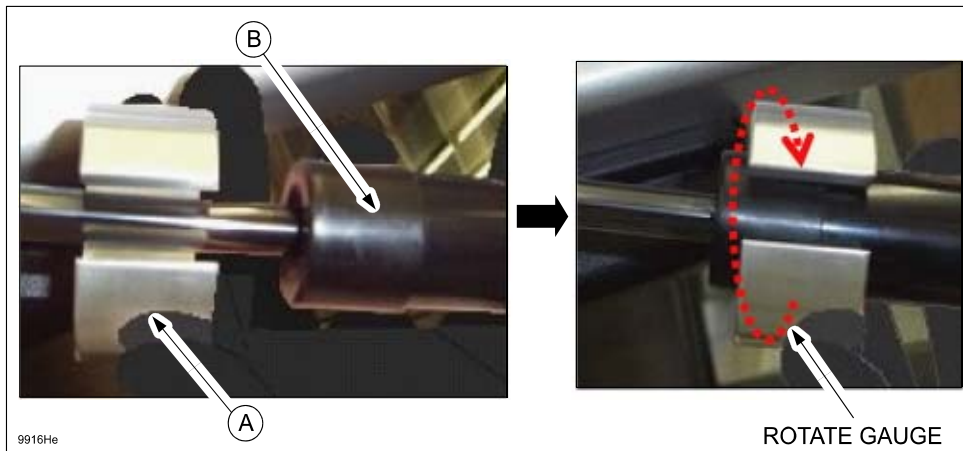
- Make one (1) rotation with the gauge tool (A) over the resin cover (B), as shown below.

NOTE: The formation of rust/corrosion inside the resin cover causes it to expand/increase in diameter. If there is resistance (even a small amount), DO NOT force the gauge tool over the resin cover.

Result	Next Step	Repair Procedure
FAIL: The gauge tool is caught on the resin cover. It does not pass smoothly or cannot be rotated over the resin cover.	1. Release the stay damper gas while on the vehicle using the tie-down strap from the kit.	A
	2. Remove the stay damper from the vehicle.	B
	3. Install new stay damper.	B
PASS: The gauge tool passes smoothly over the resin cover and the rotation does not leave scratches on the resin cover.	1. Remove stay damper from vehicle.	B
	2. Install new stay damper.	B
	3. Release stay damper gas using shop vise.	C

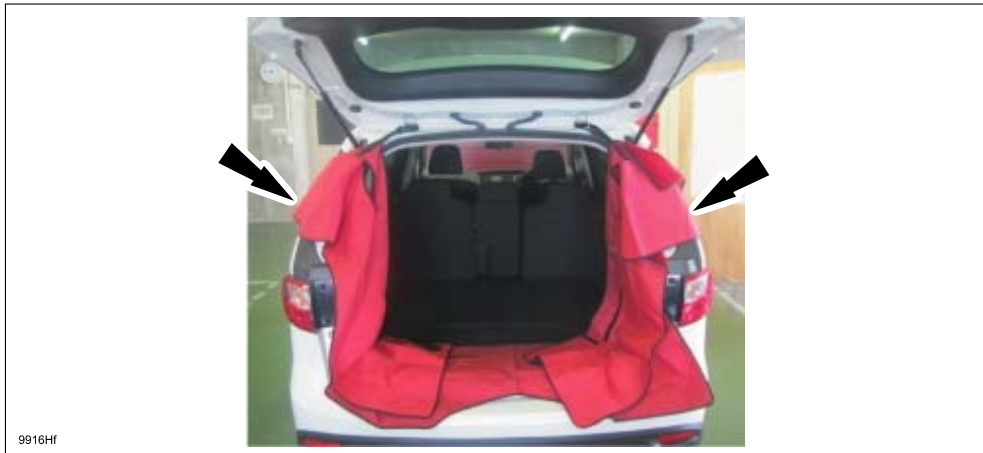
1. Install fender covers to protect the lift gate area from damage.

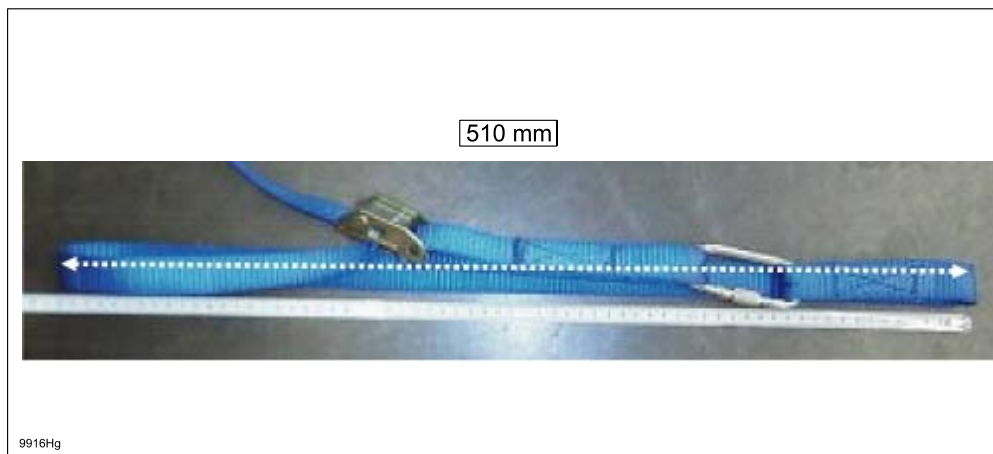
2. Adjust the length of the tie-down according to the subject vehicle.

- CX-3 - 530 mm
- CX-5 - 450 mm
- Mazda3 HB - 560 mm
- Mazda5 - 510 mm (example shown below)

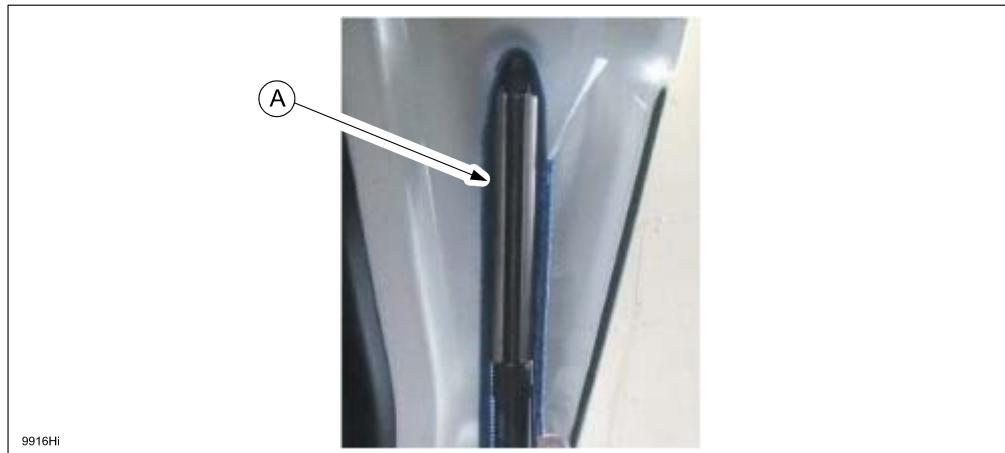
3. Attach the support cylinder (A) to the rod side of the stay damper with the cut-out side facing outward (as shown below).

NOTE: Illustration above is shown with tie-down already installed.

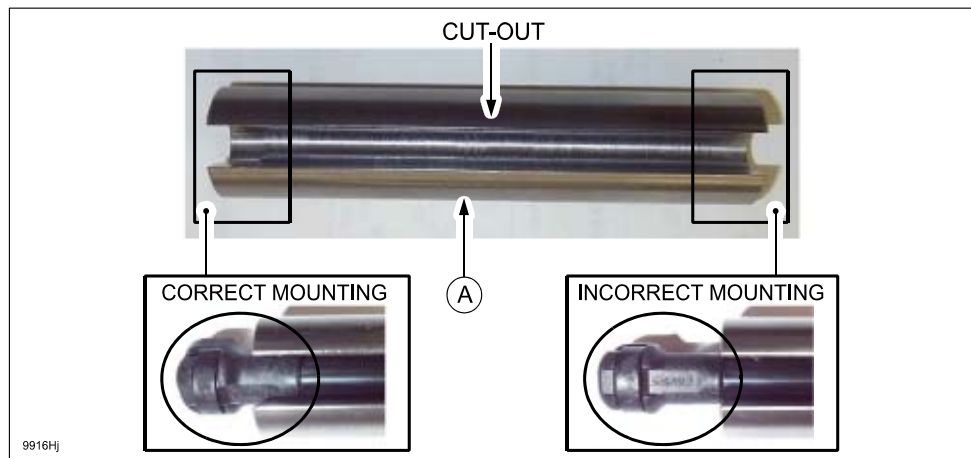
NOTE: Align the end of the support cylinder (A) with the stay damper (as shown below).

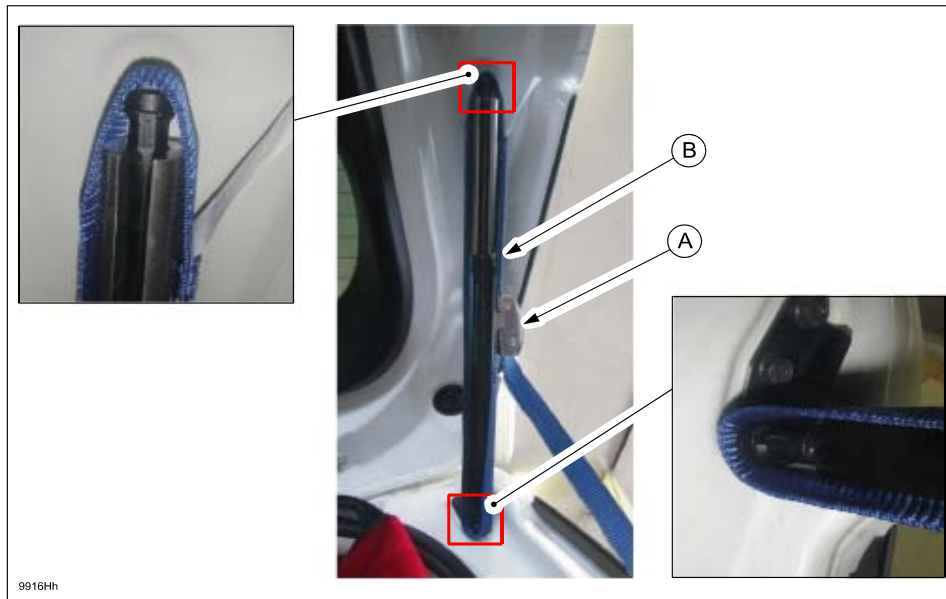
4. Install the tie-down around both ends of the stay damper (as shown below).

CAUTION: If the metal tie-down buckle (A) contacts the resin cover (B), the stay damper is likely to fall off of the vehicle.

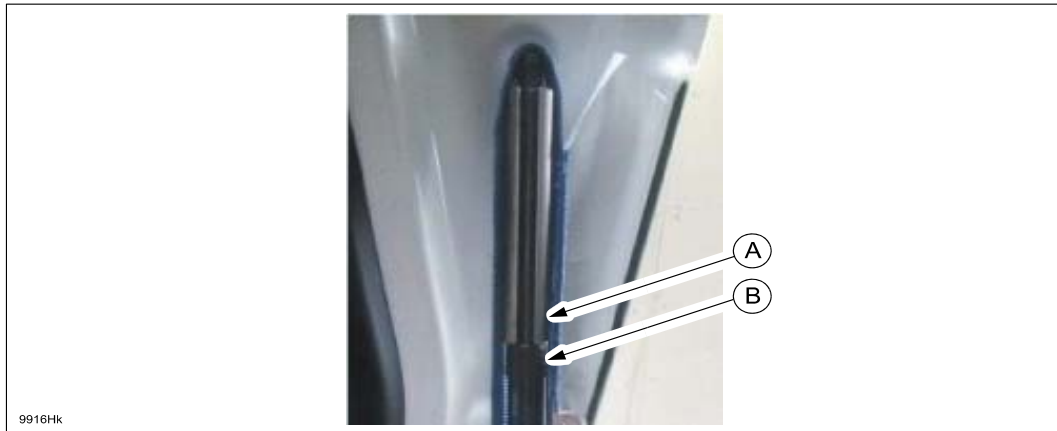
5. While the support person slowly lowers the lift gate, tighten the tie-down until the support cylinder (A) contacts the top of the stay damper resin cover (B).

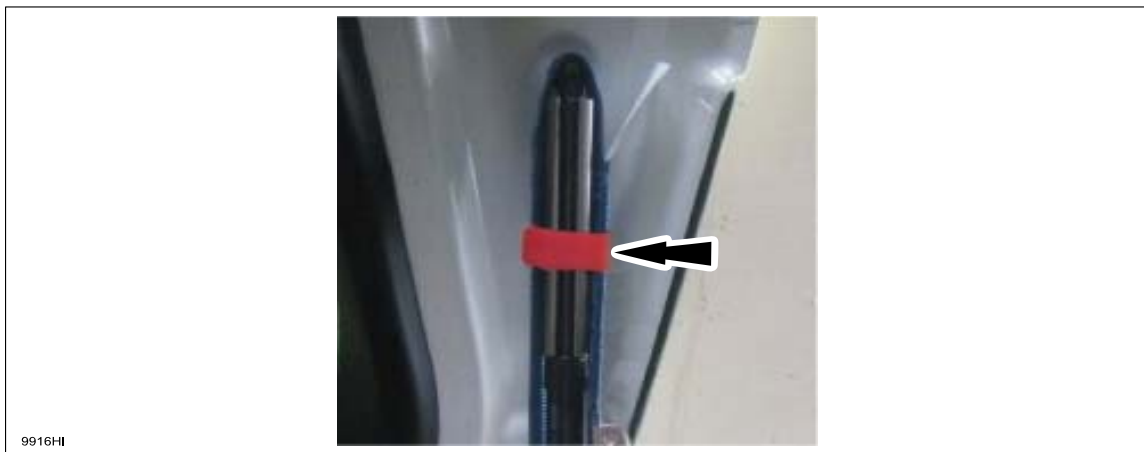
6. As the support person (or wooden support rods/dowels) holds the lift gate in place, install a band around the tie-down and supporting cylinder as shown below.

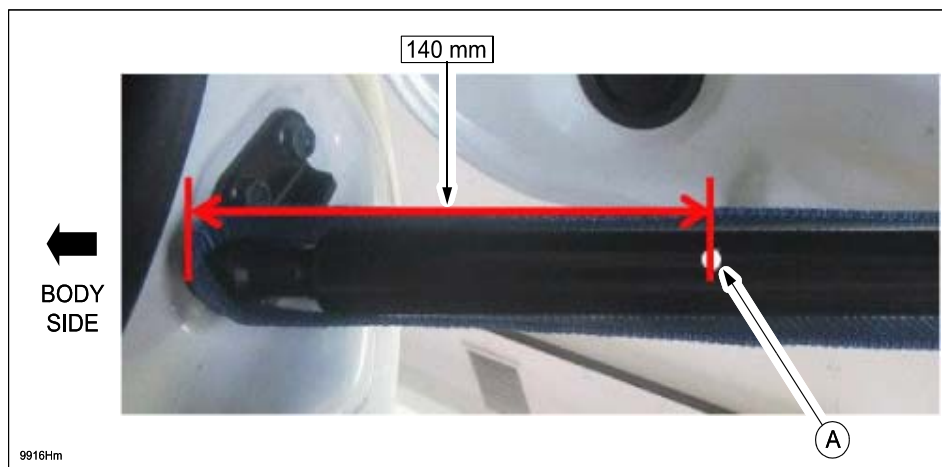
7. From inside the vehicle, mark the spot (A) 140 mm from the end of the body side of the stay damper.

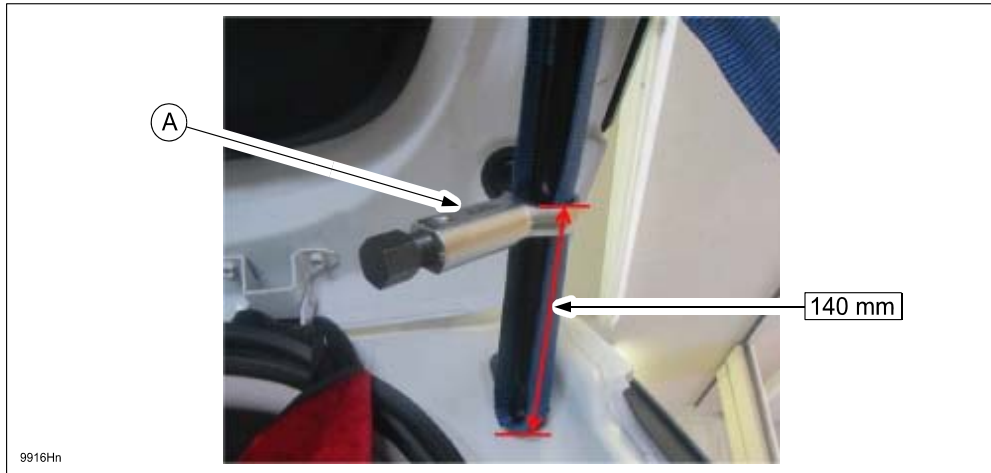
8. Install the degassing tool (A) around the stay damper, as shown below.

NOTE: Tighten the pointed tip of the degassing tool by hand, until it contacts the spot previously marked at 140 mm.

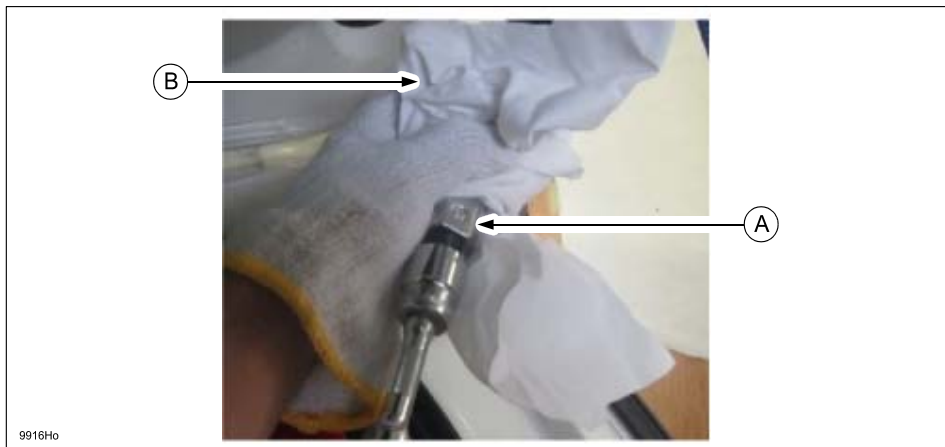
9. Tighten the end of the degassing tool (A) with a wrench, until gas is heard escaping the stay damper.

NOTE: Hold the degassing tool in one hand with a shop rag (B).

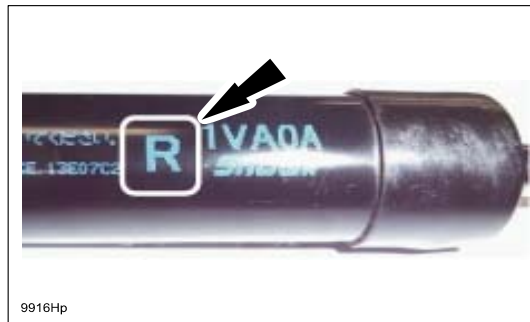
NOTE: The following repair procedures were performed using the right side stay damper.

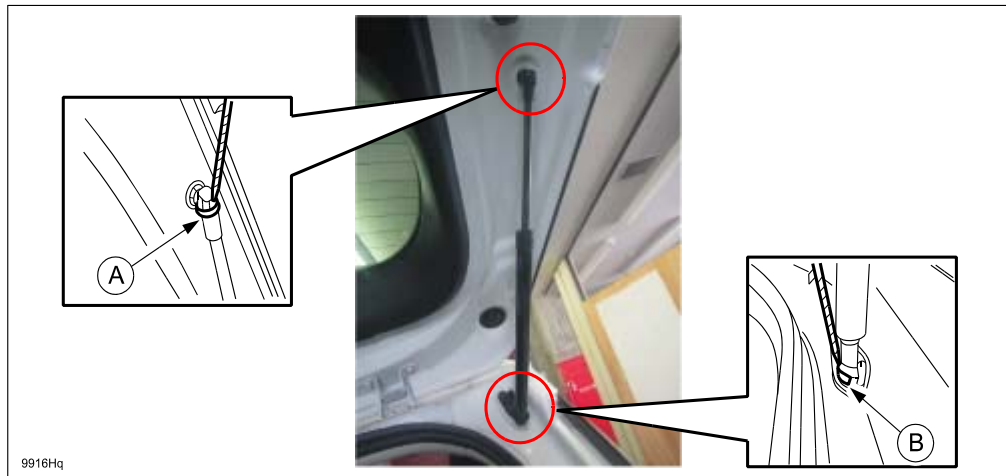
1. Using a small screwdriver, remove the stay damper bands at the lift gate side (A) and the vehicle side (B) as shown below.

- There is a possibility that the lift gate hinge was deformed when using the support cylinder to support the lift gate.
- DO NOT use the support cylinder to hold the lift gate up by the opposite side stay damper.
- Be sure that the support person holds the lift gate up by hand or with wooden support rods/dowels.

2. Clean the stud-ball on the lift gate side and the vehicle side with a cloth after stay damper removal.
3. Install the modified stay damper to the stud-ball housing onto the **vehicle side**.
4. Install the modified stay damper to the stud-ball housing onto the **lift gate side**.
5. Rotate the stay damper to make sure that the metal clip is not floating from the stud-ball housing.

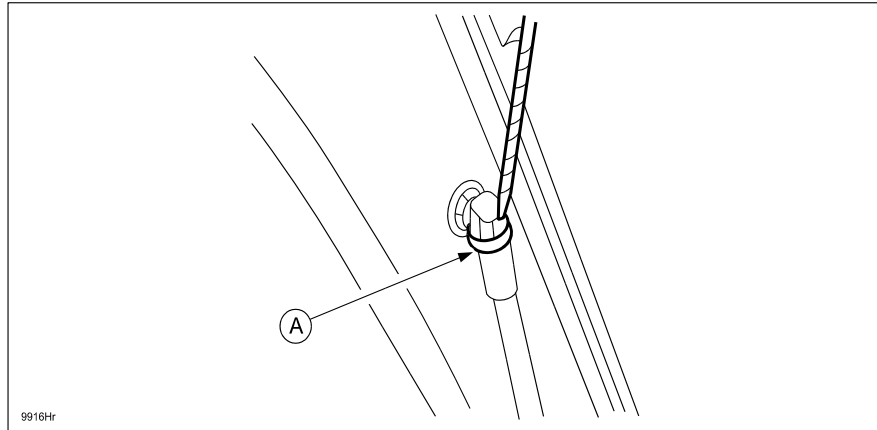
1. Using a small screwdriver, remove the stay damper band at the lift gate side (A) as shown below.

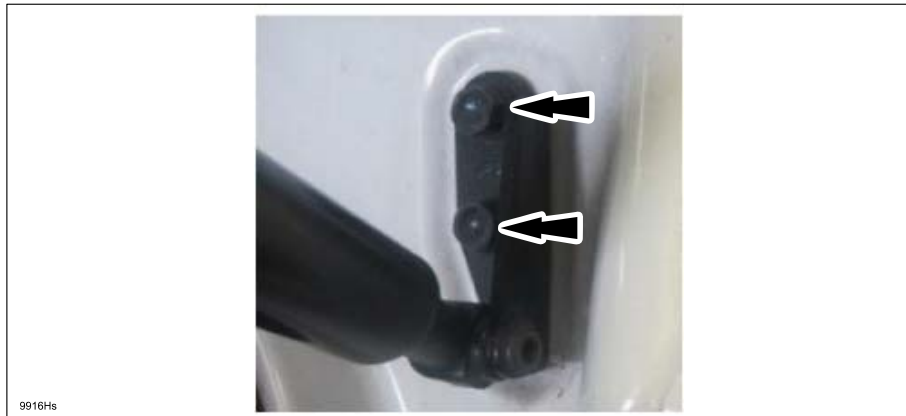
2. Remove the stay damper bracket bolts from the vehicle side (as shown below) to remove the stay damper.

3. Clean the mounting surface of the stay damper bracket, using special care to prevent damage to the painted surface under the bracket.
4. Clean the stud-ball on the lift gate side with a cloth, after stay damper removal.
5. Install the modified stay damper to the stud-ball housing onto the **lift gate side**.
6. Rotate the stay damper to make sure that the metal clip is not floating from the stud-ball housing.
7. Install the stay damper bracket bolts onto the **vehicle side**.
8. Tighten the stay damper bracket bolts to the proper torque specification.

Tightening Torque: 80 - 133 in. lbs. {92 - 153 kgm-cm, 9 - 12 Nm}

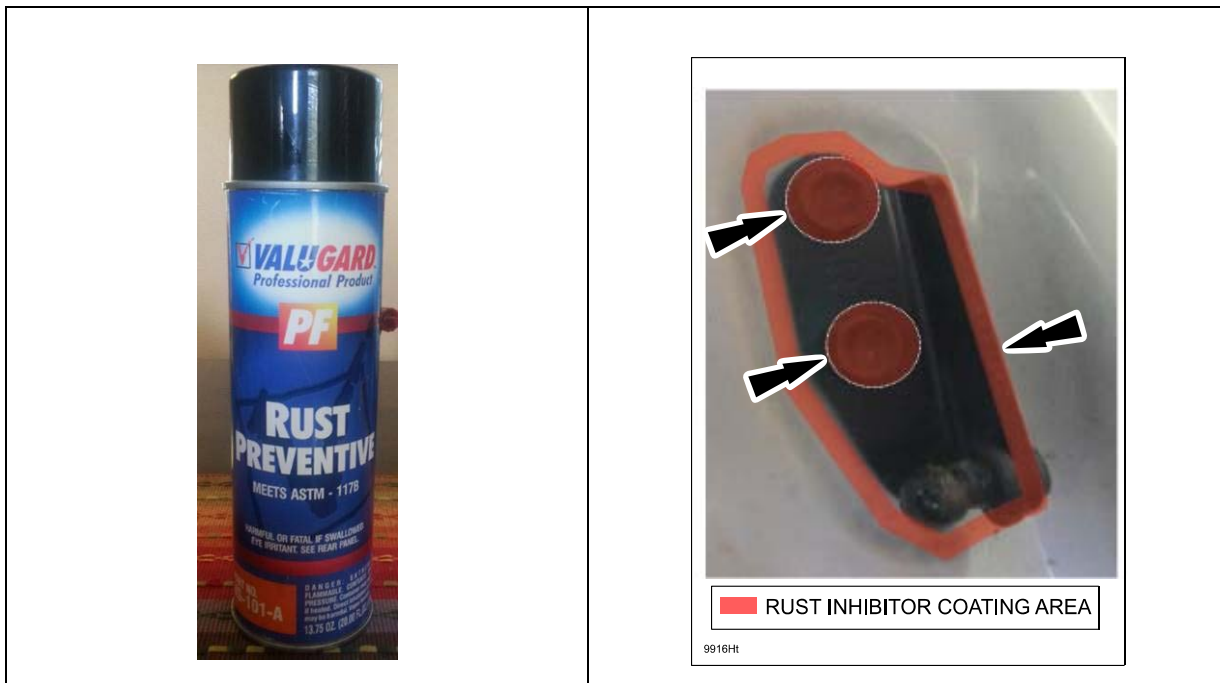
9. Apply a rust preventive coating around the mounting bracket and bolt areas (as shown below).

NOTE: Mask the area to prevent over-spray from coating the surface. Wipe off excess coating as necessary using a clean towel.

Rust Preventative Coating Recommendation: ValuGard Rust Preventative – Part # VG-101-A.

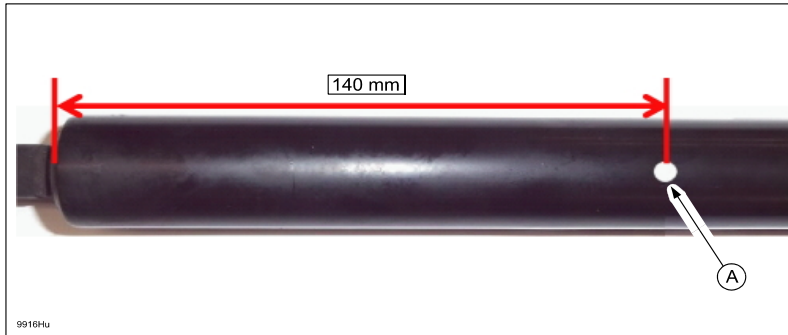
1. Mark the spot (A) 140 mm from the end of the lift gate side of the stay damper.

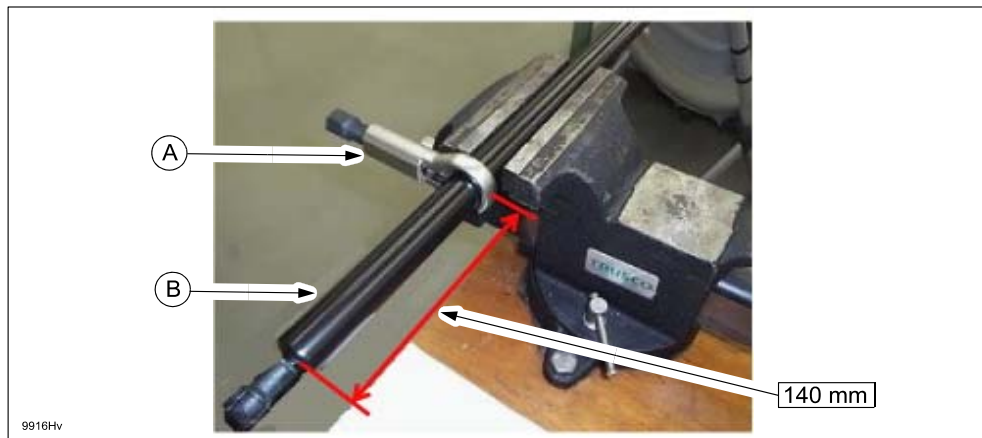
2. Secure the stay damper in a vice.
3. Install the degassing tool (A) around the stay damper (B) (as shown below).

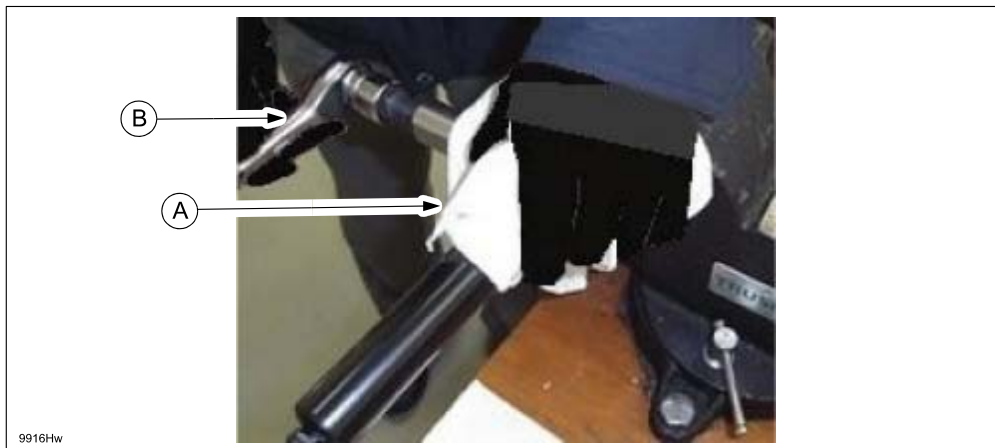
- Wear protective glasses and gloves when degassing the stay damper.
 - Do not loosen or remove the degassing tool when the gas begins to escape.
 - Cover the puncture site with a shop rag (A).
4. Tighten the end of the degassing tool with a wrench (B), until gas is heard escaping the stay damper.

NOTE: Keeping the puncture site covered with a shop rag.

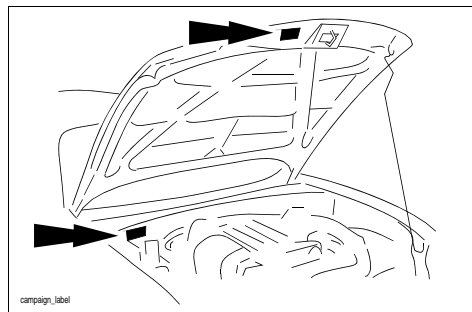
2. Affix it to the hood or bulkhead as shown:
