February 2017
FL721A-E
NHTSA #16V-656
Transport Canada #16-441

Subject: CNG Fuel Tank and CPDM Mounting Location

Models Affected: Specific Freightliner Cascadia vehicles manufactured September 24, 2012, through May 27, 2015, built with CNG fuel tanks

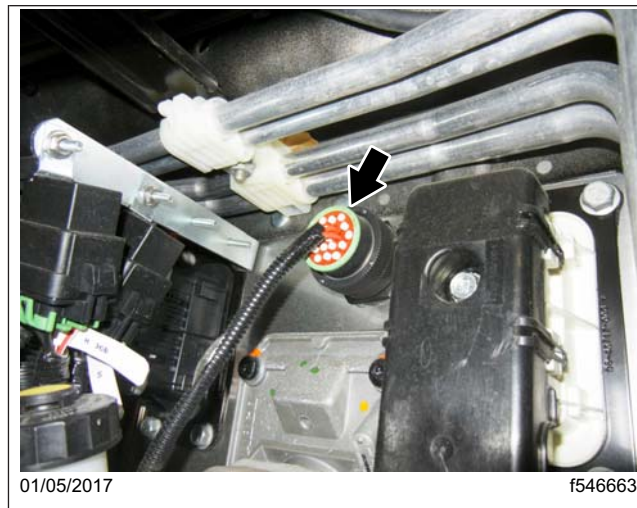
Fig. 1, Bulkhead Connector

3. Raise the hood and disconnect the bulkhead connector 1A. See [Fig. 1](#). Remove the nut that secures the dash side 1A bulkhead connector to the front wall.

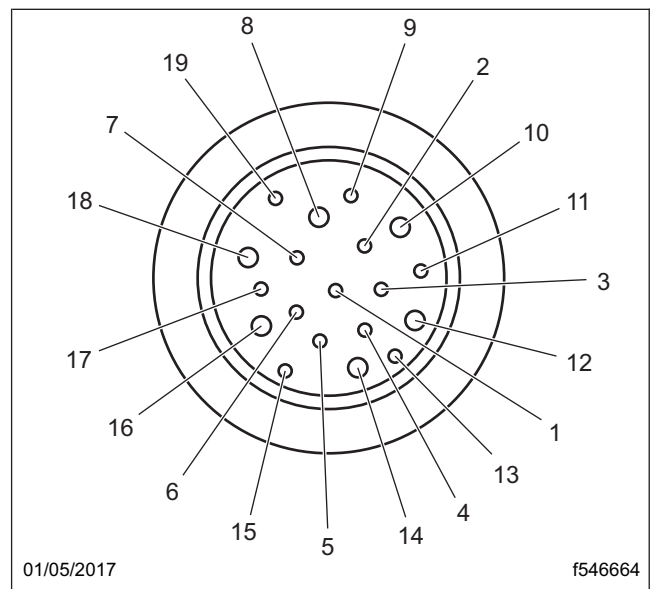
Fig. 2, 1A Bulkhead Connector Pinout (view from insertion or back side of plug)

4. Insert the terminals shown in [Table 3](#) into their respective cavities in the dash side 1A bulkhead connector. See [Fig. 2](#).

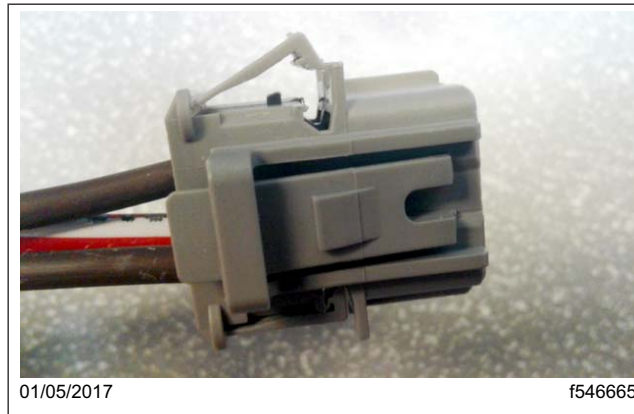
Fig. 3, 55B Terminal Lock (released or unsnapped)

5. Unsnap the terminal lock from the only populated connector (55B) on harness A06-93000-000. See [Fig. 3](#).

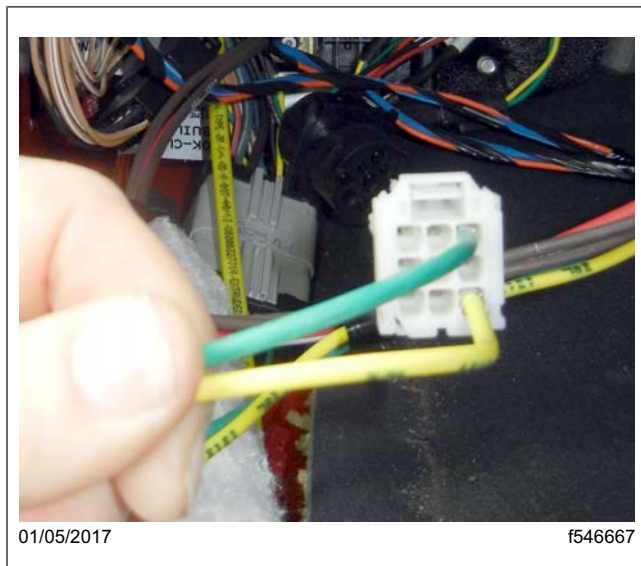
Fig. 6, Wires Inserted into Connector 53B

8. Insert circuits 38R (dark green) and 38L (yellow) from harness A06-93000-000 into cavities 7 and 9 respectively in connector 53B (the part is supplied loose in kit 23-13149-902). See [Fig. 6](#) and [Fig. 7](#).

7. Snap the terminal lock on connector 55B.
8. Insert circuits 38R (dark green) and 38L (yellow) of harness A06-93000-000 into cavities 7 and 9 respectively in connector 53B (supplied loose in kit 23-13149-902). See [Fig. 6](#) and [Fig. 7](#).

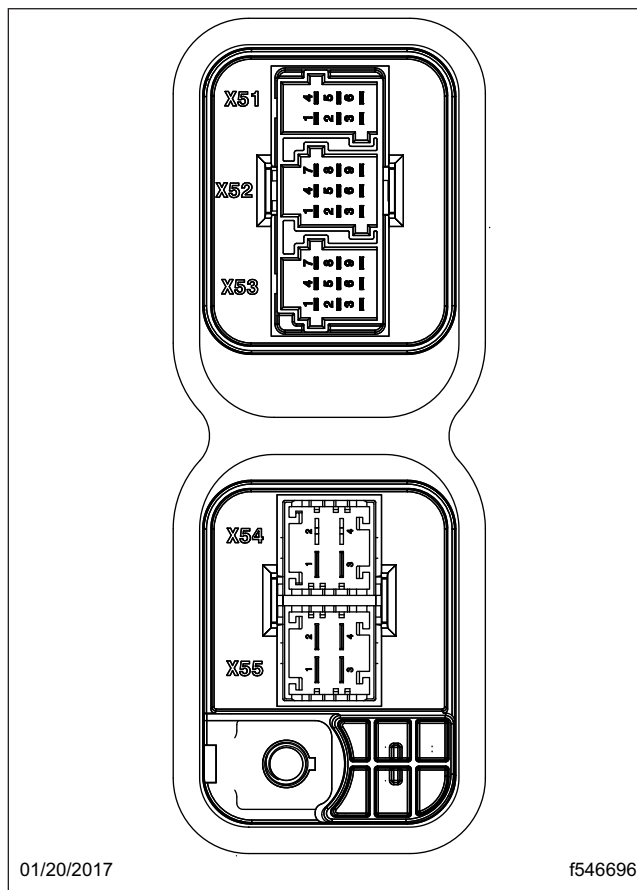
Fig. 8, SAM Chassis Connector Locations

9. Snap the terminal lock and plug in the connector into cavity X53 on the SAM Chassis. See [Fig. 8](#).

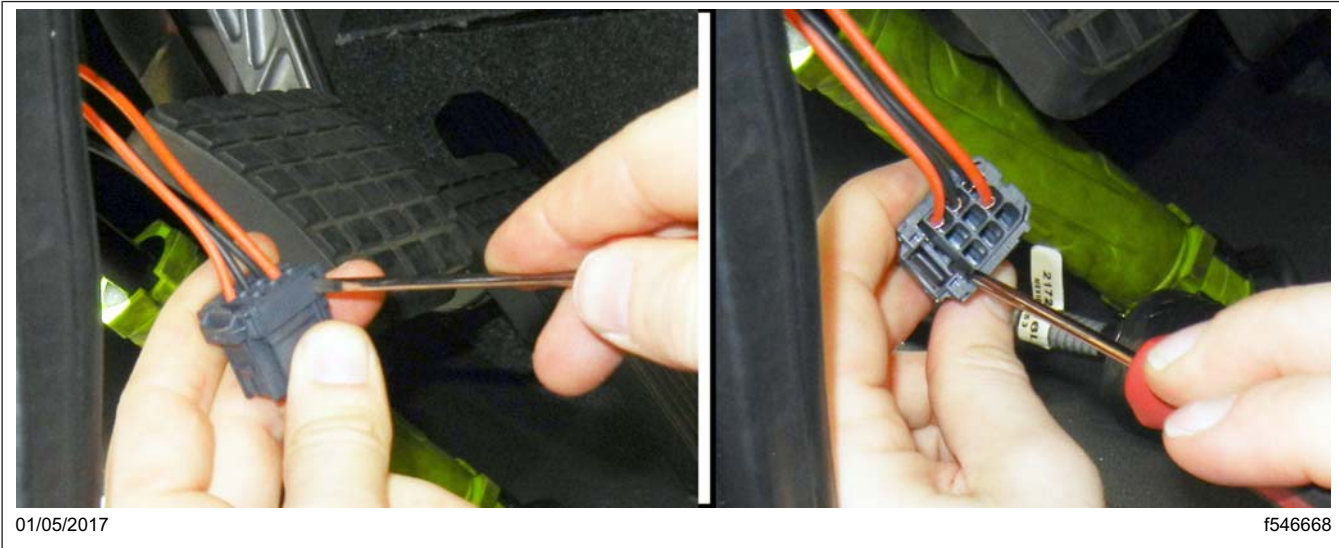
Fig. 9, Removing the Terminal Lock on Connector 52B

10. Remove connector 52B from slot X52 on the SAM Chassis.
11. Unsnap the terminal lock. See [Fig. 9](#).

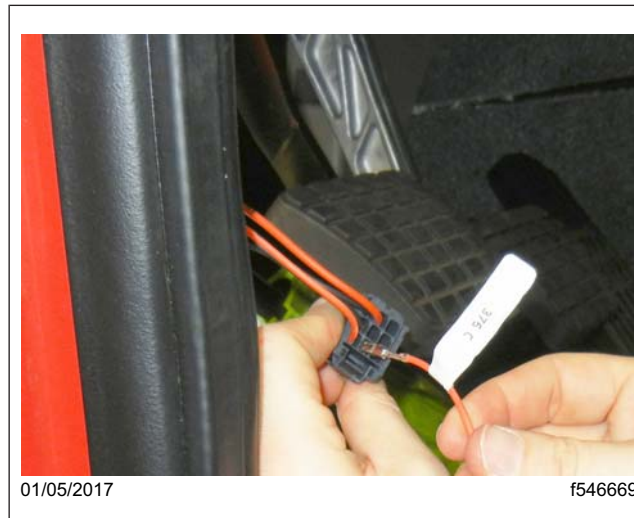
Fig. 10, Circuit 376C into Connector 52B

12. Insert circuit 376C (orange) from harness A06-93209-000 into cavity 6 on connector 52B. See [Fig. 10](#) and [Fig. 7](#)

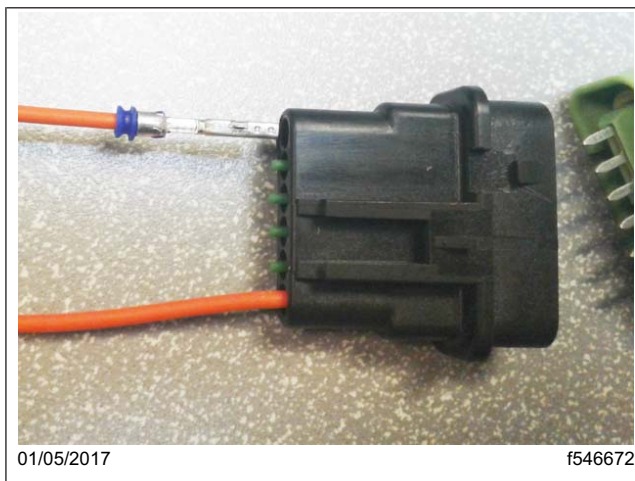
Fig. 13, Splice Pack Terminal Insertion

16. Insert the GT150S terminal end of the single wire harness A06-93668-000 into any available cavity in the splice pack. See [Fig. 13](#). Install the terminal lock and cover.
17. Route the splice pack behind the ICU near the radio. See [Fig. 14](#)

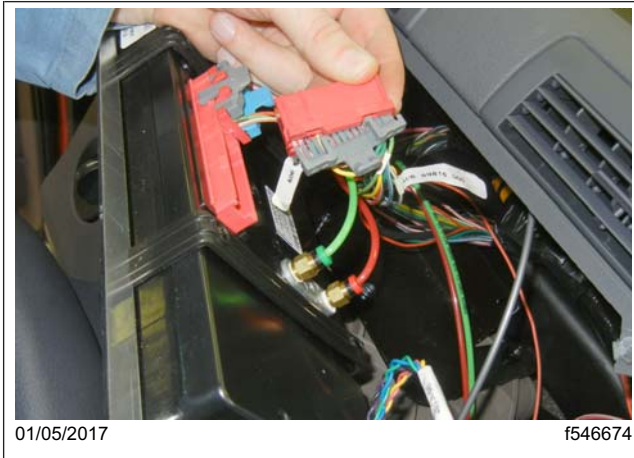
Fig. 15, ICU 2A connector Terminal Locks

18. Disconnect the 2A connector from the back of the ICU, then remove the terminal locks. See [Fig. 15](#).
19. Remove the existing wire from cavity D12 of ICU connector 2A. See [Fig. 16](#).

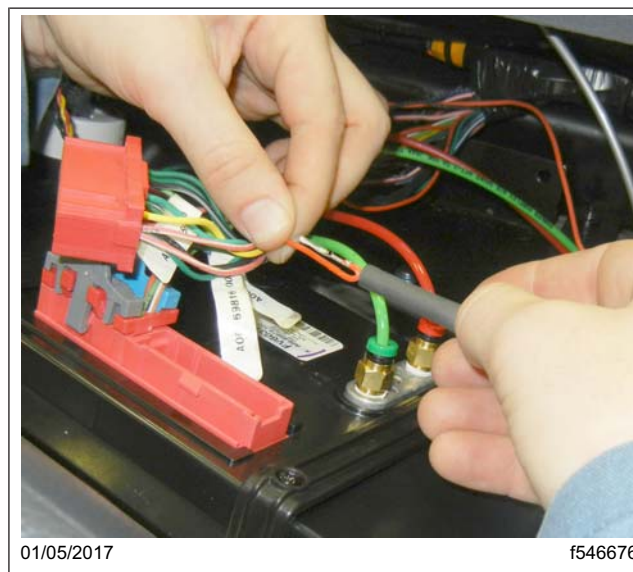
Fig. 17, 2A ICU Heat Shrink

20. Fold the wire back against itself, and cover the terminal with heat shrink tubing. See [Fig. 17](#).

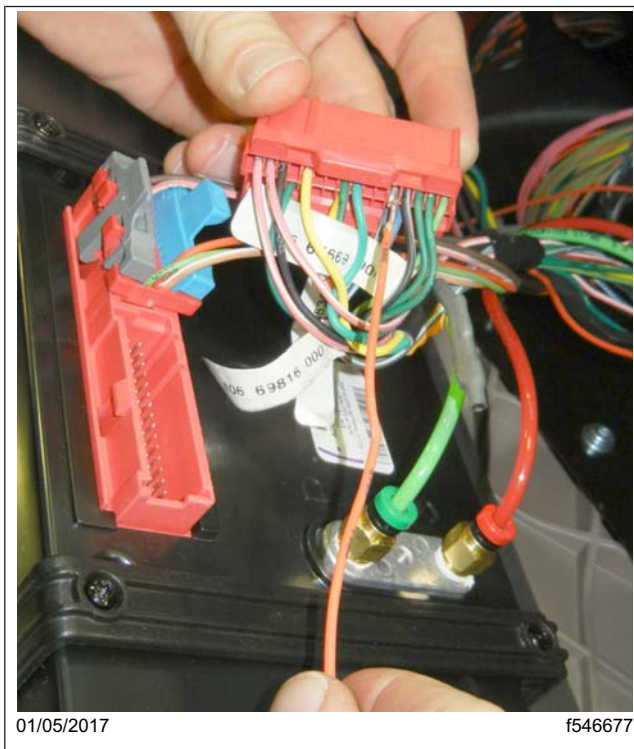
Fig. 18, Wire Insertion into Cavity D12 of ICU Connector 2A

21. Label the wire with tape with the description "Removed for FL721."
22. Insert the metri-pac 100 terminal end from single wire harness A06-82360-000 into ICU connector 2A, cavity D12. See [Fig. 18](#).
23. Install the terminal lock and plug connector 2A into the ICU.
24. Route wires A06-93668-000 and A06-82360-000 behind the dash and down to the ABS module. See [Fig. 19](#).

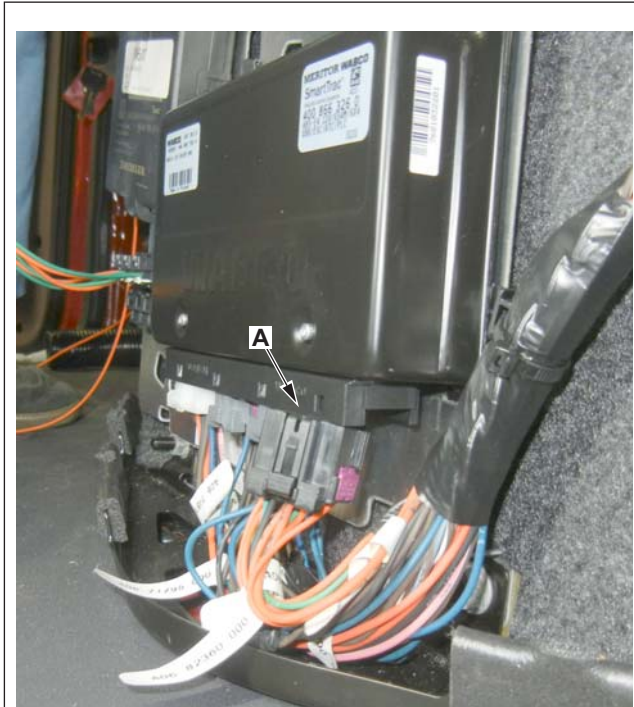
Fig. 20, Connector X1A on the ABS Module

25. Disconnect connector X1A from the ABS module and remove the terminal lock. See [Fig. 20](#) and [Fig. 21](#)

1. Cavity 2
2. Cavity 7

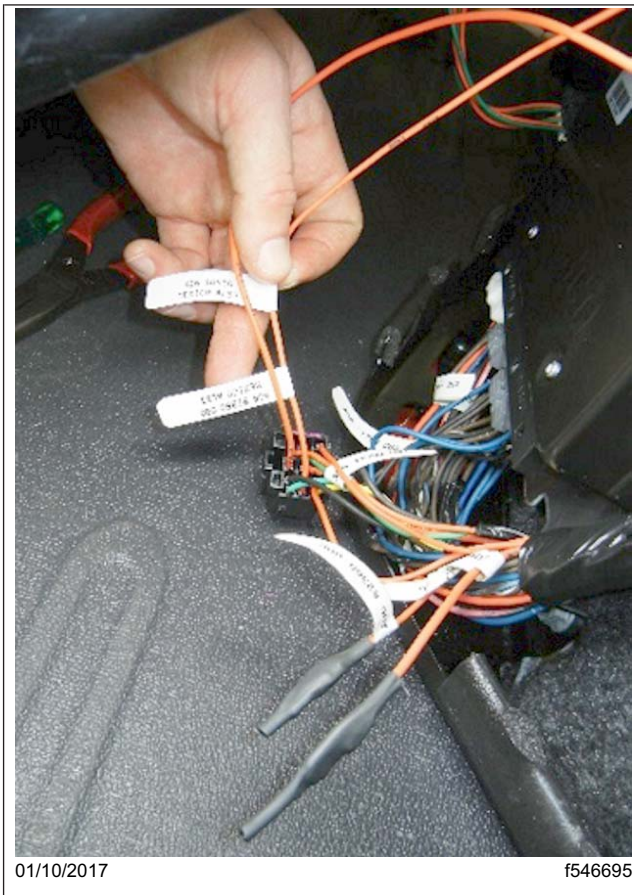
**Fig. 24, Both Wires Inserted into Connector X1A
(FL721-A installation shown)**

27. Fold the removed wires back against themselves, and cover the exposed terminal ends with heat shrink tubing.
28. Label the wire with tape with the description "Removed for FL721."
29. Insert the free ends of single-wire harnesses A06-93668-000 and A06-82360-000 into ABS module connector X1A. Connect A06-93668-000 into cavity 7, and A06-82360-000 into cavity 2. See [Fig. 24](#).
30. Install the terminal lock in connector X1A and plug the connector back into the ABS module.
31. Use cable ties to secure the bundle to the HVAC ducting behind the ICU. See [Fig. 25](#).

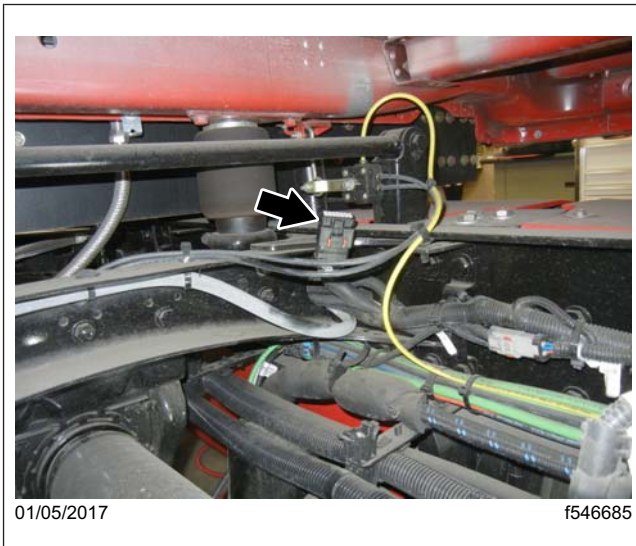
Fig. 26, 23-13153-011 Populated with 23-13218-300 Plugs

32. Outside the cab, disconnect the CPDM harness and cap it with 23-13153-011. Plug each cavity with a cavity plug (23 13218 300). See [Fig. 26](#), [Fig. 27](#), and [Fig. 28](#).

24. Install the terminal lock in connector X1A and plug the connector back into the ABS module.
25. Use cable ties to secure the bundle to the HVAC ducting behind the ICU. See [Fig. 25](#).
26. Outside the cab, disconnect the chassis PDM (CPDM) harness and cap it with 23-13153-011. Plug each cavity with a cavity plug (23-13218-300). See [Fig. 26](#), [Fig. 27](#), and [Fig. 28](#).

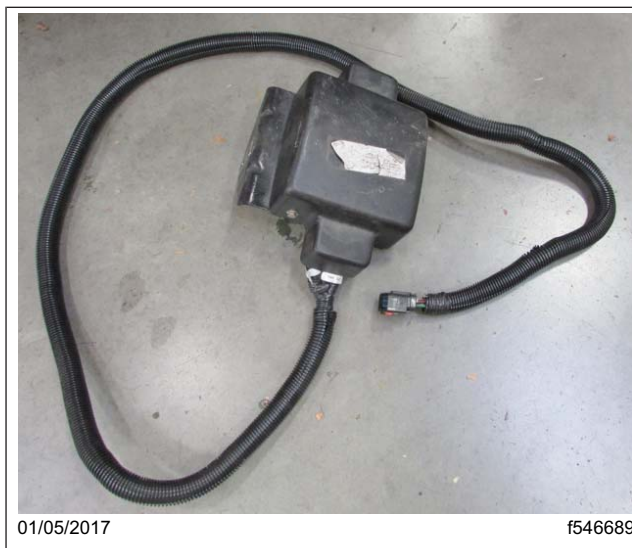
Fig. 30, CPDM Removed from the Vehicle

NOTE: The CPDM should be discarded after it is removed from the vehicle. It will not be used again.

34. Remove the CPDM from the vehicle. See [Fig. 30](#).

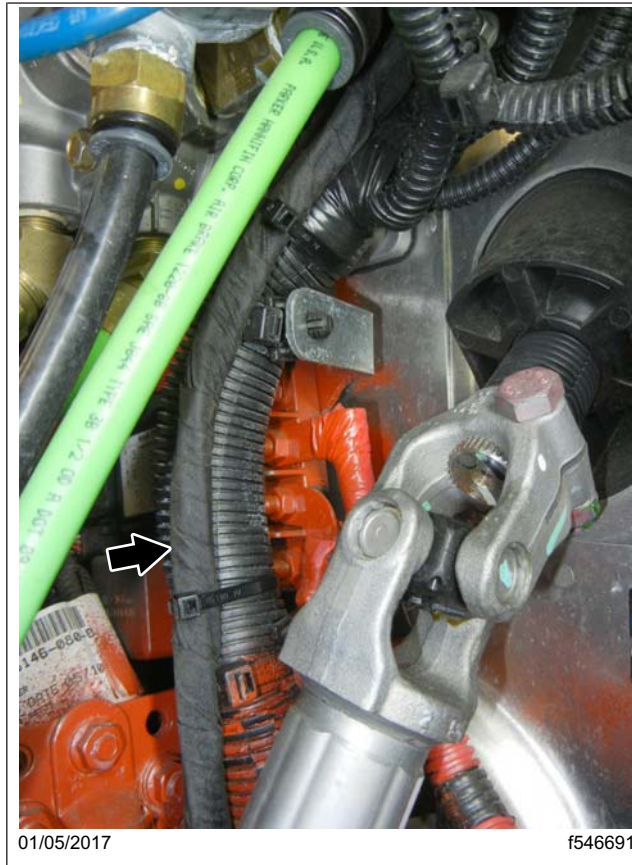
Fig. 32, Bulkhead Harness Routing

NOTE: Route the harness safely away from sharp points and edges, moveable parts, and other possible sources of abrasion, cutting, pinching, or crushing. Secure it to the frame rail at regular intervals using zip ties fastened to standoffs. Whenever possible, the harness should be routed behind the air and hydraulic lines.

36. Route harness A06-93018-084 along the frame rail to bulkhead connector 1A. See [Fig. 32](#).

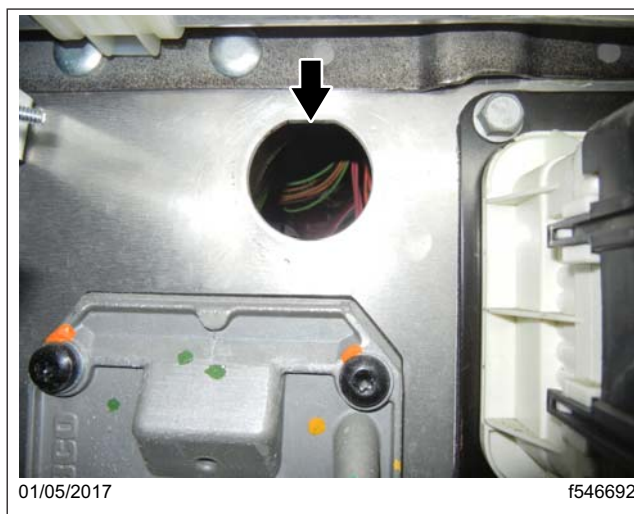
Fig. 33, Bulkhead Connector 1A Cavity on the Frontwall

NOTE: The bulkhead connector is keyed with one flat side to be aligned with the D-shape in the frontwall hole.

38. Insert the cab side 1A bulkhead connector into the D-shaped hole and connect the engine side 1A bulkhead connector to it. See [Fig. 33](#).

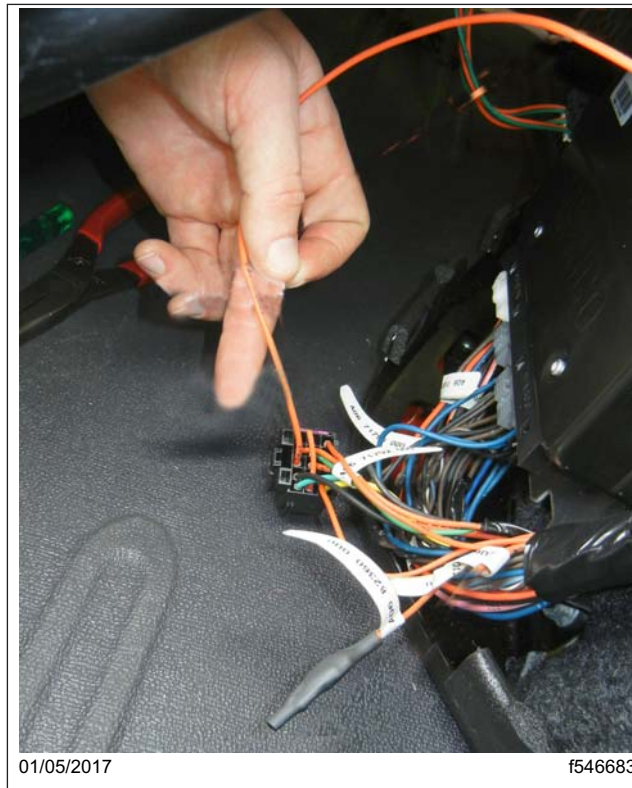
Fig. 36, Wire Inserted into Connector X1A

21. Fold the removed wire back against itself, and cover the exposed terminal end with heat shrink tubing.
22. Label the wire with tape with the description "Removed for FL721."
23. Insert the free ends of single-wire harness A06-93668-000 into ABS module connector X1A, cavity 7. Connect A06-93668-000 into cavity 7. See [Fig. 36](#).
