TO: All Mazda Dealership General Managers, Service and Parts Managers
DATE: November 2016
SUBJECT: 2014-2016 Mazda3 Fuel Leakage from Inlet Check Valve
Safety and Emission Recall 0116I

CONDITION OF CONCERN

REPAIR PROCEDURE

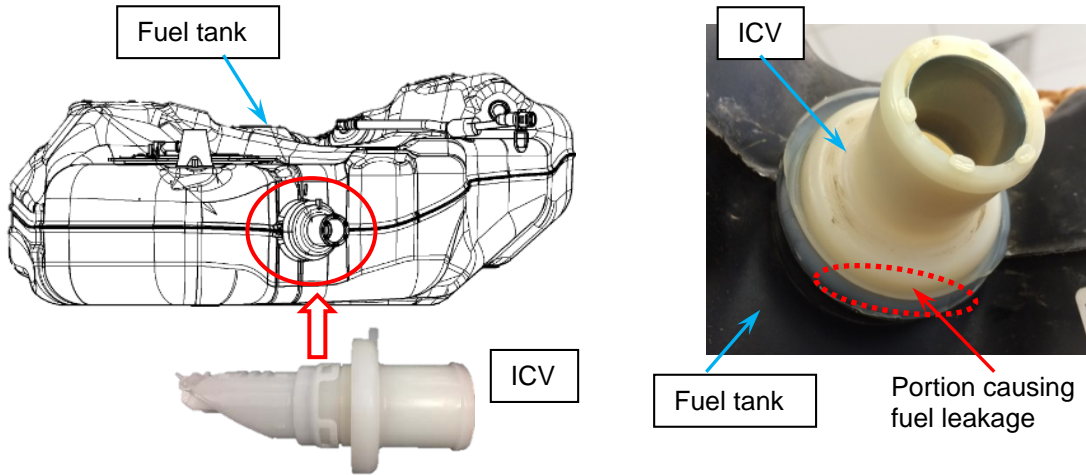
On certain Mazda3 vehicles, due to possible fuel tank deformation during manufacturing, the inlet check valve (ICV) may not be properly welded to the fuel tank. If this weld breaks during vehicle operation, fuel leakage may occur, increasing the risk of fire.

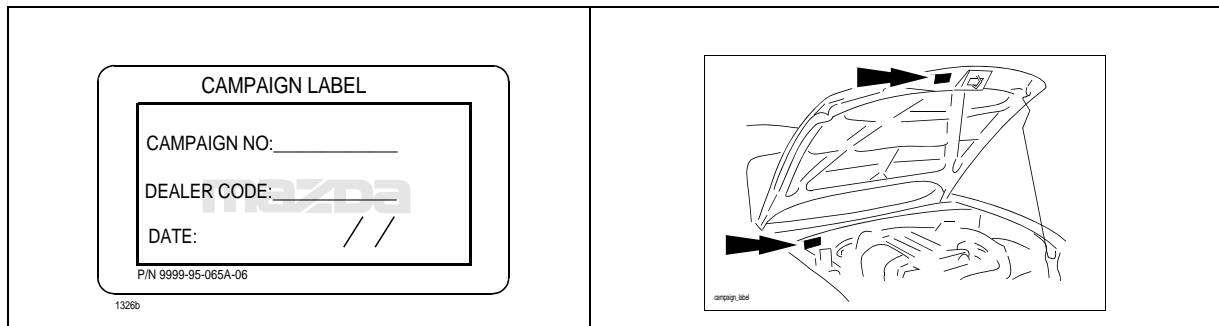
- If the vehicle is within the above range, proceed to Step 2.
 - If the vehicle is not within the above range, return vehicle to the customer or inventory.
2. Perform a Warranty Vehicle Inquiry using your eMDCS System and inspect vehicle for Campaign Labels **Recall 0116I** attached to the vehicle’s hood or bulkhead. Refer to eMDCS System - Warranty Vehicle Inquiry Results table below.

NOTE: Be sure to verify Recall number as the vehicle may have multiple Recall labels.

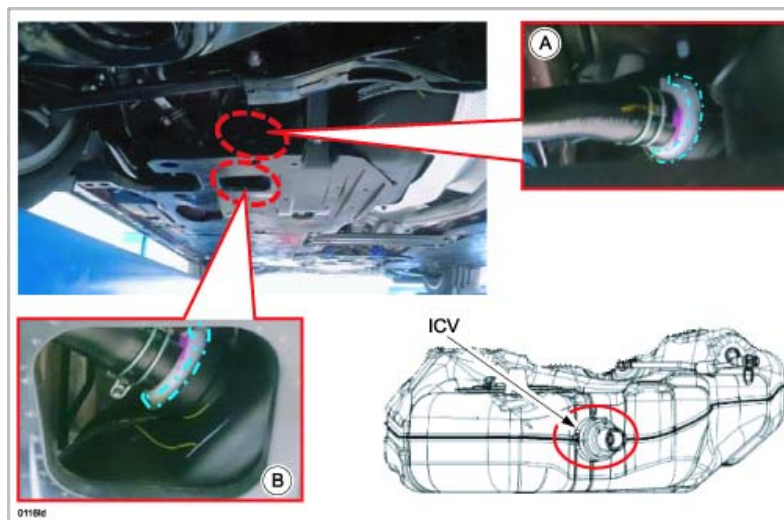
3. Use the Lot Number Calculation Tool to determine if the fuel tank requires further inspection.
 - If the lot number is within the affected range, go to next step.
 - If the lot number is outside the affected range, work is complete.
4. Visually check the welding condition all around the joint portion between the ICV and the fuel tank. Make sure a double bead is created all around the joint.

- The ICV can be viewed from Point (A) or (B) as shown.
- If the joint portion is not clearly visible, wash it off.
- If it is difficult to check the welding condition after washing it off, go to next step and install a NEW fuel tank.

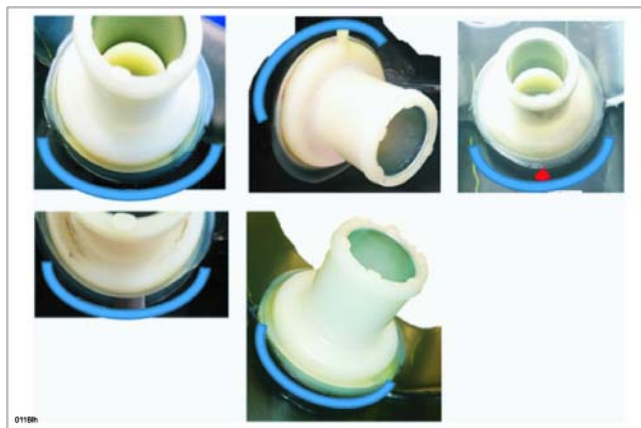
Samples of ICV with improper welding (double bead (blue line) is not created all around).

- If the welding condition is “GOOD”, work is complete.
 - If the welding condition is “NO GOOD”, go to next step.
5. Visually check all around the joint portion between ICV and the fuel tank for fuel leak
- NOTE:** If a leak/trace of a leak has been found on the fuel tank, contact PTL@mazdausa.com with photos, dealer code, RO, VIN, and dealership address. A prepaid shipping label will be provided to send the fuel tank to MNAO. MNAO does not expect any fuel tanks to exhibit a leak/trace of a leak.

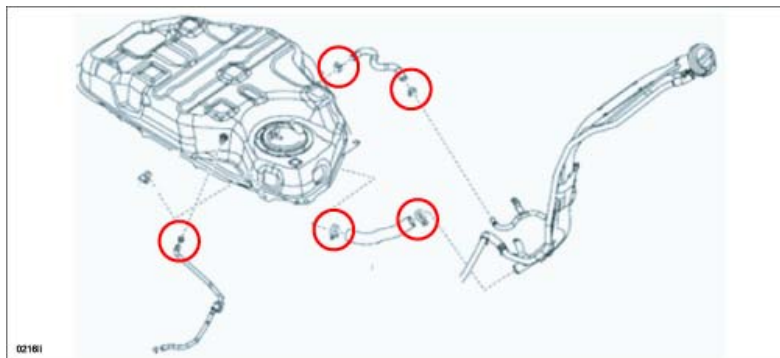
7. Install a NEW fuel tank according to the instructions on MS3 (FUEL TANK REMOVAL/INSTALLATION).

NOTE: Visually check that there is no fuel leakage or damage around the reassembled parts (hose, pipe).

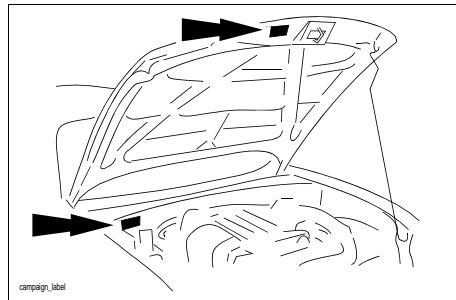
2. Affix it to the hood or bulkhead as shown:
