Volvo Car Customer Service

TJ 31955

Title	Climate unit drain hose	Page	1 (10)
Action	Replacement	Operation number:	98636-3

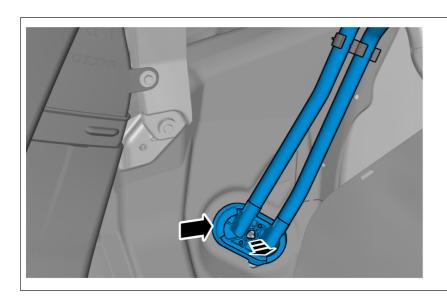
Remove the part carefully

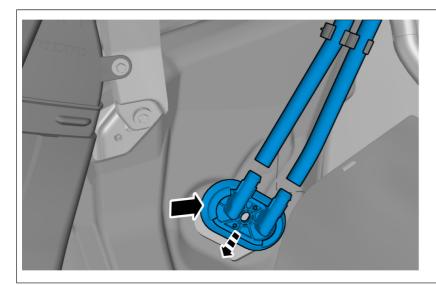
Note! Use suitable paper to absorb any escaping fluid.

Undo the hoses from the connections. Remove the marked part.

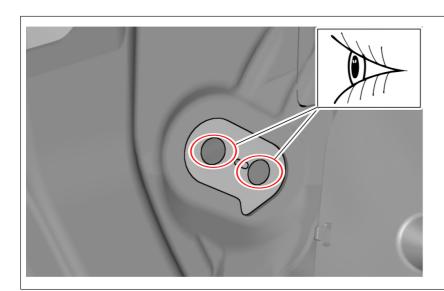
Caution! Make sure that the area indicated is flat and free from damages.

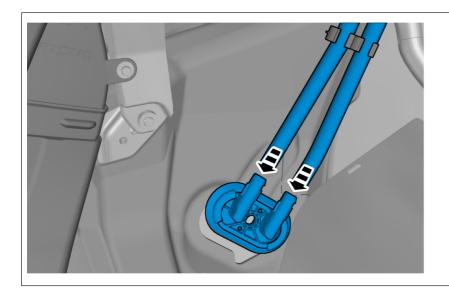
Note! Use soap solution.

Install the hoses.

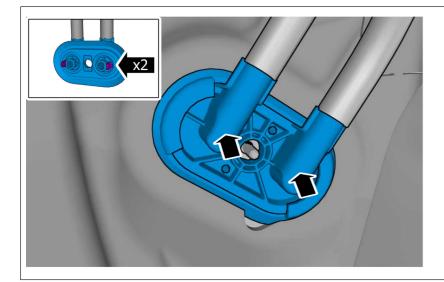
Caution! The grommet seal must rest on the metal surface, not on the carpet.

Caution! Be careful not to damage the catches.

Install the marked component. Press the marked component.

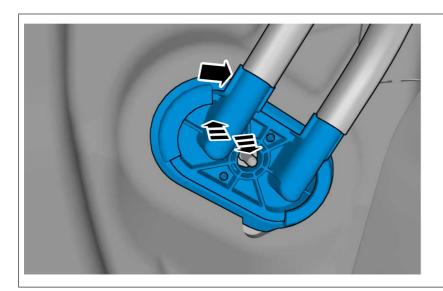
Check that the rubber grommet is not loose: 1 -First grab the hose connection and press inwards. 2 -Then pull outwards. 3 -Again push inwards.

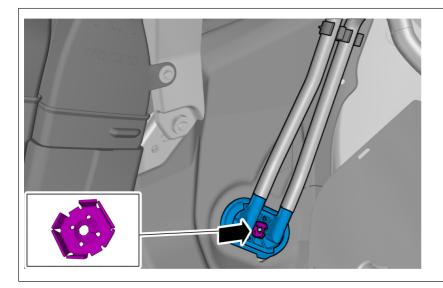
Note! Make sure that the seal is correctly located.

Install the nut.

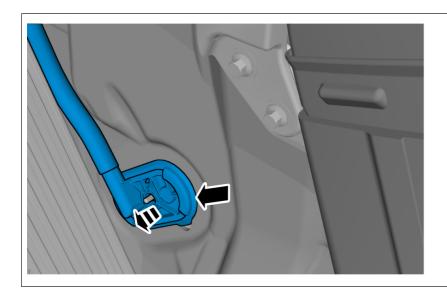
Remove the part carefully

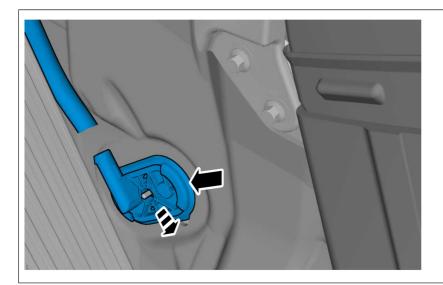
Note! Use suitable paper to absorb any escaping fluid.

Undo the hose from the connection. Remove the marked part.

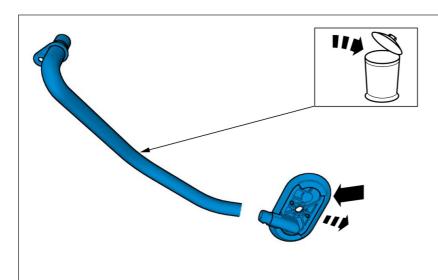
Make sure to replace the marked component with a new.

Undo the hose from the connection. Remove the marked part.

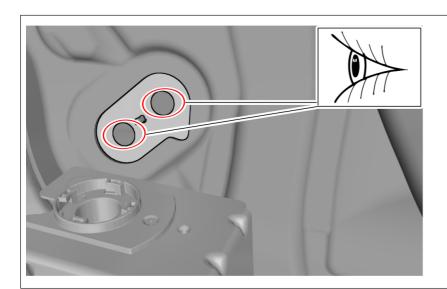
Caution! Make sure that the area indicated is flat and free from damages.

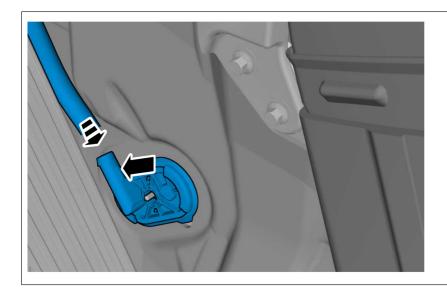
Note! Use soap solution.

Install the hose.

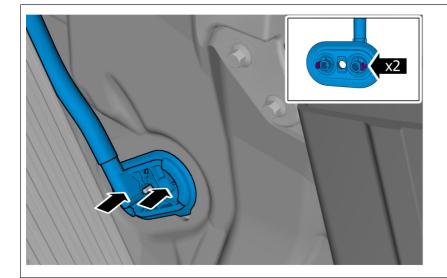
Caution! The grommet seal must rest on the metal surface, not on the carpet.

Caution! Be careful not to damage the catches.

Install the marked component. Press the marked component.

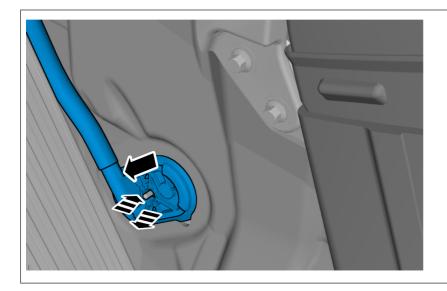
Check that the rubber grommet is not loose: 1 -First grab the hose connection and press inwards. 2 -Then pull outwards. 3 -Again push inwards.

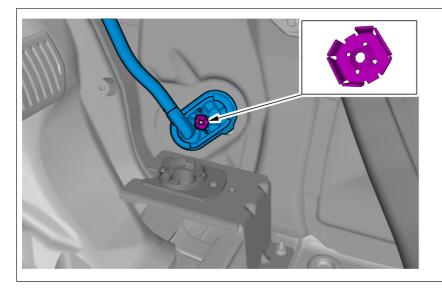
Note! Make sure that the seal is correctly located.

Install the nut.
