Volvo Car Customer Service

TJ 31955

Title	Climate unit drain hose	Page	1 (11)
Action	Inspection	Operation number:	98635-2

Model year	Model
2017	S90 (17-)
2016, 2017	XC90 (16-)

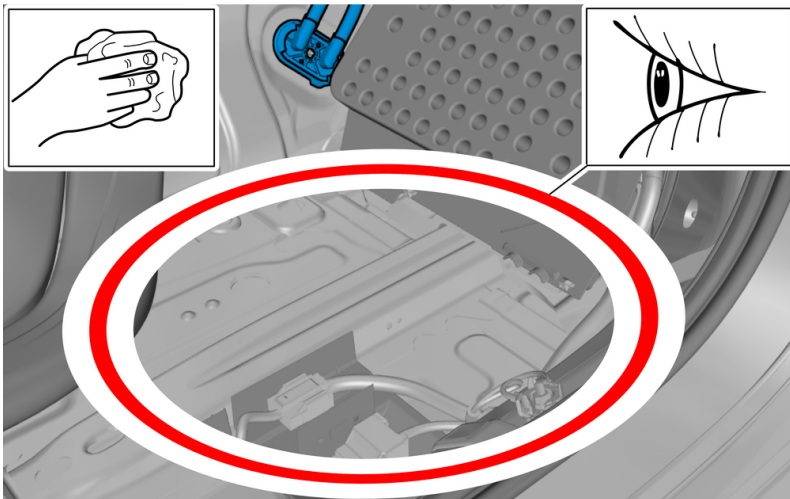
Note! Check for moisture in the area indicated.

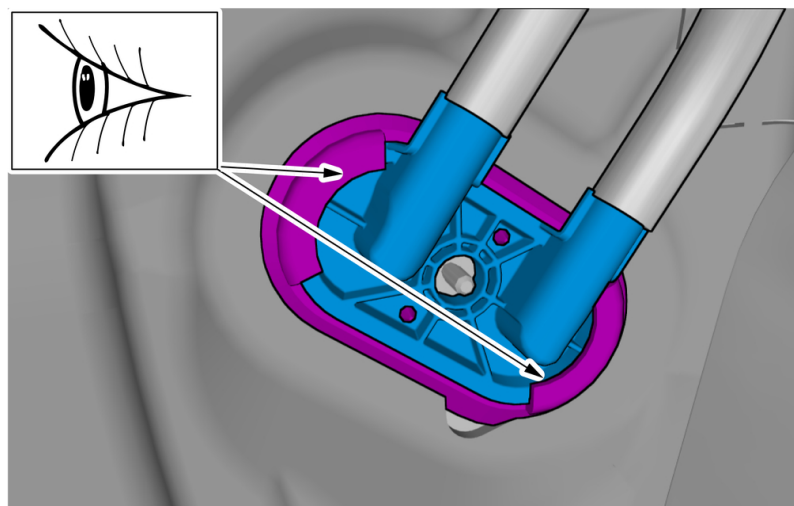
Caution! The grommet seal must rest on the metal surface, not on the carpet.

Note! Make sure that the seal is correctly located.

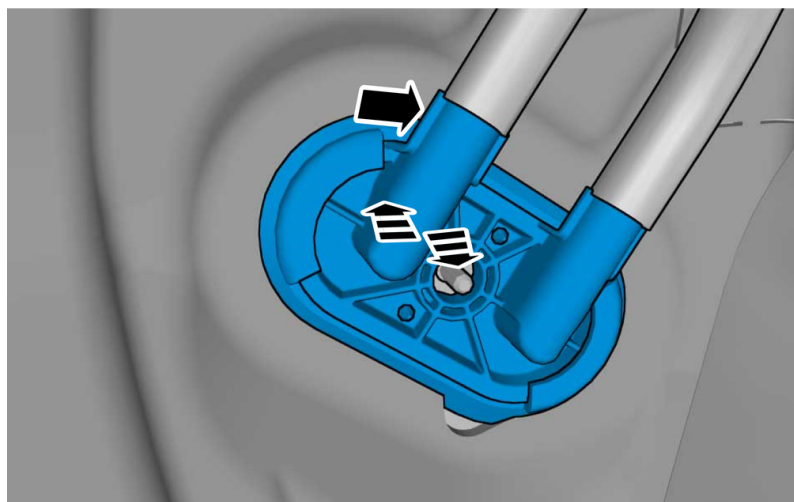
Check that the rubber grommet is not loose:
1 -First grab the hose connection and press inwards. 2 -Then pull outwards. 3 -Again push inwards.

If no faults are detected, to install, reverse the removal procedure.

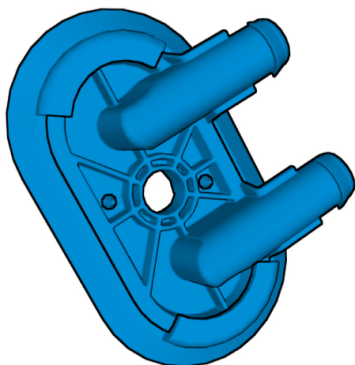
If the result of the checking procedure is not OK, the component must be replaced with a new component.

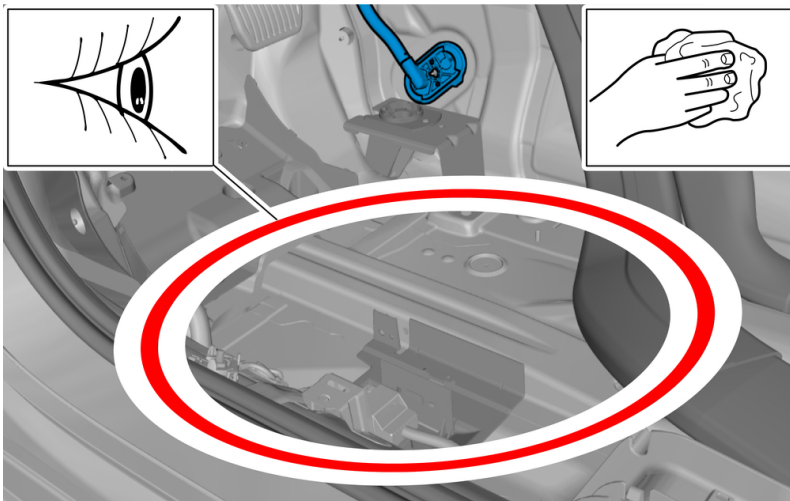
Note! Check for moisture in the area indicated.

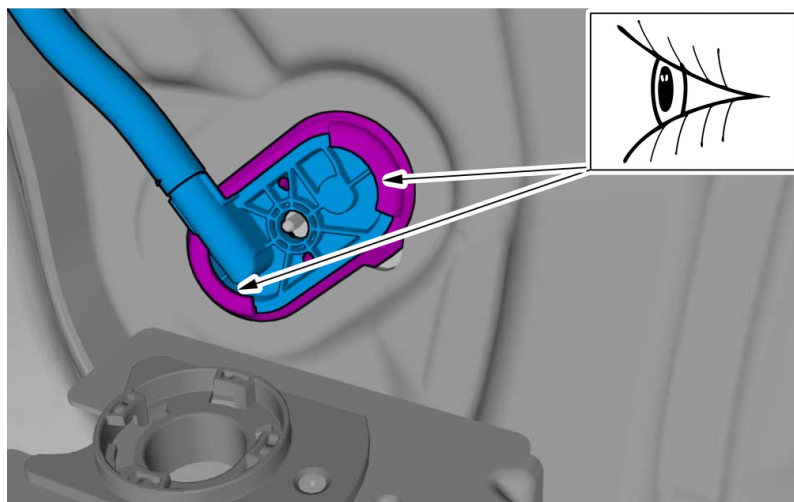
Caution! The grommet seal must rest on the metal surface, not on the carpet.

Note! Make sure that the seal is correctly located.

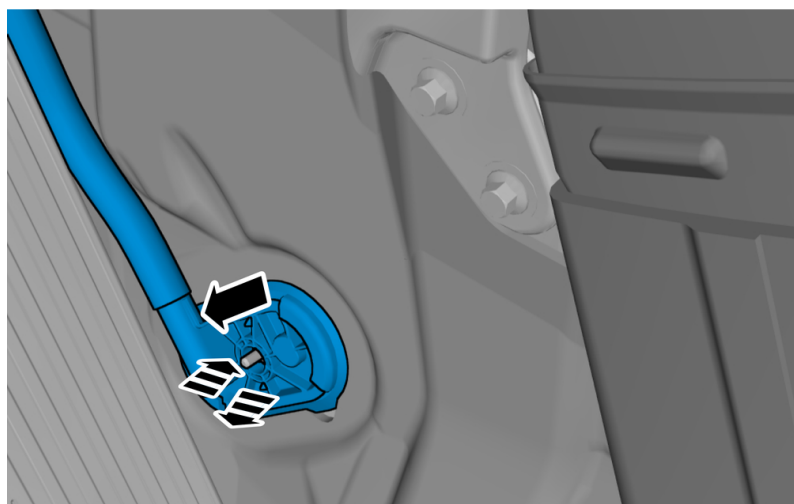
Check that the rubber grommet is not loose:
1 -First grab the hose connection and press inwards. 2 -Then pull outwards. 3 -Again push inwards.

If no faults are detected, to install, reverse the removal procedure.

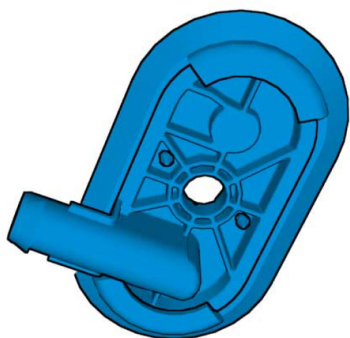
If the result of the checking procedure is not OK, the component must be replaced with a new component.
