Date: September 29, 2016
Contact: Technical Services
Subject: NHTSA Recall 16V-691

**A_160299_RC_EN** Front master cylinder pushrod/boot assembly

Affected Models: A specific range of :

2014-2015 Tuono V4 1000
2016 Tuono V4 1100
2015 Caponord 1200 ABS/ADD
2016 Caponord Rally

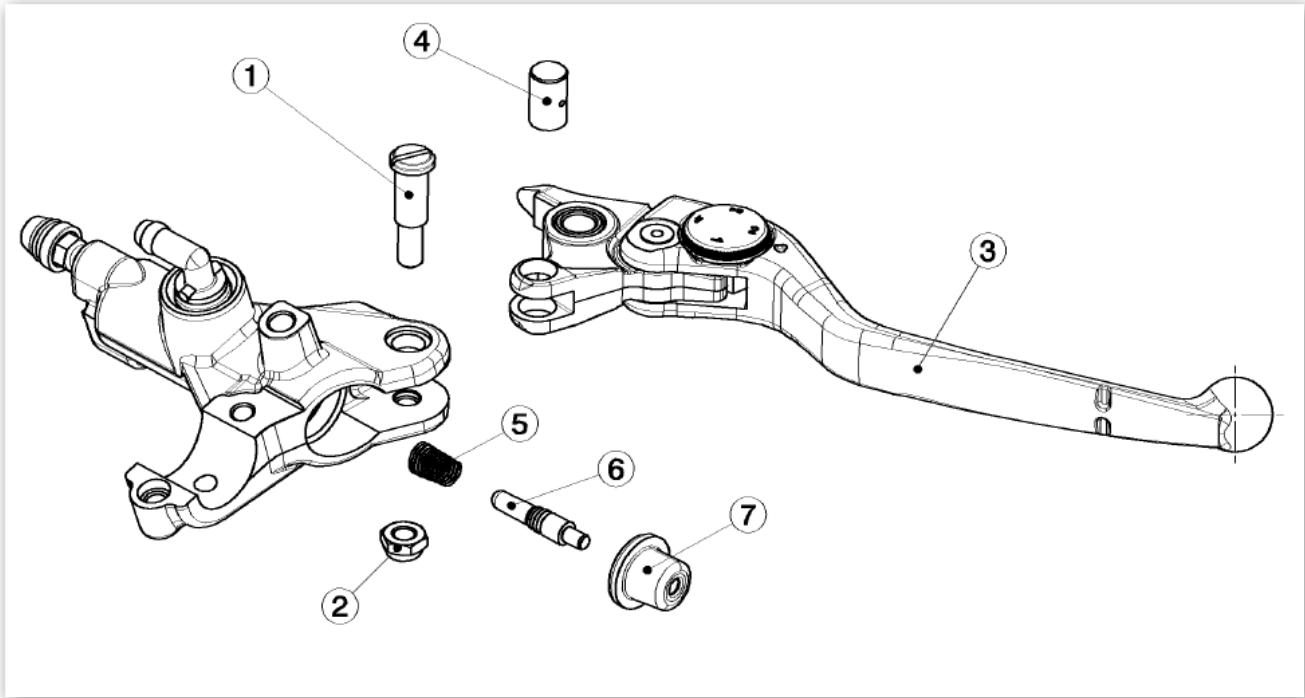
Figure 1: Brembo front brake master cylinder

1. Use a 10 mm hex nut wrench to undo the nut (2) while holding the lever pivot pin (1) with a flat head screwdriver to prevent it from turning. Undo the lever pivot pin (1) and remove it from its seat.
2. Remove the brake lever (3) from the master cylinder, taking care not to drop the barrel (4) as it detaches from the pushrod (6).
3. Use flat nose pliers to remove the pushrod (6) and the spring (5) from the boot (the spring remains attached to the pushrod).
To facilitate removal of the spring, rotate the pushrod anticlockwise while removing from the boot (see figure 2).

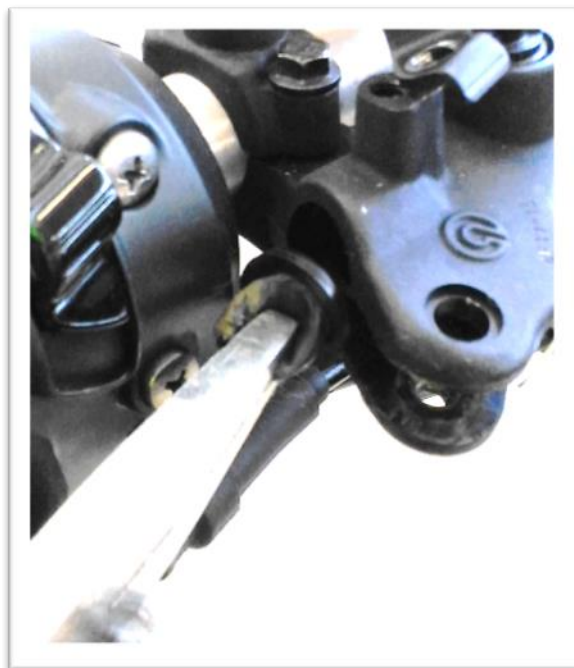
Figure 3

4. Use flat nose pliers to pull the boot (7) out of its seat, pulling axially and gradually (see figure 3).

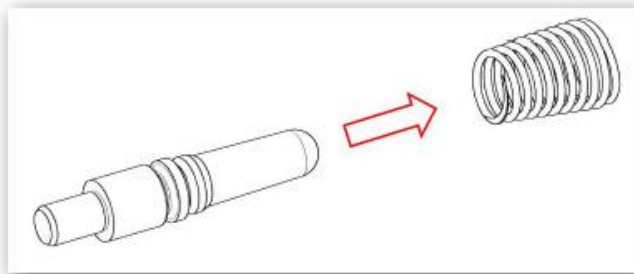
Figure 4

5. Detach the spring (5) from the pushrod (6), pulling axially and gradually. Rotate the spring on the pushrod during this operation to facilitate removal of the spring (see figure 4).

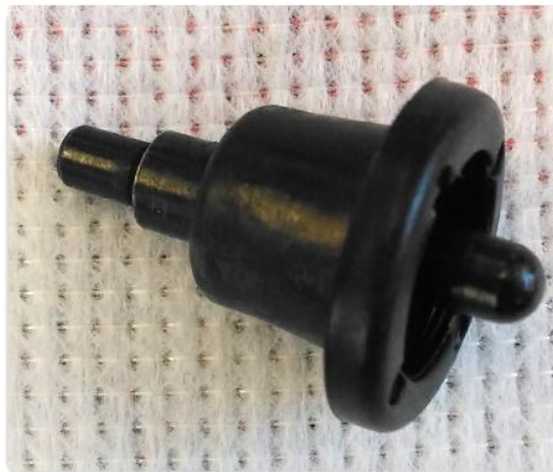
6. Refit the spring on the new pushrod assembly (6) with boot (7) included in the spare parts kit, pushing axially into place until it snaps perceptibly into its seat. Check that the spring is installed correctly by pulling gently in an axial direction: the spring must remain fastened to the pushrod.

Pushrod and boot kit P/N 2B003807

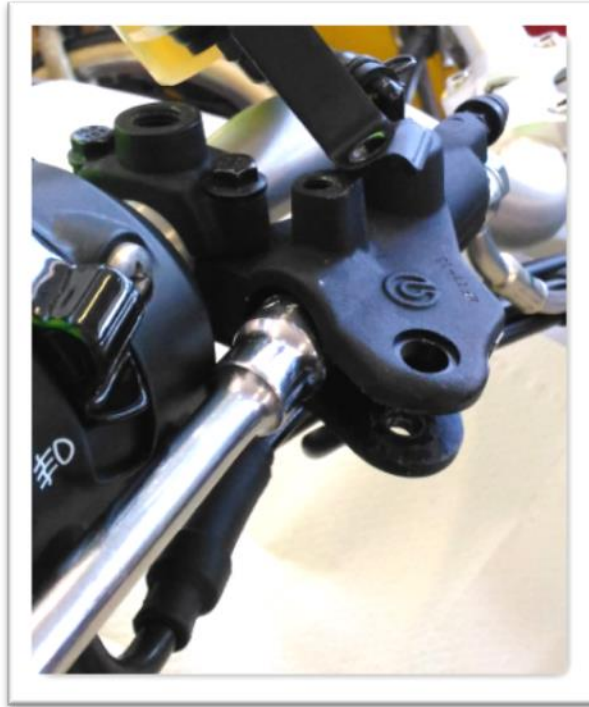
Figure 5

7. Manually push the pushrod (6), dust boot (7) and return spring (5) assembly fully into its seat in the master cylinder housing. If necessary, use a 13 mm socket wrench with a maximum outer diameter of 18.8 mm (see figure 5) to push the boot into its seat.

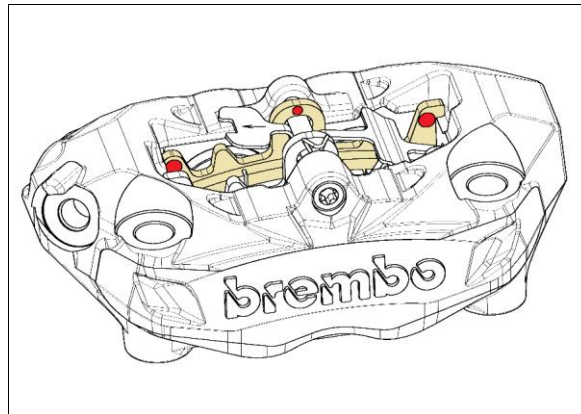
Figure 6

1. Remove the cover and the membrane from the brake fluid reservoir.
2. Retract the calliper pistons completely with circlip pliers, pushing against the brake pad backing plates in the three positions indicated in fig 6.

NOTE: push against the backing plate only, do not touch the friction material.
