Campaign No. 2017010005, February 2017

SUBJECT: **Model 447, Model Year 2017**
Replace Front Passenger-side Air Bag

Daimler AG ("DAG"), the manufacturer of Mercedes-Benz vans, has determined that in certain Metris vans, the front passenger airbag may have been produced with an incorrect Tether Activation Unit (TAU). In the event of a crash necessitating deployment of the front passenger airbag, the TAU may not open the vent and the airbag may not vent properly. An improperly vented airbag may not protect the seated occupant as expected, and therefore may increase the risk of injury. An authorized Mercedes-Benz Sprinter dealer will replace the front passenger airbag on affected vehicles.

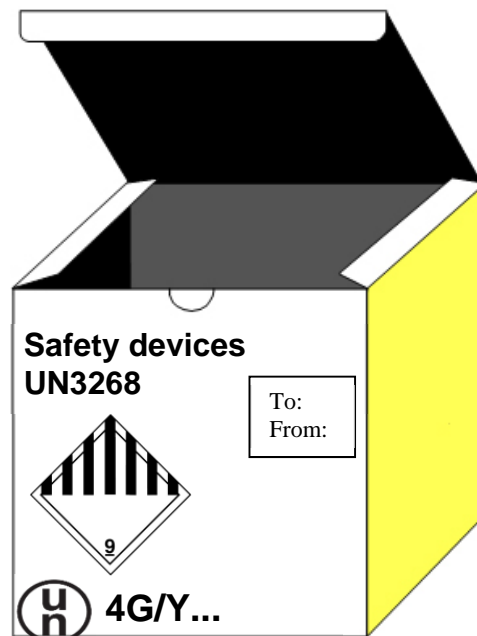
- Carefully open received box and remove new airbag. Keep box intact & save all contents!
- Place used airbag into replacement airbag box, re-using any packaging material (e.g., cardboard inserts) used for the new airbag. Package as the new airbag was packaged.
- Use plastic adhesive tape 50 mm wide to secure the box closed. Do not obscure labels or text on the box with the tape.
- Ensure that the 4G fiberboard box is not ripped or damaged.

- A **Class 9 Miscellaneous** label must be clearly visible on one side of the box.

- The following words ("marking") must also be clearly visible on the same side of the box as the Class 9 label:
Safety devices
UN3268 (font size must be $\geq \frac{1}{2}$ inch)
- Affix "**To/From**" address label to same or adjacent packaging face as the hazardous markings/labels.
- The UN 4G code preprinted near the bottom edge of the box must also be clearly visible.

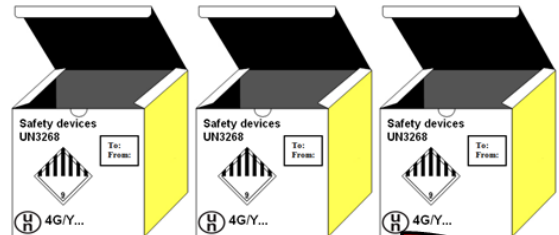
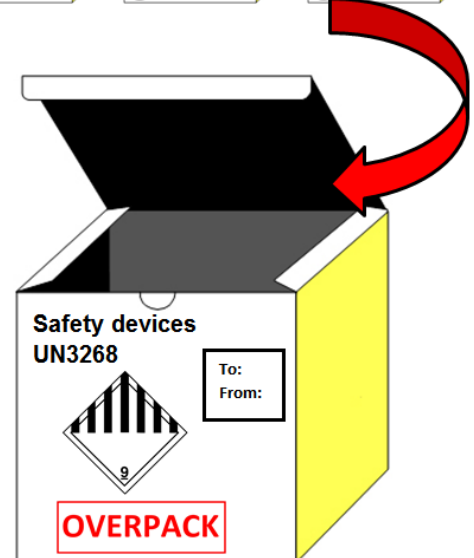
- Place each individual airbag box (noted above) inside a larger non-UN spec box to keep shipment together.
- This larger box is called an "**OVERPACK**."

- The OVERPACK must have the identical markings and label as the boxes contained inside.
- The OVERPACK must have the "**OVERPACK**" statement on the same face as the hazard markings and labels. **Package example:**
