IMPORTANT SAFETY RECALL
16V-012

RE: Recaro Recall No. 15E-088

Axess, Arrivo, E-Z Rider and XHF model buses with Recaro ERGO-M commercial bus operator seats

| Operation # | SAP Line # | Operation Description | Level | Date | Author | |
|---|---|--|---|---|---|---|
| M0999507 | N/A | Service Instruction Inspect and Repair J-brackets | 05 | Released | 10/21/2015 | Chris Perkins |

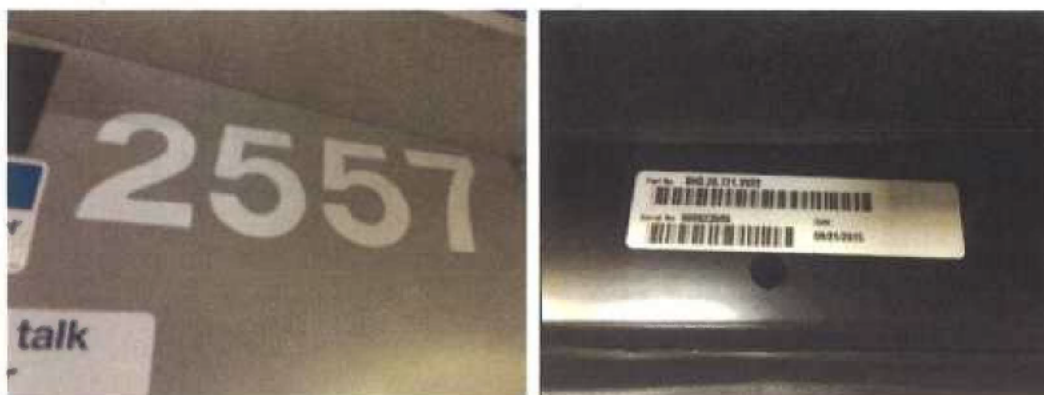
1. Position the seat to “full forward” and “full up” to obtain the serial number on the seat. The serial number decal is located on the back of the seat on the top of the suspension between the seat tracks, shown above. Record the bus number and serial number of the seat.

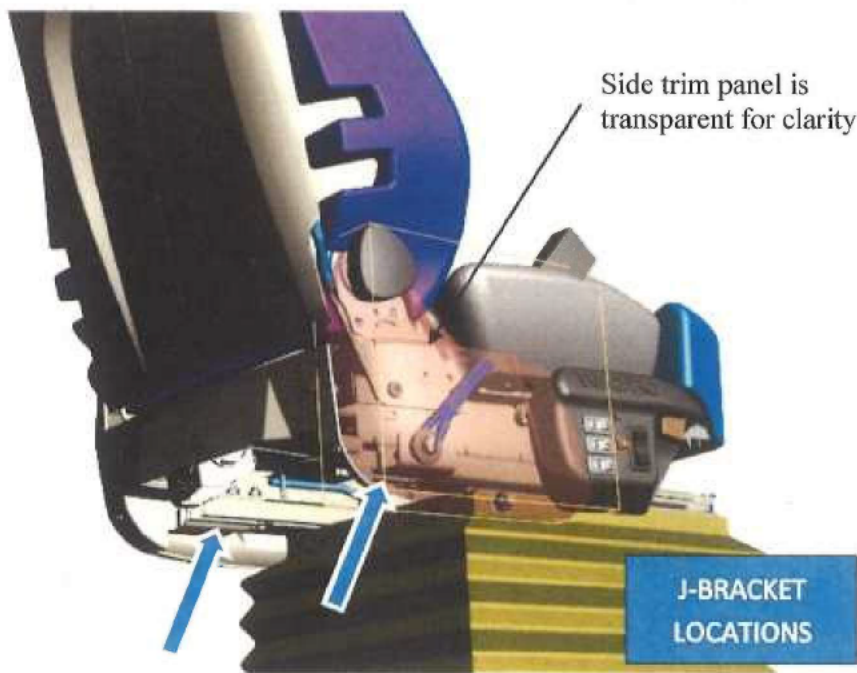
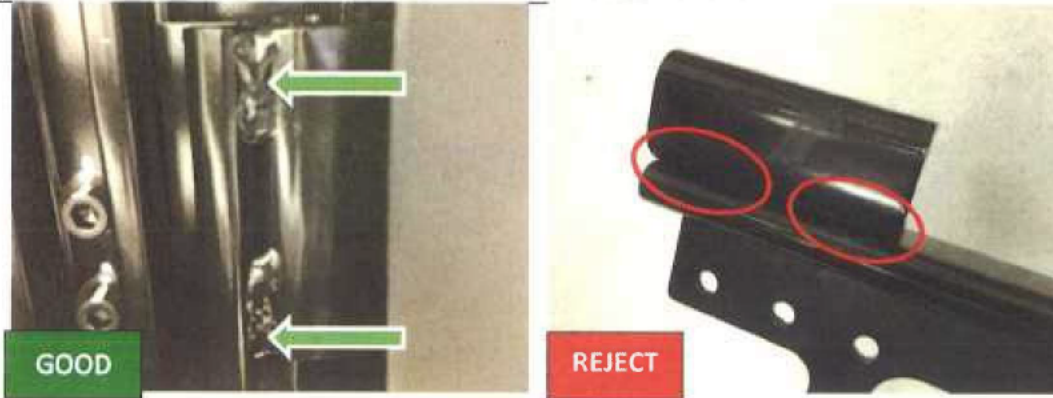
- Position the seat to best expose the underside of the J-brackets, “full up” and “full rear” would typically be best best location. Examine both J-brackets for presence of underside welds. Document condition of J-brackets.

If any of the welds are missing from the bottom of either J-Bracket, continue to section 2. If both welds are present and the parts are good, no further work is required.

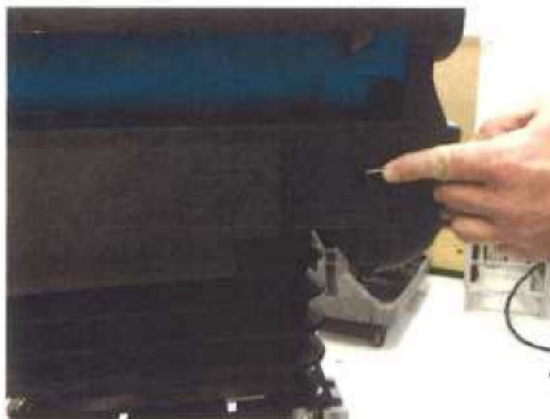
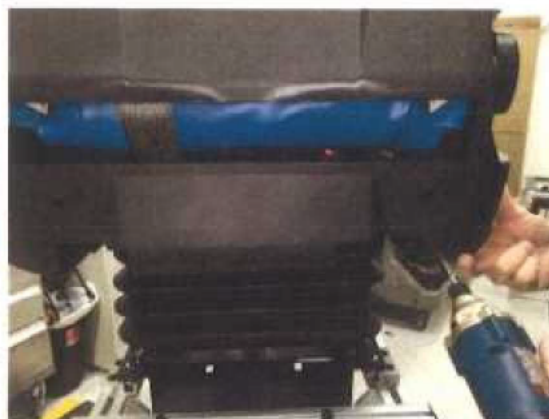
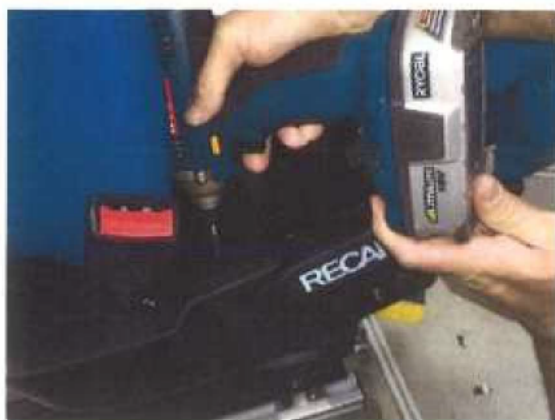
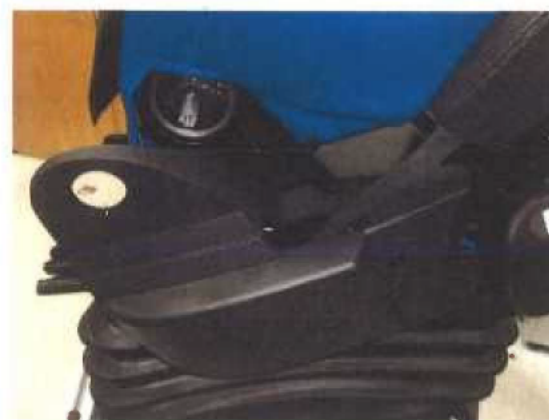
- If J-bracket(s) need to be replaced, remove the 2 hole plugs and 4 screws in the rear trim panel and the mounting screw from the rear corner panel(s). Remove the recliner handwheel.

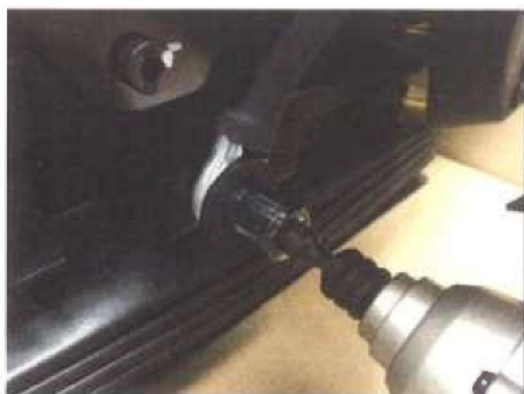
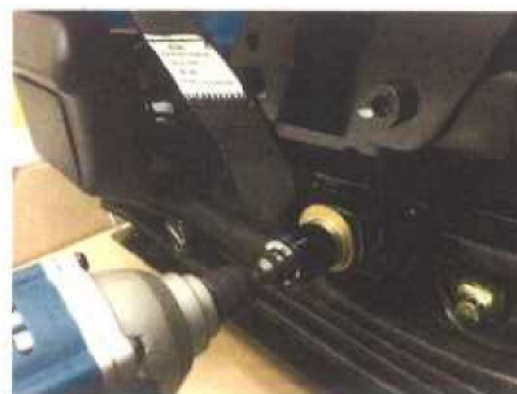
- Remove the belt buckle (or belt retractor/3pt anchor) from the bad J-bracket with a 5/8 socket. Set the removed components aside.

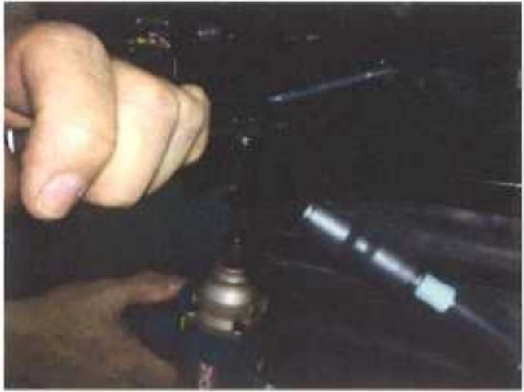
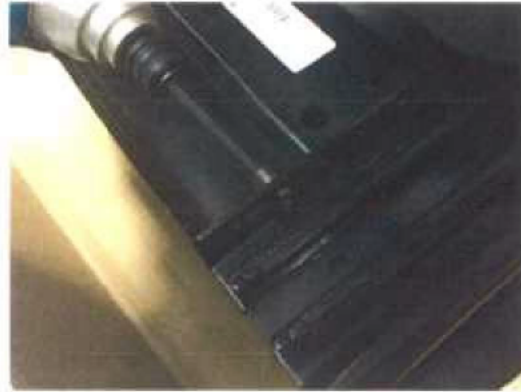
- Position the seat back to "full forward". Unfasten the front track bolt from the cushion frame using a 6mm hex bit and a 13mm wrench. Check the rear of seat for a track stop bolt. If present, remove it with the 6mm hex bit.

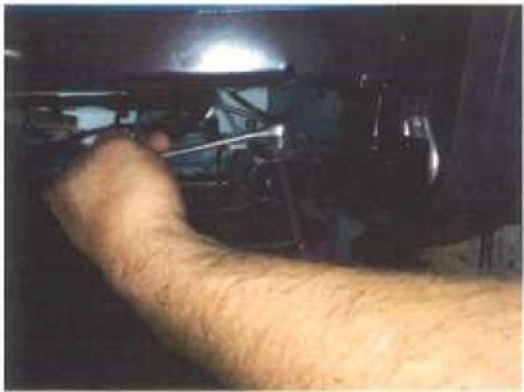
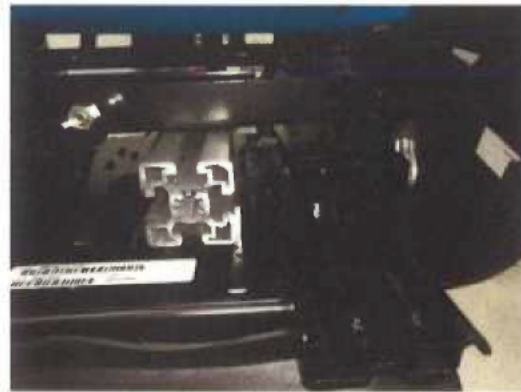
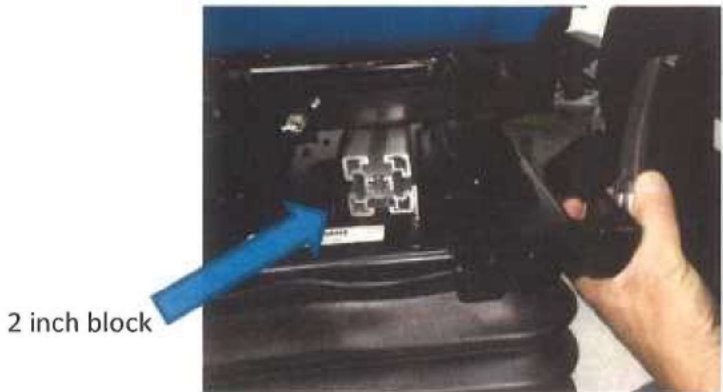
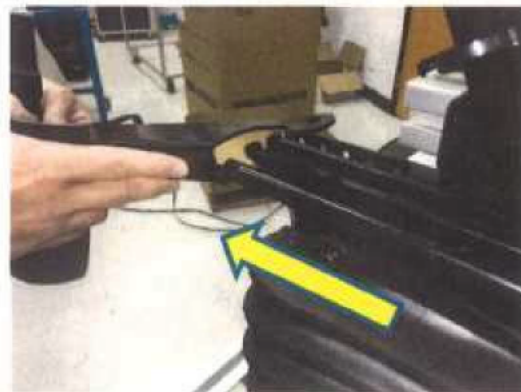
- Position the seat to "full rear". Unfasten the rear track bolts from the cushion frame using an 6mm hex bit and a 13mm wrench. Place a 2 inch block between the cushion frame and suspension to create just enough clearance to remove the J-bracket by sliding it rearward along the path of the track.

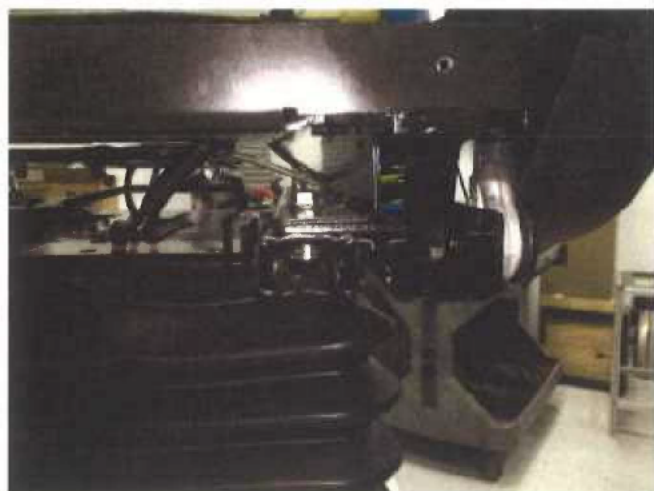
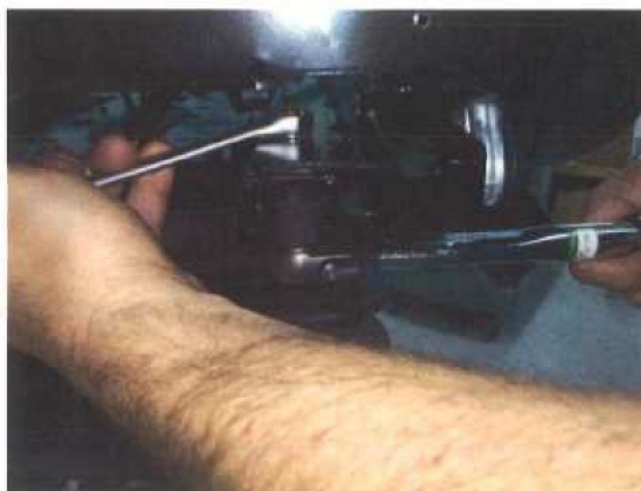
- Position the replacement part utilizing the same path and aligning all the mounting holes. Obtain replacement M8 bolts. Place rear fasteners thru the mounting holes from below and start the flange nuts by hand. Torque to 22 Nm.

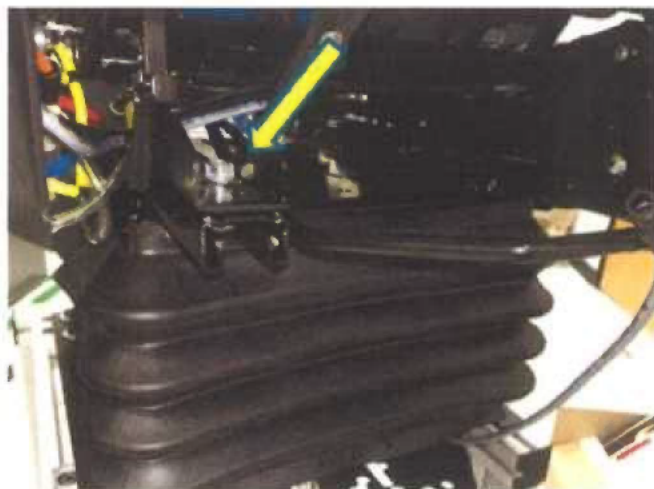
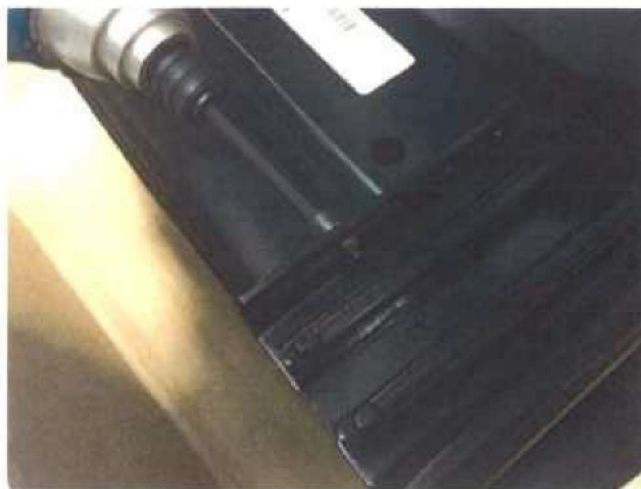
- Position the seat to "full forward". Obtain replacement M8 bolts. Place front fastener thru the mounting holes from below and start, by hand, the flange nut. Torque to 22 Nm.
- If applicable, replace the track stop bolt previously removed.

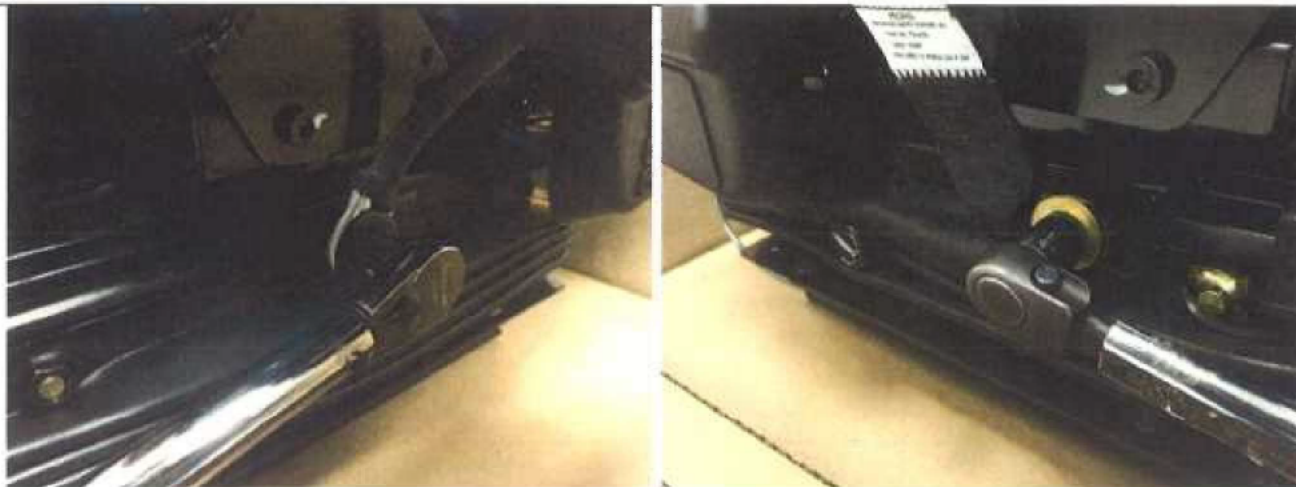
9. Route the buckle through the rear trim panel. Hand start the seat belt buckle bolt into the replacement J-Bracket part now in the seat. Torque to 50 Nm.
10. If needed, replace the other side J-bracket using the same procedure documented in steps 5-10.

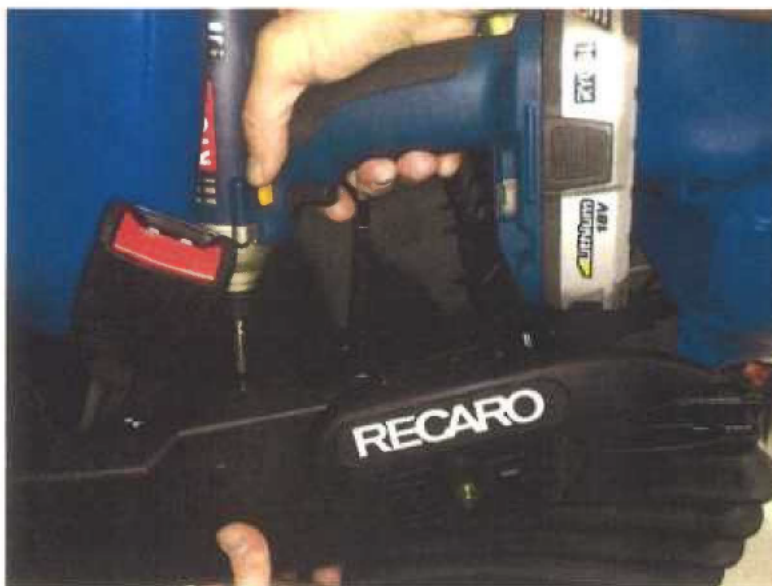
11. Replace the corner panel(s) in original position and secure with the mounting screw(s) previously removed.

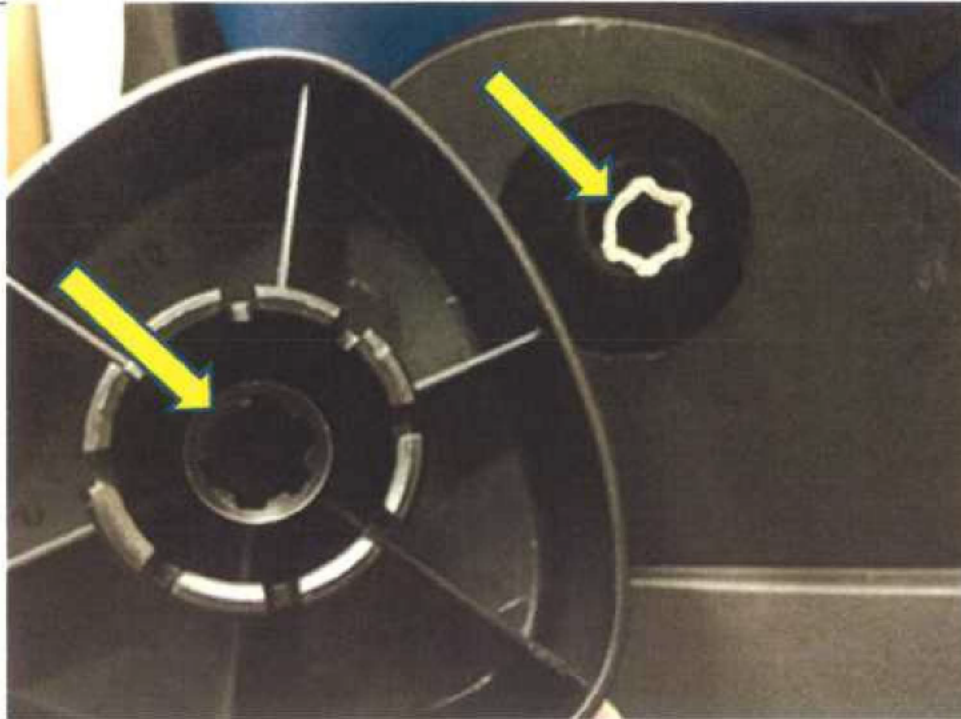
- Replace the recliner handwheel making sure to align the keyed pattern of the recliner rod to the handwheel.

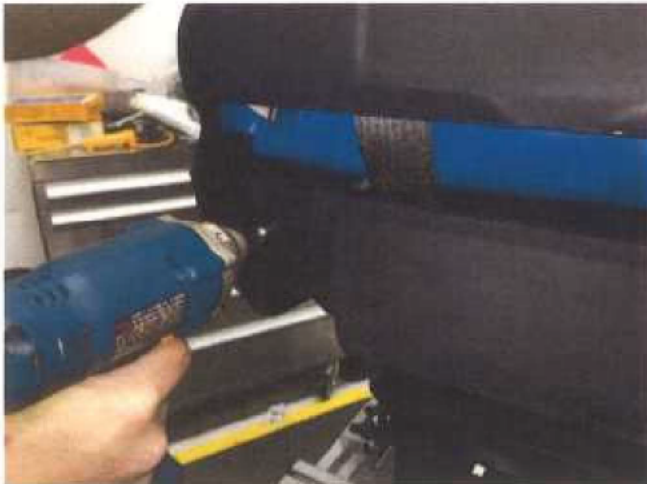
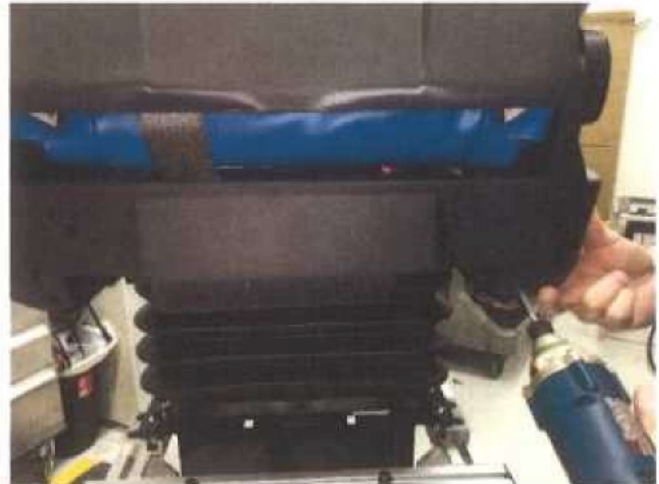
- Position the rear trim panel into its original position and secure with the mounting screws previously removed. Install the hole plugs into the rear trim panel that were previously removed.

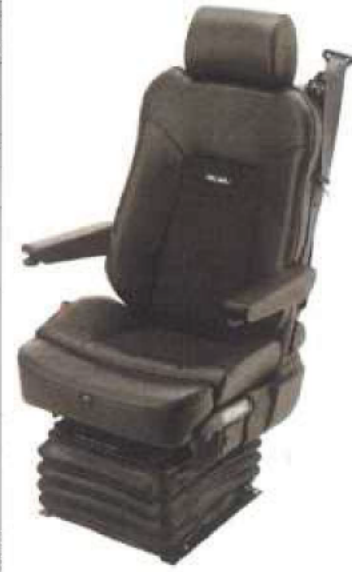
| | <p>1 Dual Recliner Gears Dual recline gears make adjusting the seat-back smooth and easy.</p> |
| | <p>2 4 Way Adjustable Headrest Manually adjustable headrest moves up, down, forward and backward providing optimum comfort and safety.</p> |
| | <p>3 Thigh Extension & Tilt Seat cushion extends and tilts upward and downward, allowing for fit from a 5th percentile female up to a 95 percentile male.</p> |
| | <p>4 11" Fore / Aft Seat Travel Manual or Air Track Release for seat travel adjustment.</p> |
| | <p>5 Dual Shock / Adjustable Pneumatic suspension with 6" suspension travel. Allows operator to adjust the suspension to individual comfort needs.</p> |
| | <p>6 Pneumatic Adjustable Lumbar 3 separate chambers fill with air independently allowing for individually optimized lumbar support.</p> |
