IMPORTANT SAFETY RECALL
NHTSA Recall# 16V484

Bulletin No: TCH-003-054

Subject: **BENDIX® SR-5™ TRAILER SPRING BRAKE VALVE**

FIELD REPAIR KIT FOR THE BENDIX® SR-5™ TRAILER SPRING BRAKE VALVE

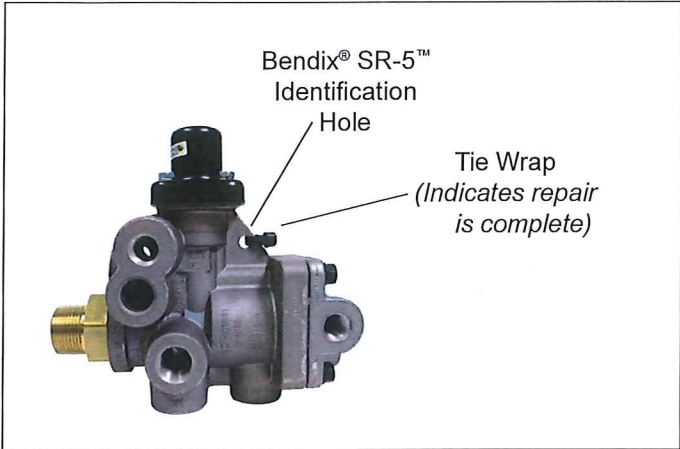
Figure 2 – Tie Wrap Location

Note: Bendix SR-5 valves with a green or black tie wrap through the identification hole in the body have already been repaired. No further servicing is required. (Refer to Figure 2.)

The presence of a tie wrap in the SR-5 valve identification hole indicates the valve has already been repaired and no further action is necessary. SR-5 valves that do not have a tie wrap in this hole can be identified by the supplier code and the date of manufacture located on the valve body as shown in the illustration above. Verification of **both** is required to determine if the valve is a part of the campaign. Valves covered by this campaign must meet the following criteria:

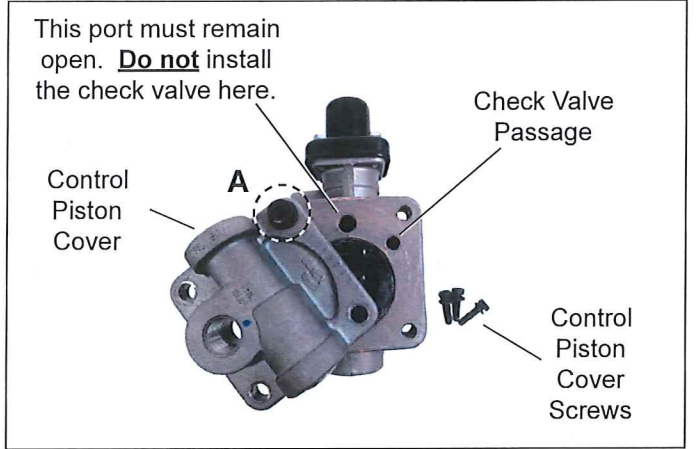
Figure 5 – Check Valve Passage

1. Identify and disconnect all the air lines connected to the control piston cover. (*Refer to Figure 4.*)
2. It is necessary to rotate the fitting in the trailer supply port to complete this step. Rotate the fitting counterclockwise only (loosening) no more than 90°. (*Refer to Figure 3.*)
3. Remove cover screws "B", "C", and "D". While holding the control piston cover in place, loosen cover screw "A" 4-5 turns. Carefully rotate the cover clockwise – pivoting on screw "A" – until the check valve passage in the body is visible. Hold the cover in this position to retain the control piston in the body. (*Refer to Figure 5.*)

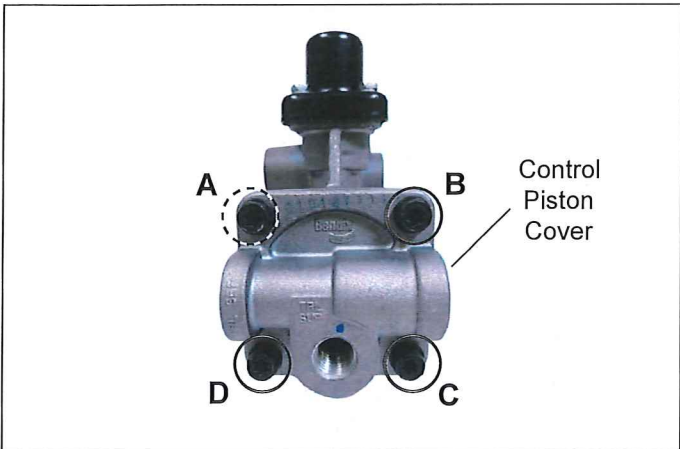
Figure 3 – Control Piston Cover Screws

3. Rotate the cover back into position and install the three screws. Torque all four screws in a crossing pattern to 100 in-lbs. (A, C, D then B). (Refer to Figure 3.)
4. Reposition any fittings that may have been moved and reconnect the air lines.
5. Perform the OPERATIONAL AND LEAKAGE TESTS detailed below before placing the vehicle back into service.

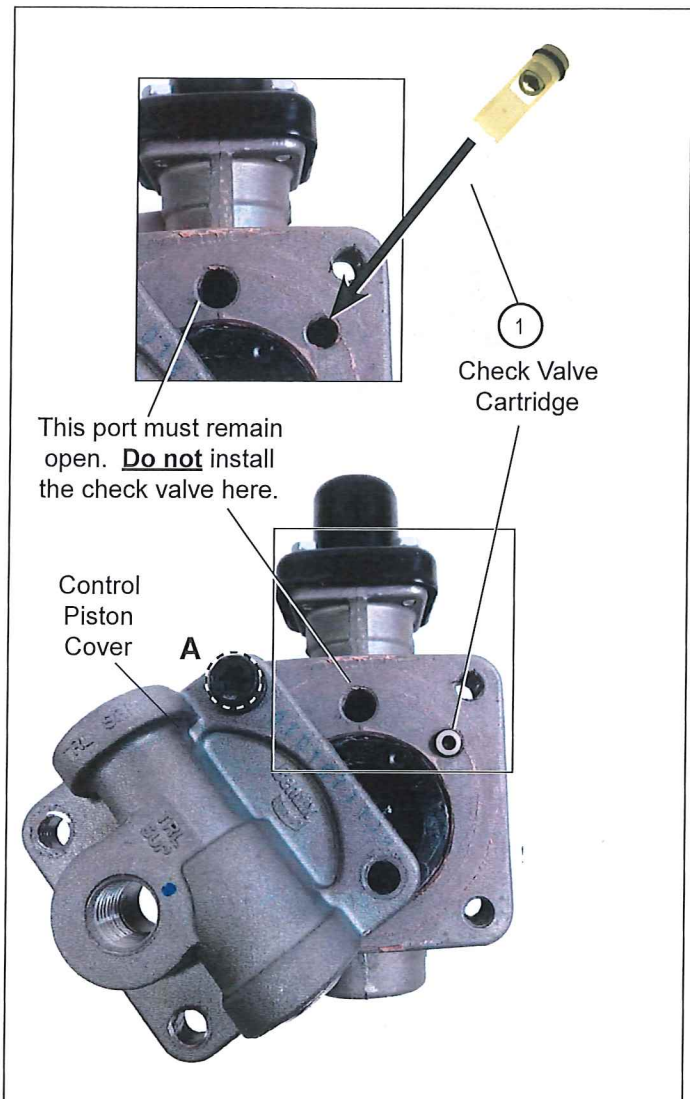
Figure 8 – Check Valve Cartridge Installation

1. Ensure that the check valve cartridge (1) is intact as shown in Figure 8.
2. Holding the larger diameter (o-ring end) of the check valve cartridge (1), insert the pointed end into the air passage. Push the check valve cartridge (1) in lightly with your finger until it is flush with the body housing. (Refer to Figure 8.)

THE CHECK VALVE CARTRIDGE (1) WILL FIT SNUGLY INTO THE CORRECT AIR PASSAGE. DO NOT INSERT THE CHECK VALVE CARTRIDGE (1) INTO THE LARGER AIR PASSAGE.
