IMPORTANT SAFETY RECALL
NHTSA Recall# 16V484

Bulletin No: TCH-003-054

Subject: **BENDIX® SR-5™ TRAILER SPRING BRAKE VALVE**

FIELD REPAIR KIT FOR THE BENDIX® SR-5™ TRAILER SPRING BRAKE VALVE

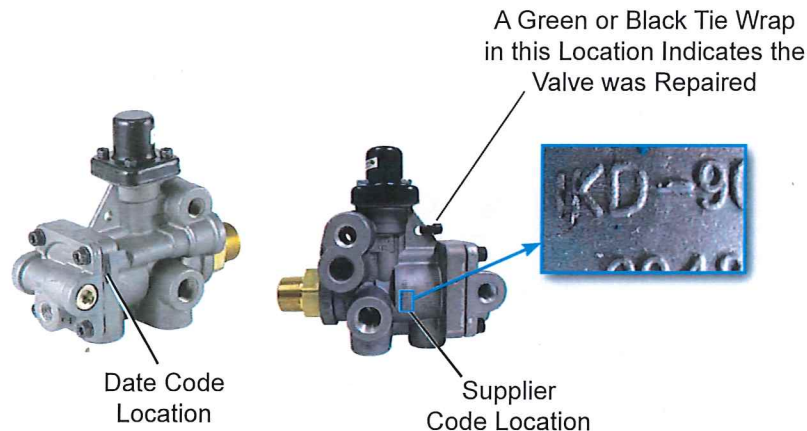
Bendix SR-5 Trailer Spring Brake Valve

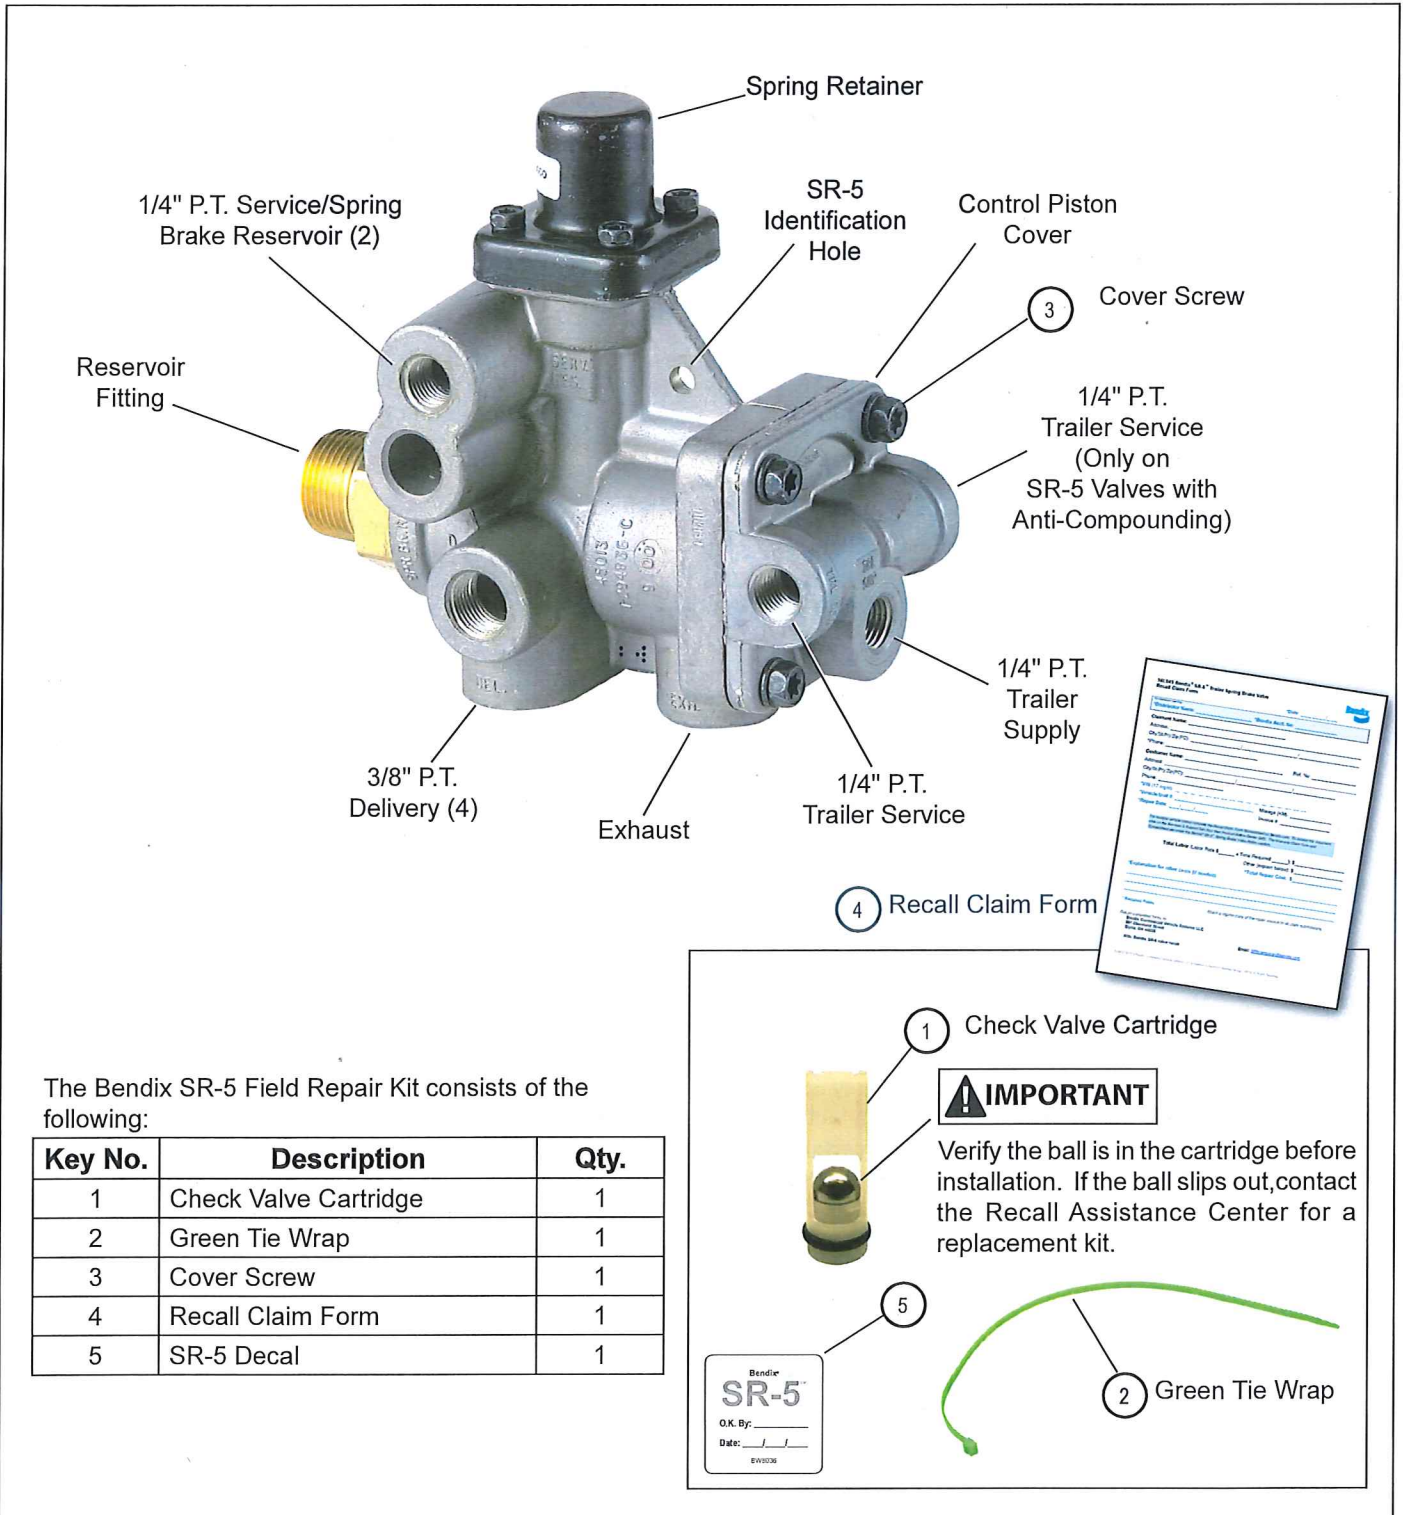
Figure 1 – Bendix SR-5 Trailer Spring Brake Valve Exterior View

The Bendix SR-5 Field Repair Kit consists of the following:

Key No.	Description	Qty.
1	Check Valve Cartridge	1
2	Green Tie Wrap	1
3	Cover Screw	1
4	Recall Claim Form	1
5	SR-5 Decal	1

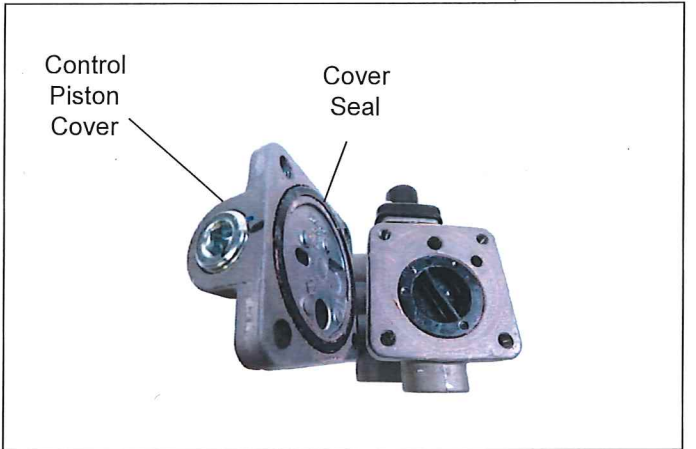
Figure 6 – Cover Seal

4. Exercise caution to prevent damage to the cover seal as shown in Figure 6.

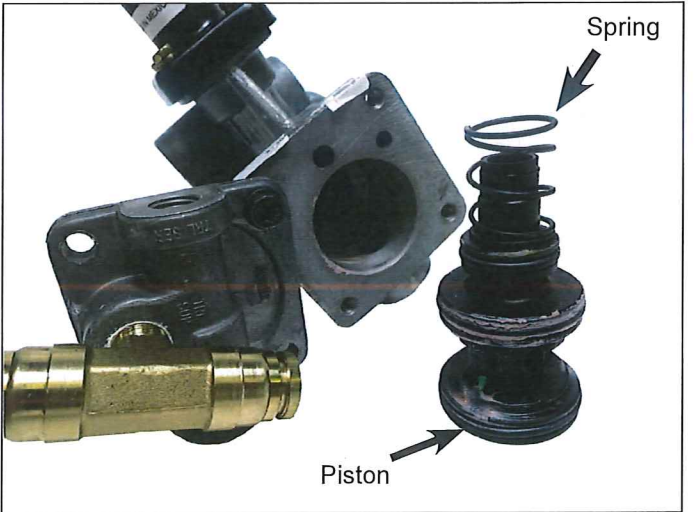
Figure 7 – Piston and Spring

OVER-ROTATING THE COVER MAY ALLOW THE CONTROL PISTON AND RETURN SPRING TO COME OUT OF THE VALVE. IF THIS HAPPENS, REMOVE ANY DEBRIS THAT MAY ADHERE TO THE PISTON AND REINSERT, SPRING FIRST. (*Refer to Figure 7.*)

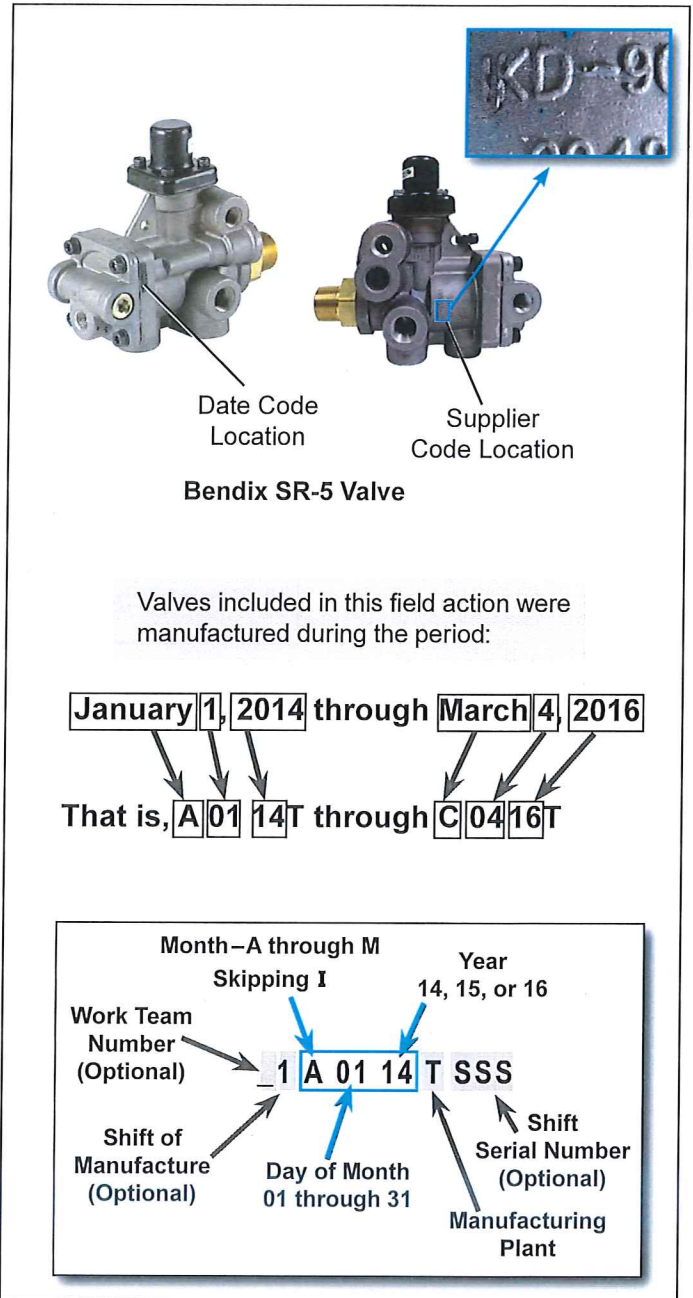
Figure 9 – Recall Identification

1. The supplier code—"IKD"—located as shown in Figure 9; *and*
2. The date of manufacture between January 1, 2014 and March 4, 2016, inclusive. To verify the date code see INTERPRETING THE DATE CODE below.

A date code is stamped (not cast) on the SR-5 valve body housing. *Locate the date code – removing the paint coating, if necessary – to read the code.* Disregard the Work Team Number, Shift of Manufacture, Manufacturing Plant and Shift Serial Number codes shown in gray below. The portion of the date code that determines the date of manufacture is highlighted and can be interpreted as follows:

- The first field is the month (A=January, B=February, etc. – excluding the letter I – so that J=September, and so on),
- The next two fields are the day of the month (e.g. 01 = 1st); and
- The next two fields are the year (e.g. 14=2014).

The SR-5 valves covered by this campaign can be identified by the supplier code and the date of manufacture located on the valve body. Verification of both is required to determine if the valve is a part of the campaign. Valves covered by this campaign must meet the following criteria:
