SERVICE BULLETIN

UTM Reference: SB-08-200 / 410219

NHTSA Reference #16E045

Subject: BENDIX® SR-5 VALVE

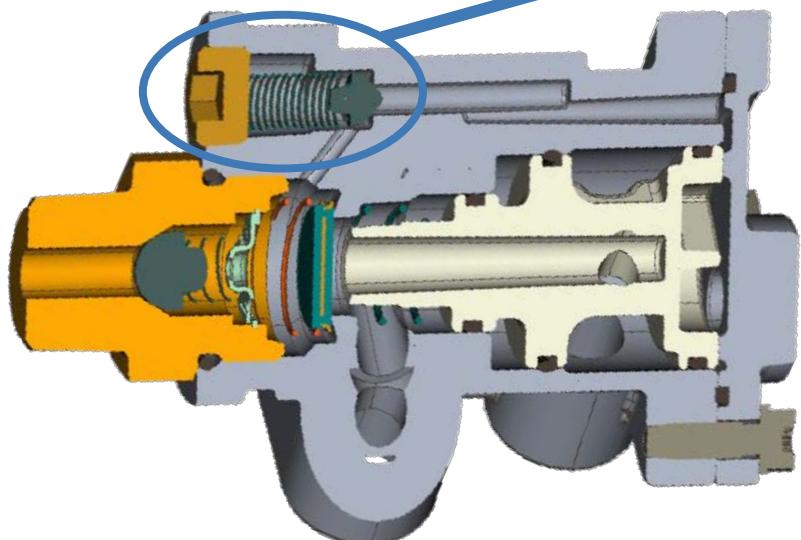
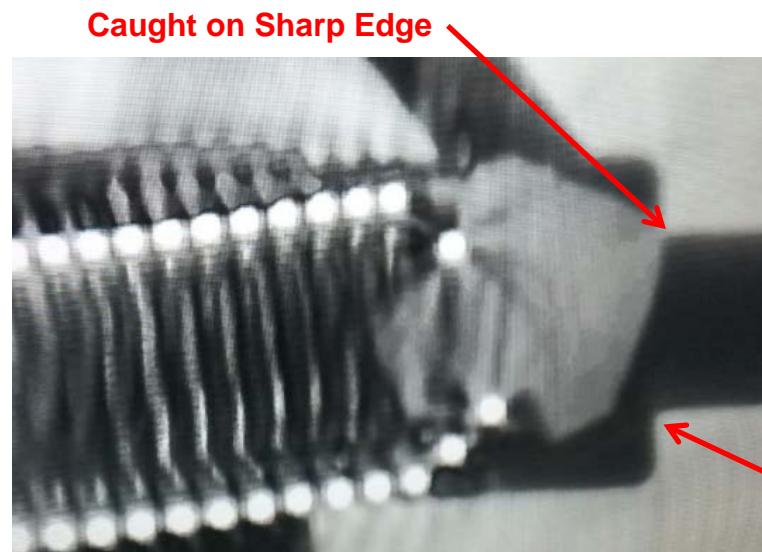
Sectional view of check valve assembly in seated position

Missing Radius on Aluminum valve Body

When combined with certain field conditions – causes misalignment of internal Check Valve

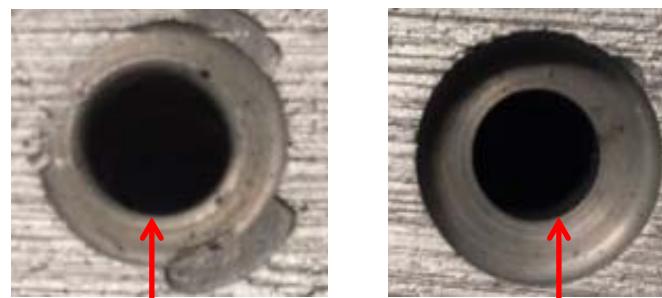
Missing Radius on Valve Body

Check Valve seat
(Radius Present / Radius Not Present)

If Valve becomes Misaligned, Leakage can be Large enough to cause 'Slow to Park'

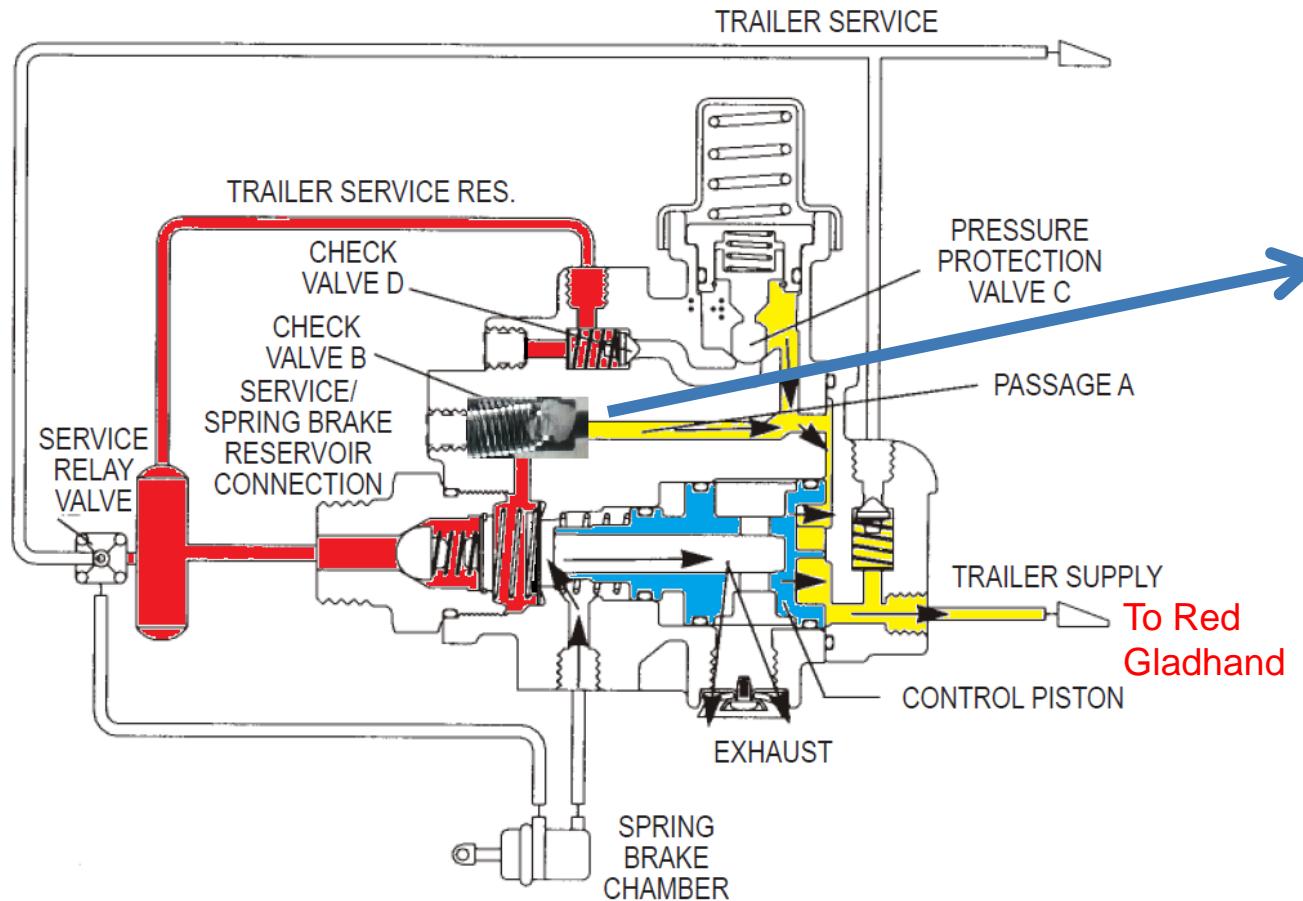
If Leakage is present (& large enough), the leaking air provides enough back pressure on the main control piston (BLUE) to prevent normal movement. If the main piston does not move, immediate exhaust (<3 seconds) cannot happen.

This is how the leakage from the check valve is causing the 'slow to park' condition.

Once leakage fully exhausts tank pressure, the backpressure drops, the main piston moves & the trailer parks.

Missing Radius (combined with other conditions) can cause leakage – preventing immediate parking

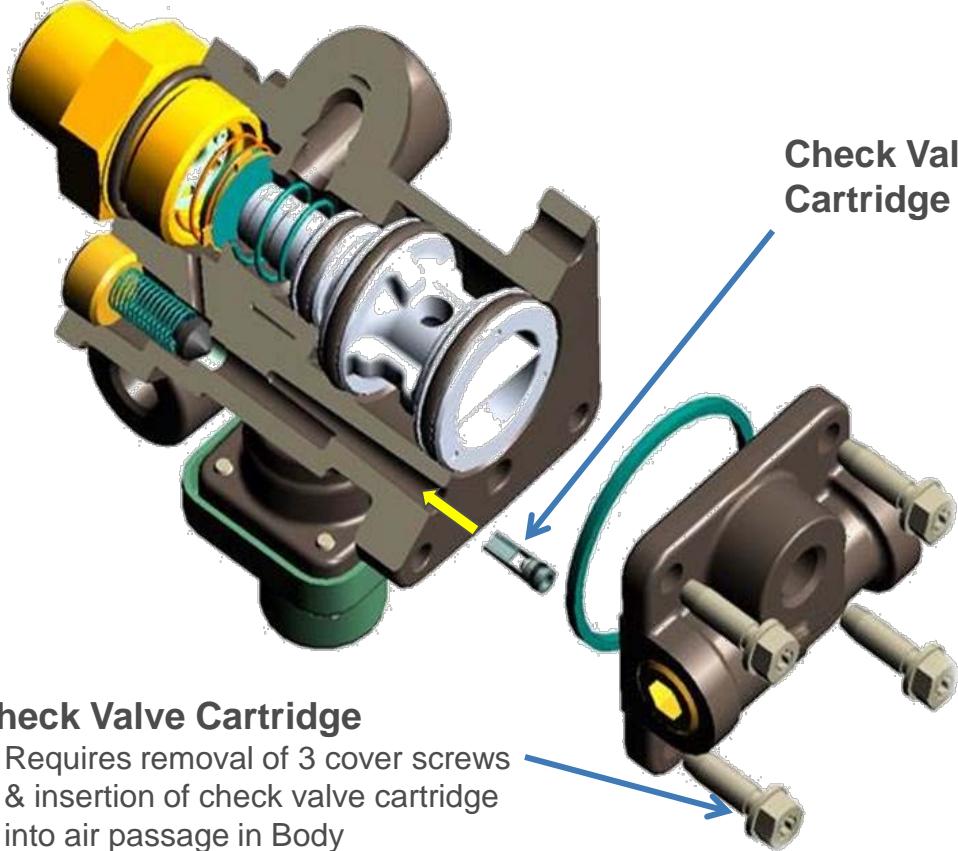
Field Remedy – Field Rework Procedure to insert a Redundant Check valve cartridge in air passageway. Procedure will not require removal & replacement of SR-5.

Production Remedy - Re-introduce Radius on Valve Body (Began on Mar 4, 2016)

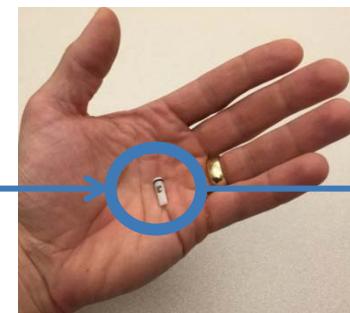
Check Valve Cartridge

- Requires removal of 3 cover screws & insertion of check valve cartridge into air passage in Body
- Successfully remedied 100% of field returns w/ issue.

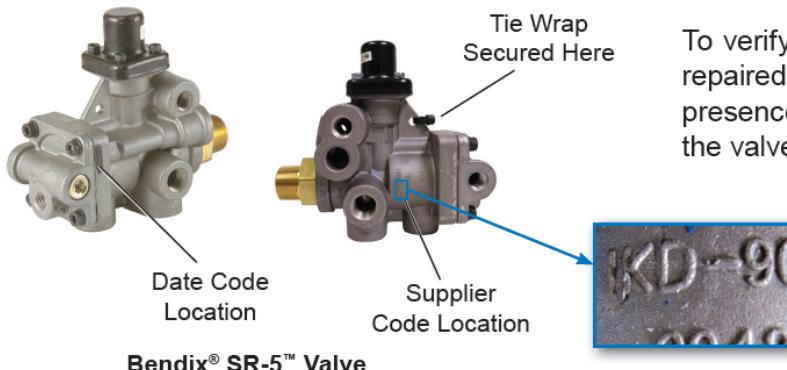
To verify that the Bendix® SR-5™ valve has been repaired per the recall campaign, look for the presence of a black or green tie wrap secured to the valve body. **No further action is required.**

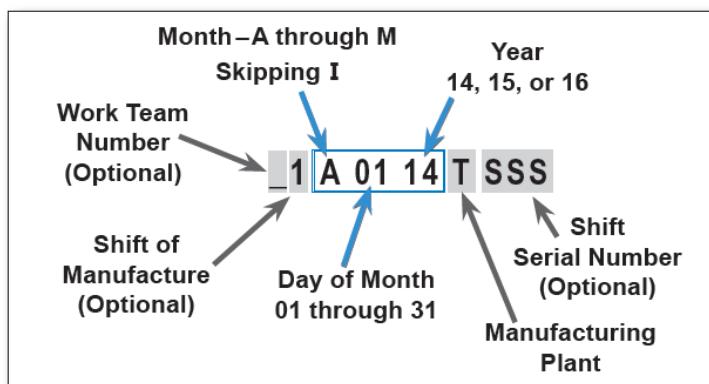
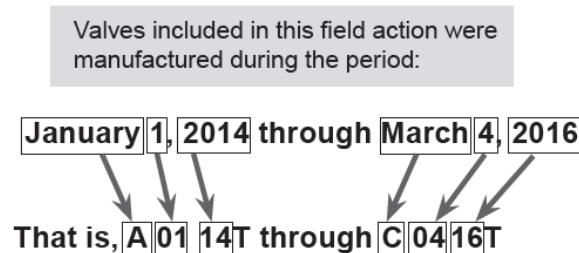
A date code is stamped (not cast) on the SR-5 valve body housing. *Locate the date code – removing the paint coating, if necessary – to read the code.* Disregard the Work Team Number, Shift of Manufacture, Manufacturing Plant and Shift Serial Number codes shown in gray below. The portion of the date code that determines the date of manufacture is highlighted and can be interpreted as follows:

- The first field is the month (A=January, B=February, etc. – excluding the letter I – so that J=September, and so on),
- The next two fields are the day of the month (e.g. 01=1st); and
- The next two fields are the year (e.g. 14=2014)

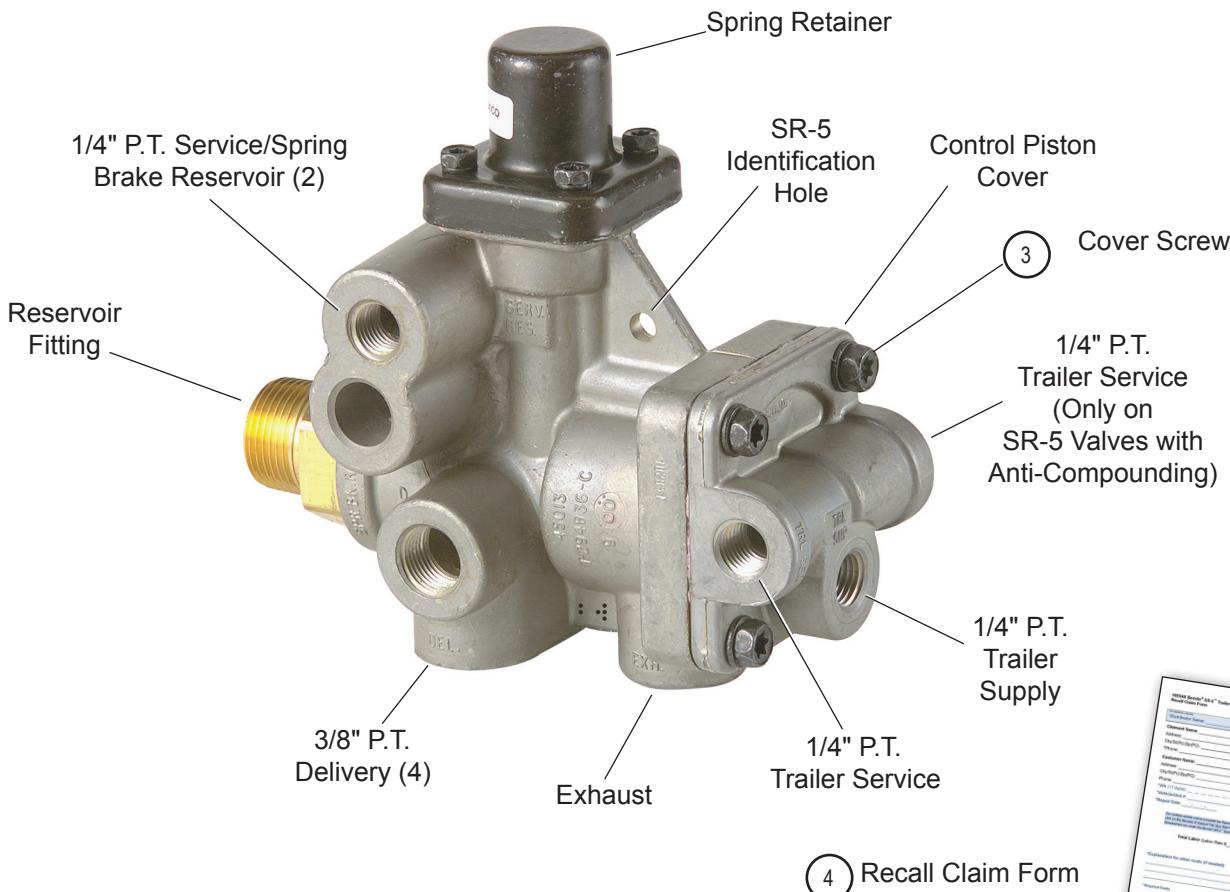
The Bendix SR-5 Field Repair Kit Consists of the Following:

Key No.	Description	Qty.
1	Check Valve Cartridge	1
2	Green Tie Wrap	1
3	Cover Screw	1
4	Recall Claim Form	1
5	Bendix Decal (not shown)	1

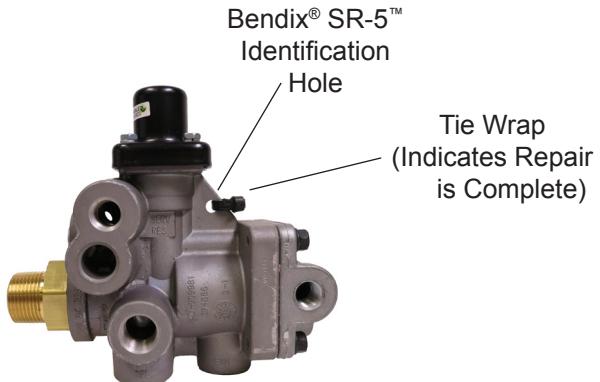
Figure 2 – Tie Wrap Location

Note: Bendix SR-5 valves with a green or black tie wrap through the identification hole in the body have already been repaired. No further servicing is required. (Refer to Figure 2.)

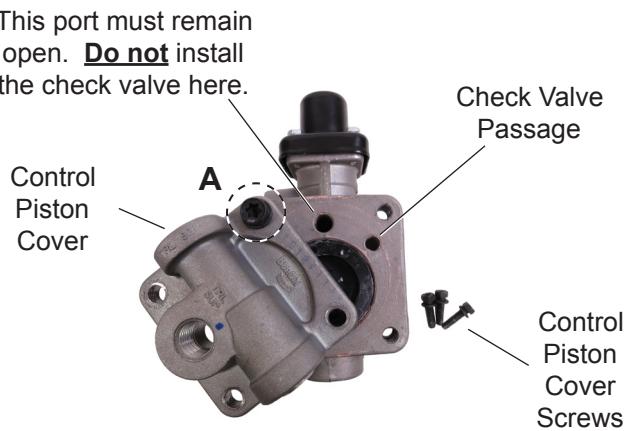
Figure 5 – Check Valve Passage

1. Identify and disconnect all the air lines connected to the control piston cover. (Refer to Figure 4.)
2. It is necessary to rotate the fitting in the trailer supply port to complete this step. Rotate the fitting counterclockwise only (loosening) no more than 90°. (Refer to Figure 3.)
3. Remove cover screws "B", "C", and "D". While holding the control piston cover in place, loosen cover screw "A" 4-5 turns. Carefully rotate the cover clockwise – pivoting on screw "A" – until the check valve passage in the body is visible. Hold the cover in this position to retain the control piston in the body. (Refer to Figure 5.)

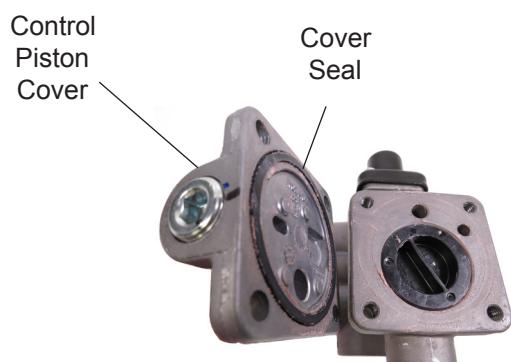
Figure 6 – Cover Seal

4. Exercise caution to prevent damage to the cover seal as shown in Figure 6.

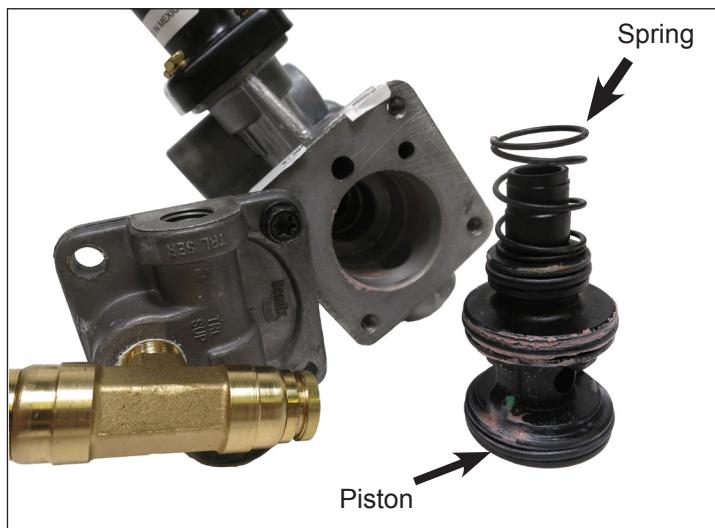
Figure 7 – Piston and Spring

OVER-ROTATING THE COVER MAY ALLOW THE CONTROL PISTON AND RETURN SPRING TO COME OUT OF THE VALVE. IF THIS HAPPENS, REMOVE ANY DEBRIS THAT MAY ADHERE TO THE PISTON AND REINSERT, SPRING FIRST. (Refer to Figure 7.)

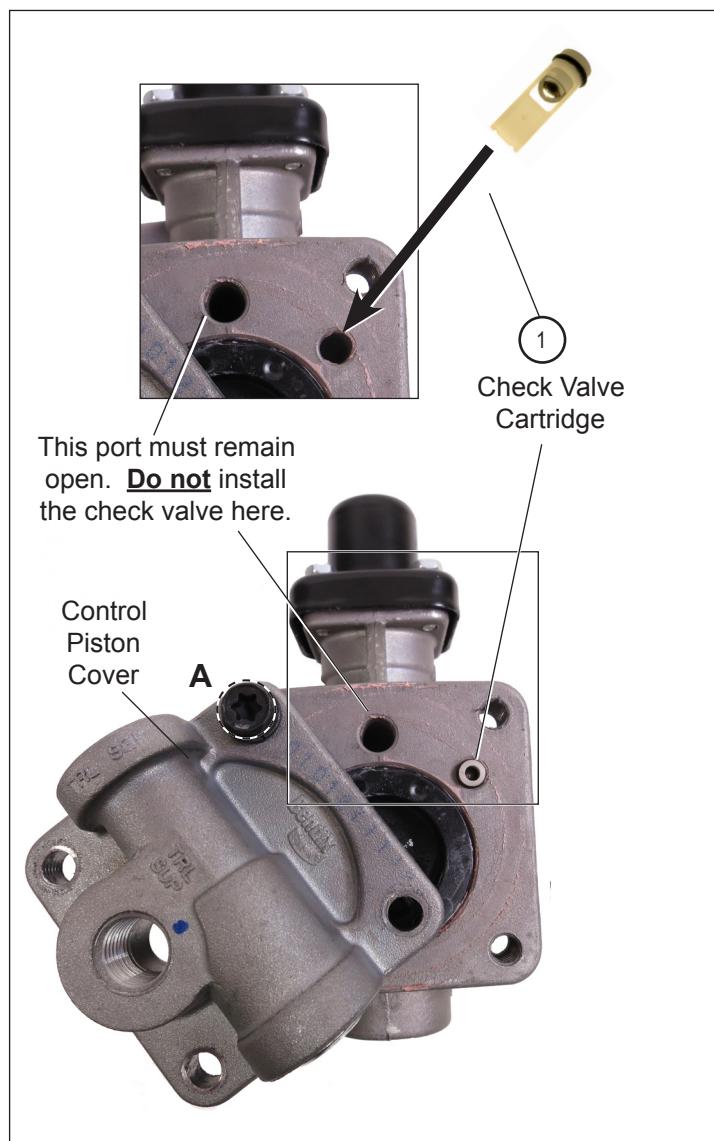
Figure 8 – Check Valve Cartridge Installation

1. Ensure that the check valve cartridge (1) is intact as shown in Figure 8.
2. Holding the larger diameter (o-ring end) of the check valve cartridge (1) insert the pointed end into the air passage. Push the check valve cartridge (1) in lightly with your finger until it is flush with the body housing. (Refer to Figure 8.)

THE CHECK VALVE CARTRIDGE (1) WILL FIT SNUGLY INTO THE CORRECT AIR PASSAGE. DO NOT INSERT THE CHECK VALVE CARTRIDGE (1) INTO THE LARGER AIR PASSAGE.

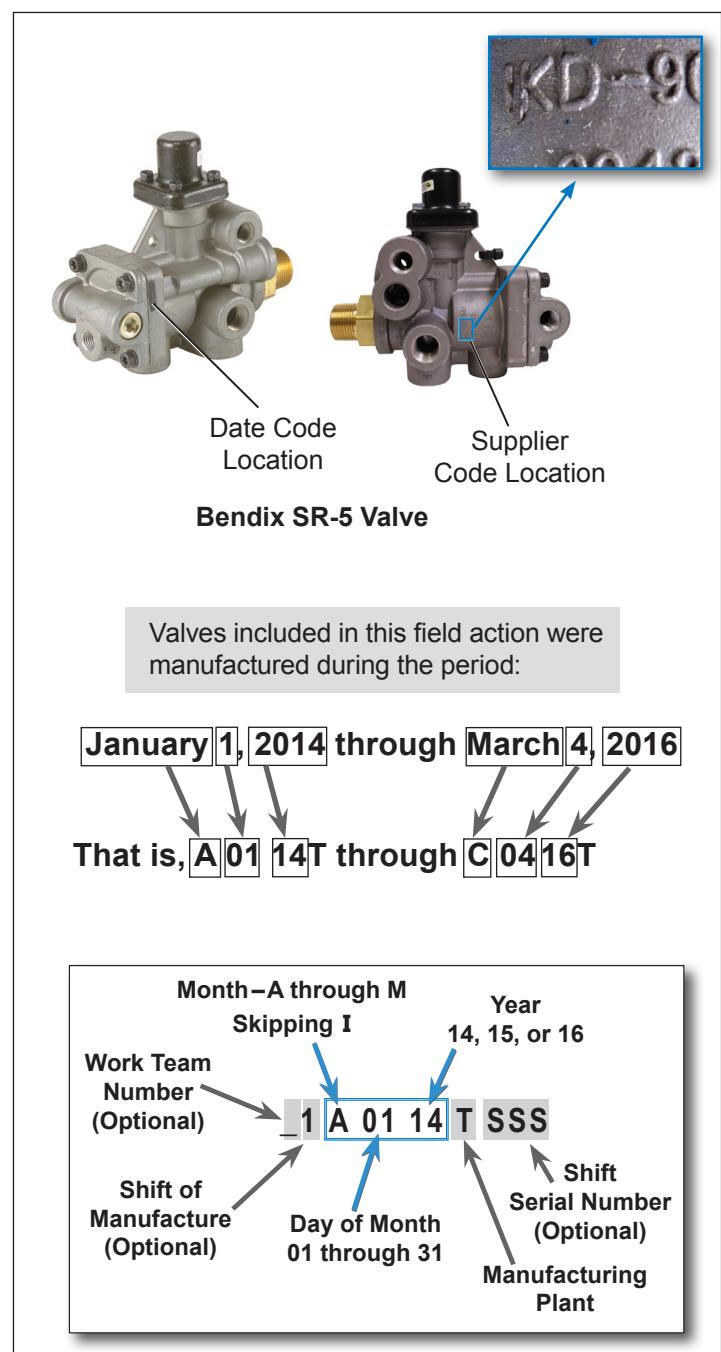
Figure 9 – Recall Identification

1. The supplier code – “IKD” – located as shown in Figure 9; and
2. The date of manufacture between January 1, 2014 and March 4, 2016, inclusive. To verify the date code see INTERPRETING THE DATE CODE below.

A date code is stamped (not cast) on the SR-5 valve body housing. *Locate the date code – removing the paint coating, if necessary – to read the code.* Disregard the Work Team Number, Shift of Manufacture, Manufacturing Plant and Shift Serial Number codes shown in gray below. The portion of the date code that determines the date of manufacture is highlighted and can be interpreted as follows:

- The first field is the month (A=January, B=February, etc. – excluding the letter I – so that J=September, and so on);
- The next two fields are the day of the month (e.g. 01=1st); and
- The next two fields are the year (e.g. 14=2014).
