Operation #	SAP Line #	Operation Description	Level	Date	Author	
M0999507	N/A	Service Instruction Inspect and Repair J-brackets	05	Released	10/21/2015	Chris Perkins
	Page 1 / 8			Revised	10/30/2015	Chris Perkins

This procedure describes a 2 part process. Both inspection and repair, if necessary, are covered by this document. (Inspection reimbursement is 5-minutes per bus (@ a rate of \$65.00/hour)

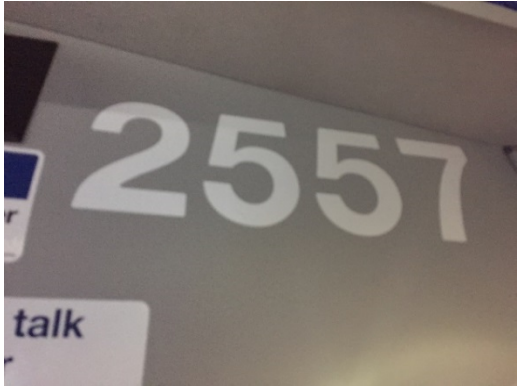
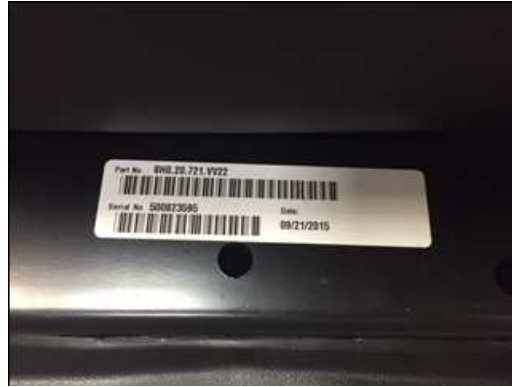
1. Position the seat to “full forward” and “full up” to obtain the serial number on the seat. The serial number decal is located on the back of the seat on the top of the suspension between the seat tracks, shown above. Record the bus number and serial number of the seat.
