Service Bulletin No. 431

<i>MODEL</i>	D / J4500 Series	<i>TYPE</i>	Field Change Program	<i>SECTION/GROUP</i>	3-Body	<i>DATE</i>	
<i>SUBJECT</i>	RECARO ERGO-M DRIVER SEAT BELT ANCHORAGE J-BRACKETS						
<i>CONDITIONS</i>

Ref. Johnson Controls NHTSA Recall No.:15E-088

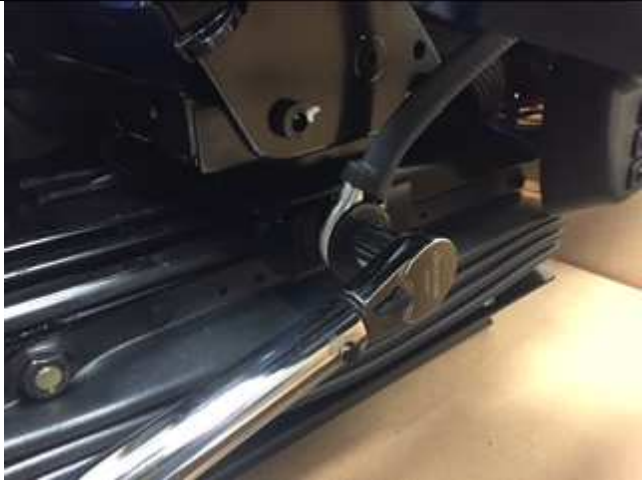
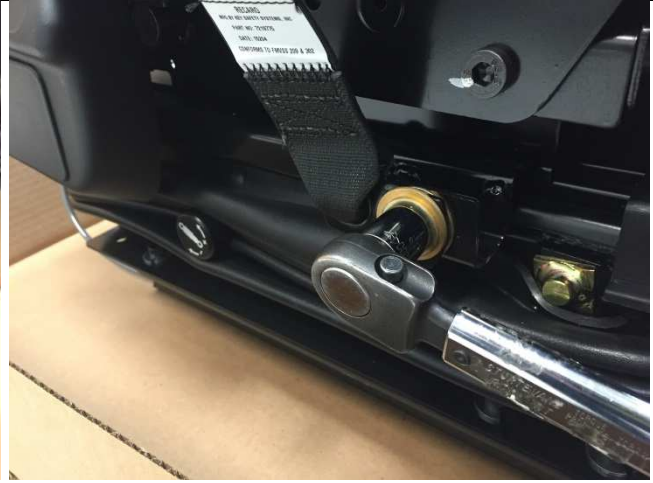
9. Route the buckle through the rear trim panel. Hand start the seat belt buckle bolt into the replacement J-Bracket part now in the seat. Torque to 50 Nm.
10. If needed, replace the other side J-bracket using the same procedure documented in steps 5-10.

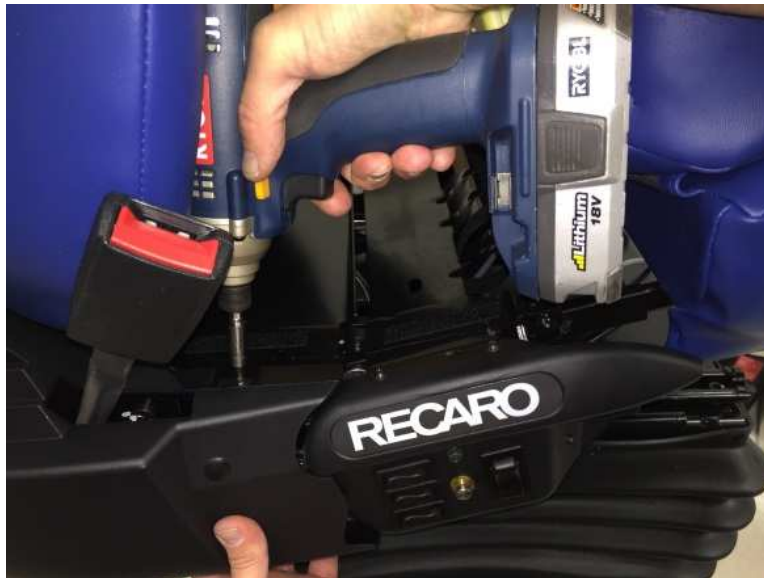
11. Replace the corner panel(s) in original position and secure with the mounting screw(s) previously removed.

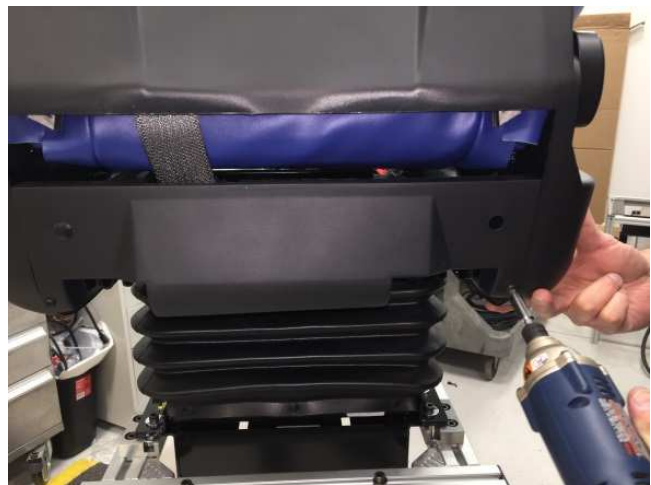
- Position the rear trim panel into its original position and secure with the mounting screws previously removed. Install the hole plugs into the rear trim panel that were previously removed.
