# Service Bulletin No. 431

<i>MODEL</i>	D / J4500 Series	<i>TYPE</i>	Field Change Program	<i>SECTION/GROUP</i>	3-Body	<i>DATE</i>	Feb. 12, 2016
<i>SUBJECT</i>	<b>RECARO ERGO-M DRIVER SEAT BELT ANCHORAGE J-BRACKETS</b>						
<i>CONDITIONS</i>

Operation #	SAP Line #	Operation Description	Level	Date	Author	
M0999507	N/A	<b>Service Instruction Inspect and Repair J-brackets</b>	05	Released	10/21/2015	Chris Perkins
	Page 1 / 8			Revised	10/30/2015	Chris Perkins

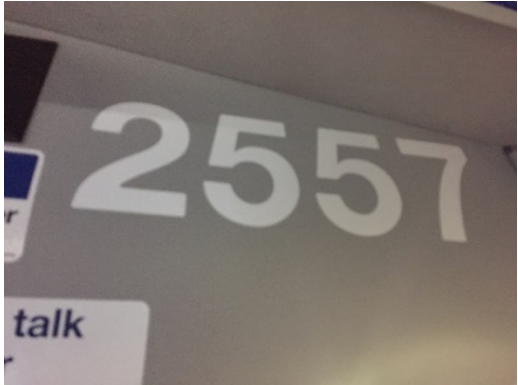
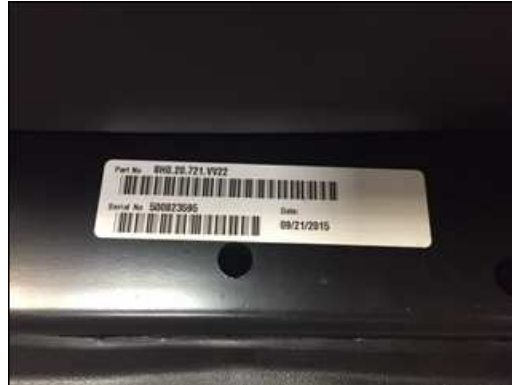
1. Position the seat to “full forward” and “full up” to obtain the serial number on the seat. The serial number decal is located on the back of the seat on the top of the suspension between the seat tracks, shown above. Record the bus number and serial number of the seat.

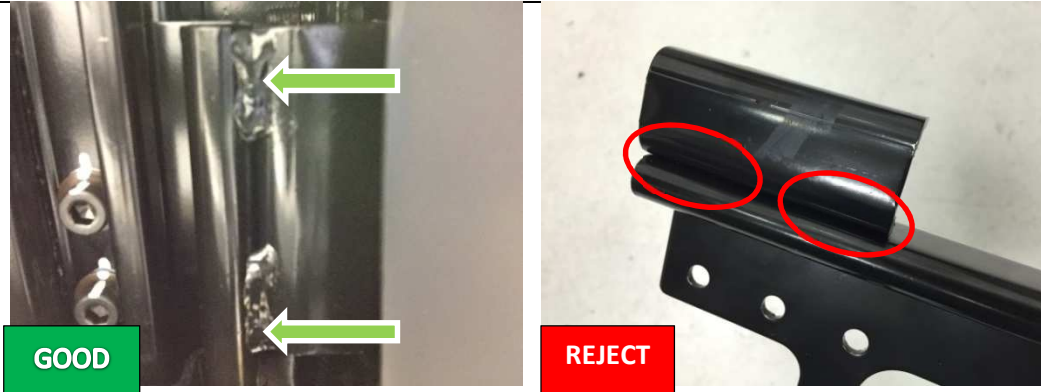
Johnson Controls has notified Motor Coach Industries ( "MCI" ) that a defect which relates to motor vehicle safety may exist in certain RECARO ERGO-M driver seats installed on certain D and J4500 coaches. Johnson Controls reports that the potential exists that two safety critical welds may be missing on the RH or LH seatbelt anchorage J-brackets.

- Position the seat to best expose the underside of the J-brackets, “full up” and “full rear” would typically be best best location. Examine both J-brackets for presence of underside welds. Document condition of J-brackets.

If any of the welds are missing from the bottom of either J-Bracket, continue to section 2. If both welds are present and the parts are good, no further work is required.

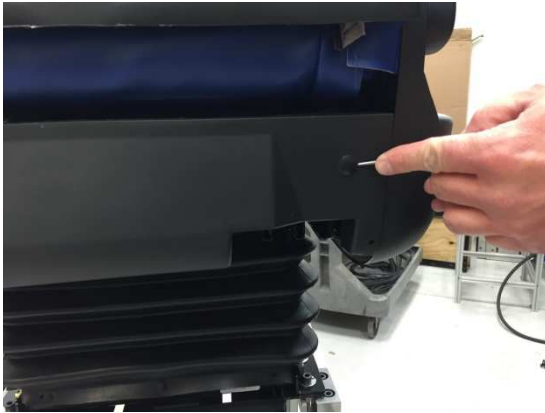
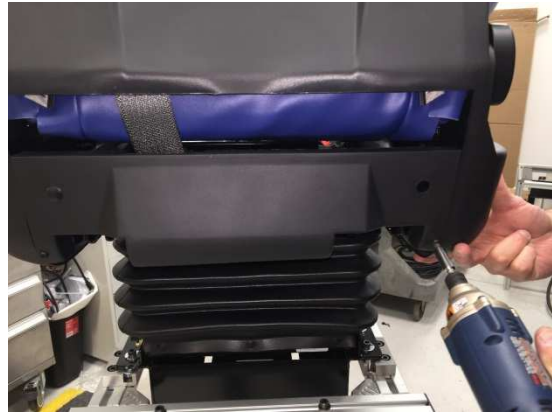
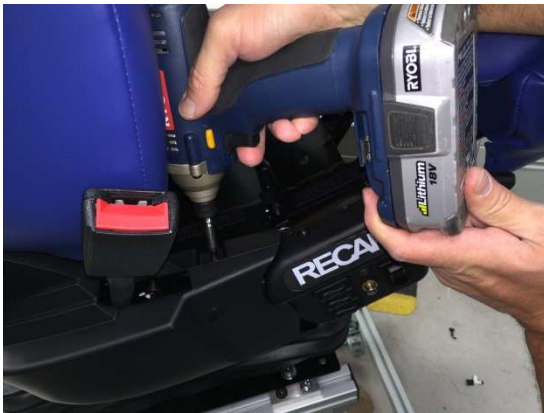
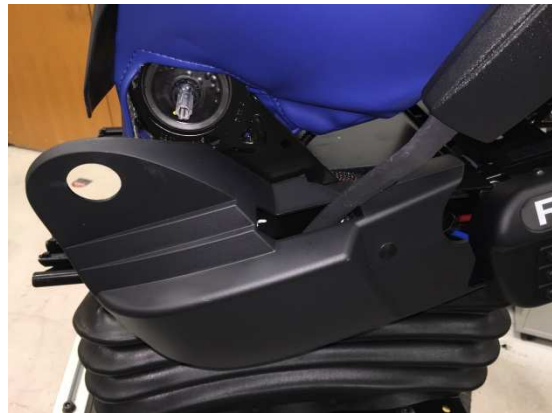
- If J-bracket(s) need to be replaced, remove the 2 hole plugs and 4 screws in the rear trim panel and the mounting screw from the rear corner panel(s). Remove the recliner handwheel.

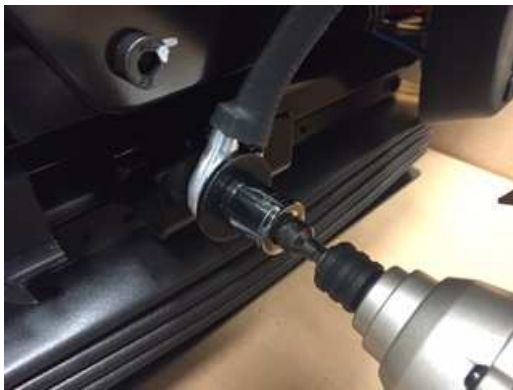
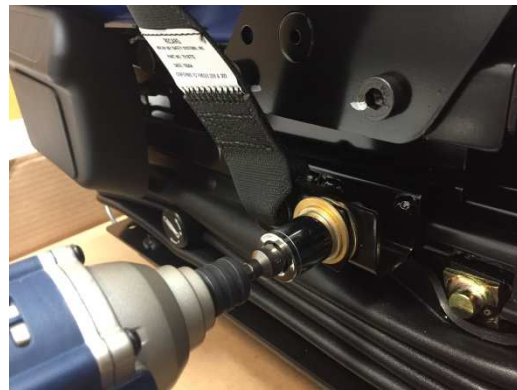
3. Remove the belt buckle (or belt retractor/3pt anchor) from the bad J-bracket with a 5/8 socket. Set the removed components aside.

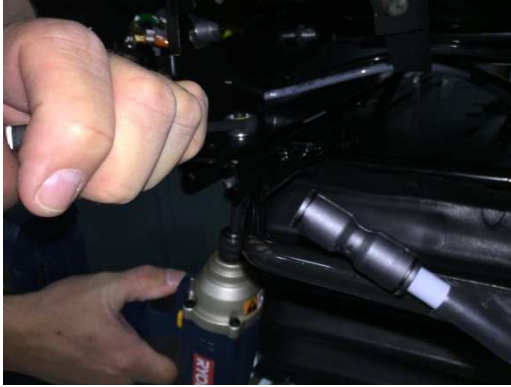
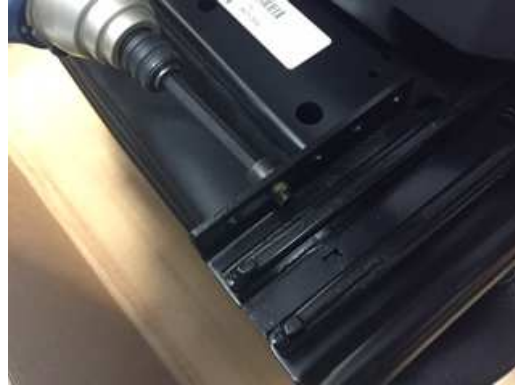
4. Position the seat back to "full forward". Unfasten the front track bolt from the cushion frame using a 6mm hex bit and a 13mm wrench. Check the rear of seat for a track stop bolt. If present, remove it with the 6mm hex bit.

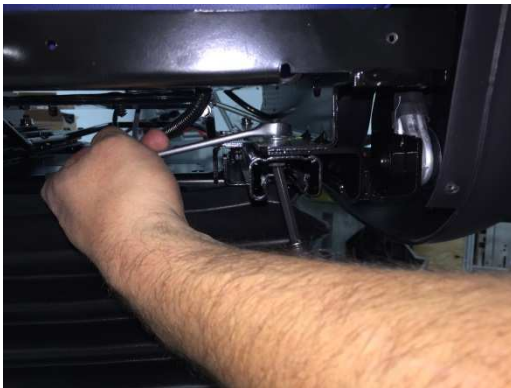
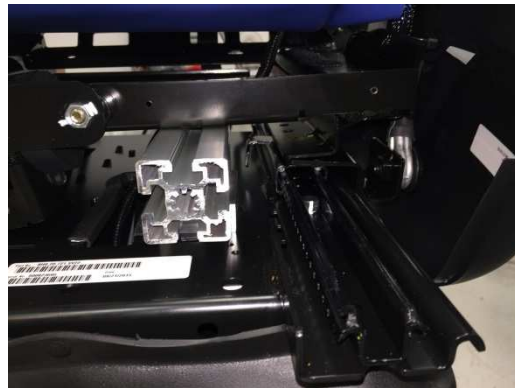
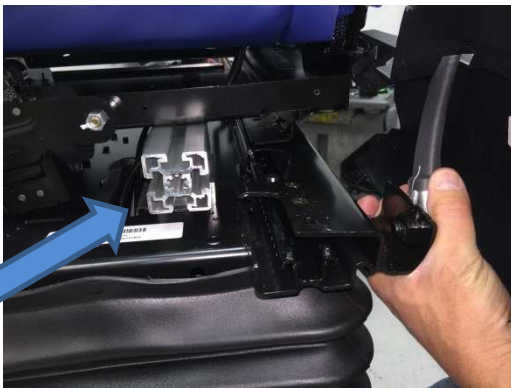
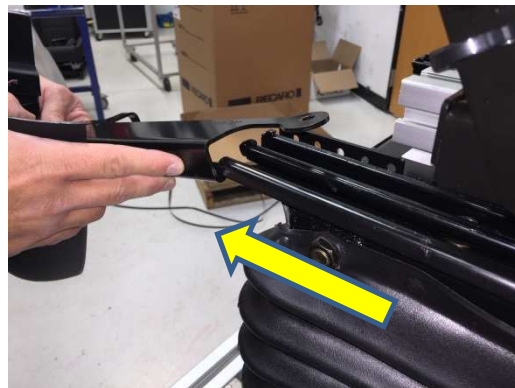
- Position the seat to “full rear”. Unfasten the rear track bolts from the cushion frame using an 6mm hex bit and a 13mm wrench. Place a 2 inch block between the cushion frame and suspension to create just enough clearance to remove the J-bracket by sliding it rearward along the path of the track.

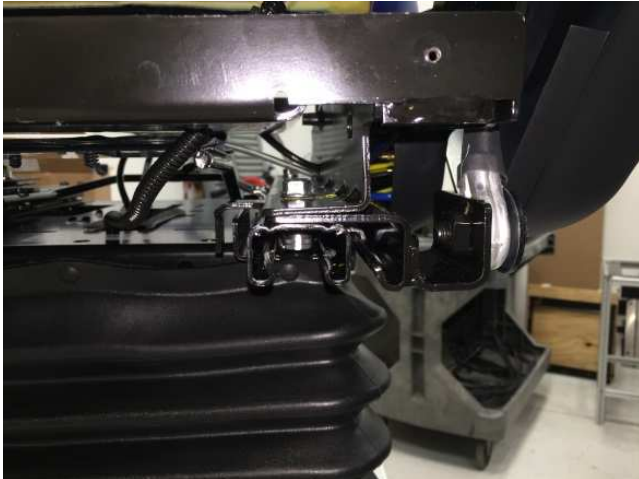
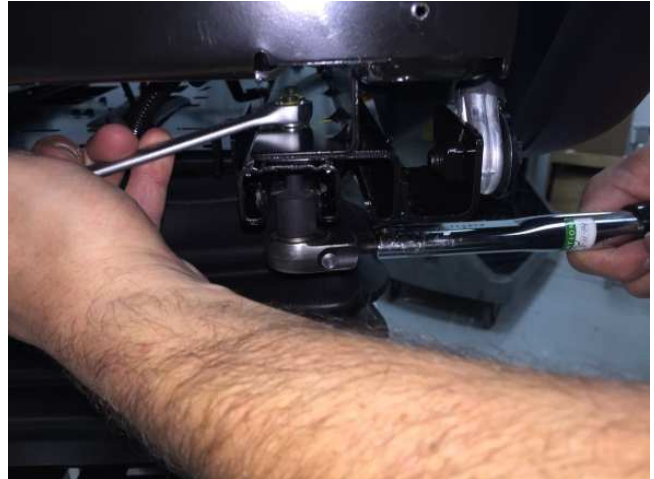
- Position the replacement part utilizing the same path and aligning all the mounting holes. Obtain replacement M8 bolts. Place rear fasteners thru the mounting holes from below and start the flange nuts by hand. Torque to 22 Nm.

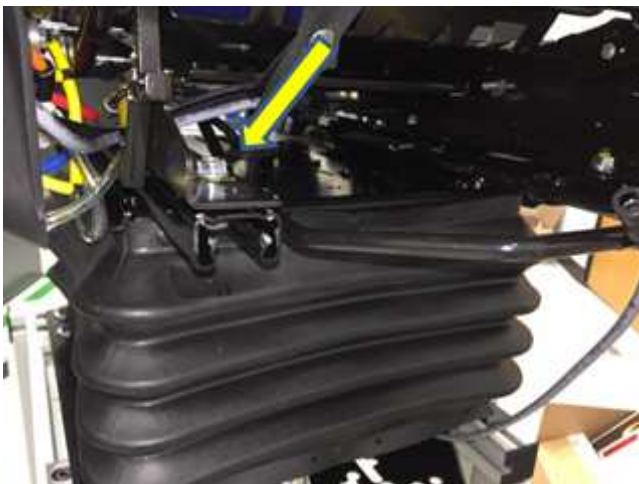
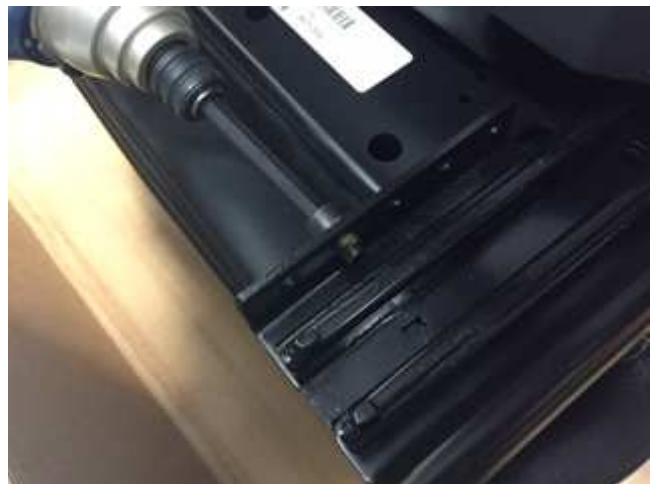
- Position the seat to “full forward”. Obtain replacement M8 bolts. Place front fastener thru the mounting holes from below and start, by hand, the flange nut. Torque to 22 Nm.
- If applicable, replace the track stop bolt previously removed.

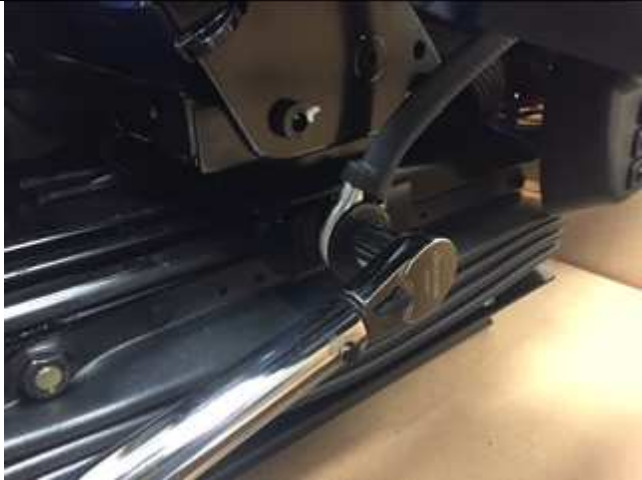
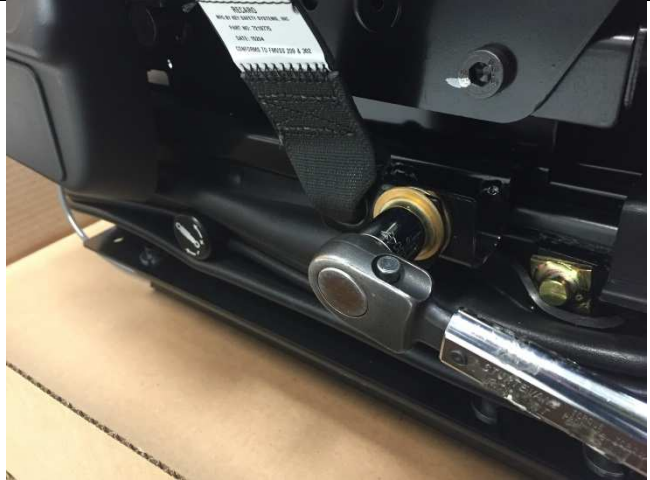
9. Route the buckle through the rear trim panel. Hand start the seat belt buckle bolt into the replacement J-Bracket part now in the seat. Torque to 50 Nm.
10. If needed, replace the other side J-bracket using the same procedure documented in steps 5-10.

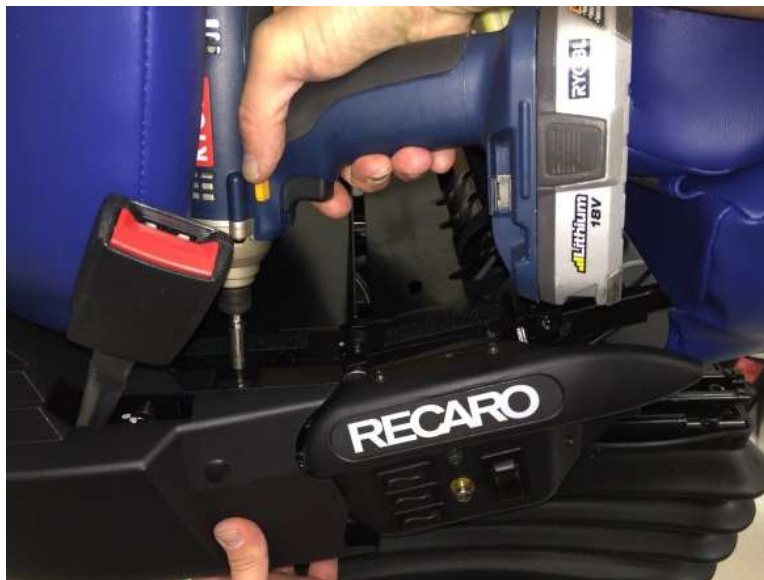
11. Replace the corner panel(s) in original position and secure with the mounting screw(s) previously removed.

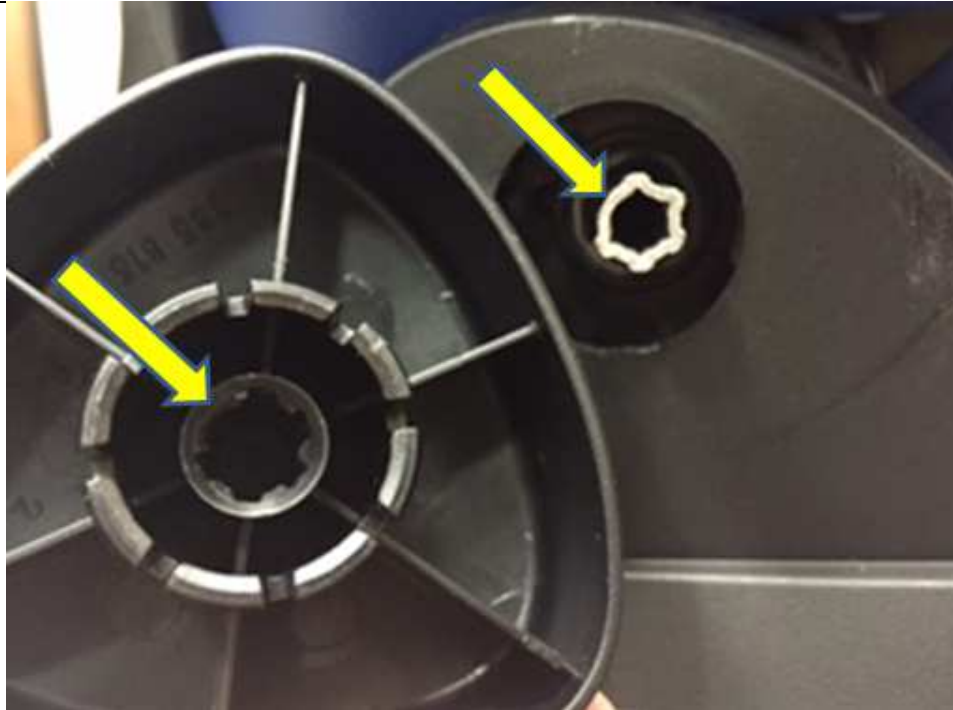
- Replace the recliner handwheel making sure to align the keyed pattern of the recliner rod to the handwheel.

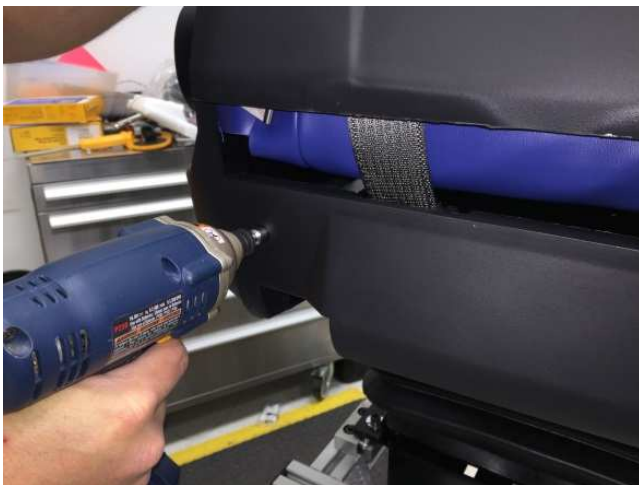
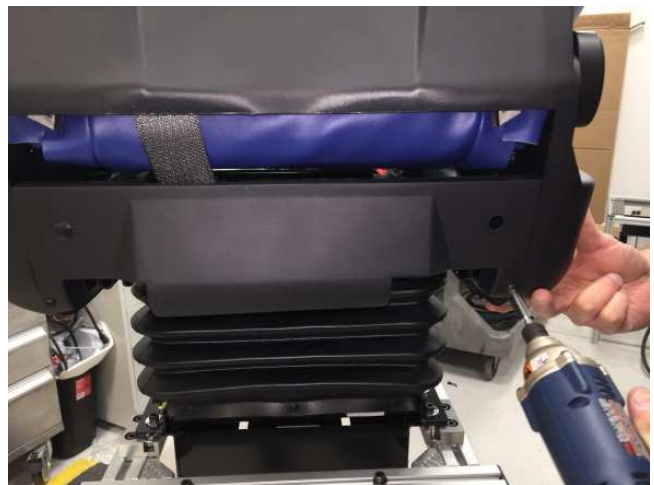
- Position the rear trim panel into its original position and secure with the mounting screws previously removed. Install the hole plugs into the rear trim panel that were previously removed.
