Safety Recall

Code: 53B8

Subject	Hybrid Battery Tray Drain Installation
Release Date	May 12, 2016
Affected Vehicles	U.S.A.: 2011-2015 MY Volkswagen Touareg Hybrid <i>Check Campaigns/Actions screen in Elsa on the day of repair to verify that a VIN qualifies for repair under this action. Elsa is the <u>only</u> valid campaign inquiry & verification source.</i> <ul style="list-style-type: none">✓ Campaign status must show "open."✓ If Elsa shows other open action(s), inform your customer so that the work can also be completed at the same time the vehicle is in the workshop for this campaign.
Problem Description	The rear hatch area where the hybrid battery tray is located does not sufficiently drain. Because of this, any water entering this area remains below the hatch floor cover in the battery tray and is not easily visible to customers. If too much water collects in this area, it could cause an electrical short in the high voltage battery. An electrical short in the high voltage battery caused by significant water intrusion may lead to a vehicle fire.

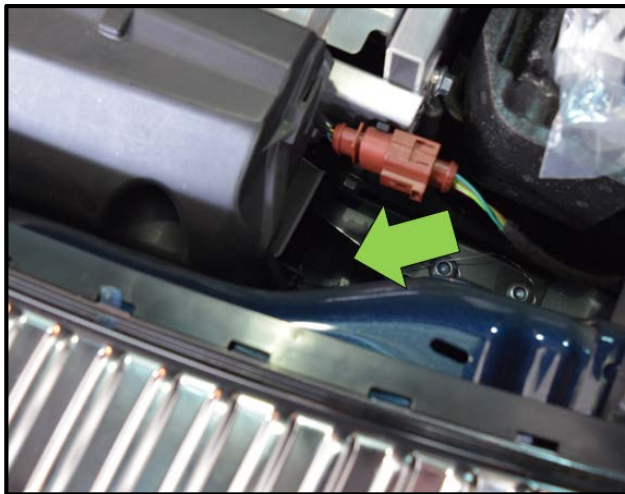
- Open the battery tray compartment cover.
- Inspect the lower battery tray compartment <arrow> to verify there is no standing water/excess moisture present.

If standing water is present in the battery tray compartment **STOP ALL WORK**. Open a VTA case and contact the Volkswagen Technician’s Helpline for further assistance. A QTM will be dispatched to inspect the vehicle.

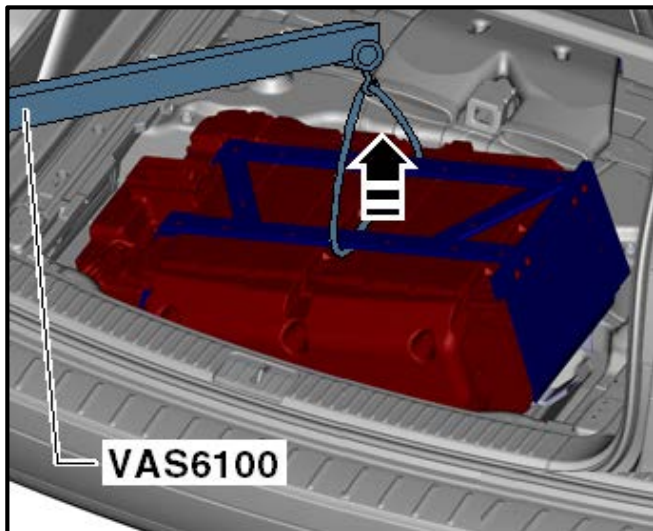
- Using the retaining strap T40155 and the Shop Crane VAS6100 (or equivalent), slightly lift the Hybrid Battery Unit (AX1) in the center as shown.

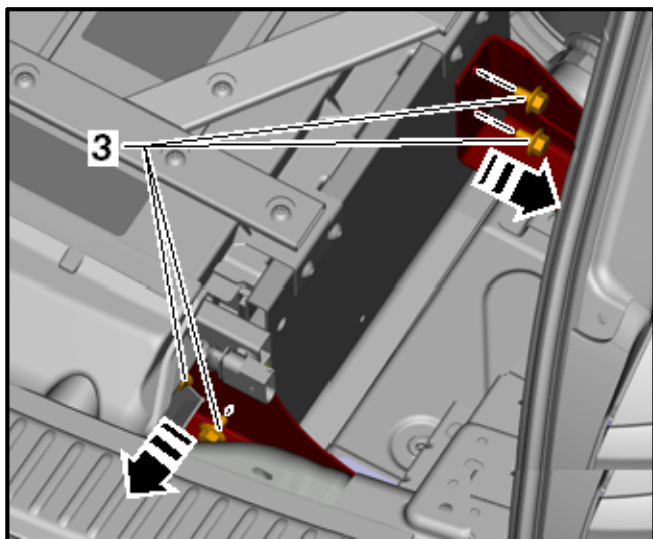
- Once the AX1 is raised slightly off the floor of the battery tray, remove the four mounting bolts <3> and remove the mounting brackets <direction of arrows>.

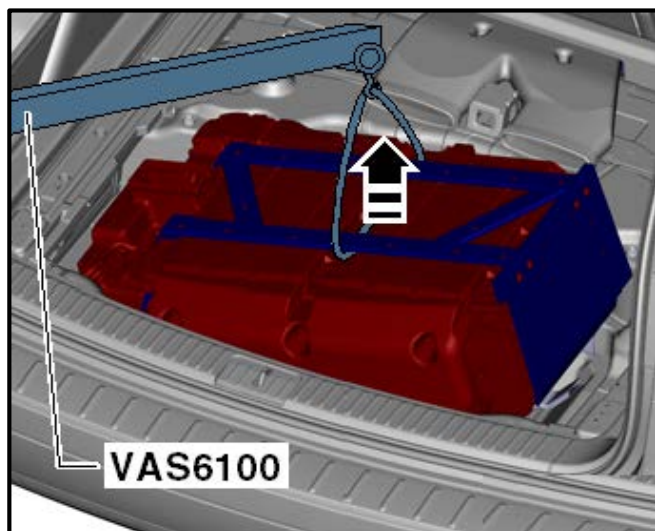
- Shift the AX1 slightly to the right, then lift it out of the vehicle <direction of arrow>.
- Place the AX1 in a clean, dry, level location.

- Due to the weight and size of the Hybrid Battery Unit (AX1), assistance from a second technician may be helpful to remove the AX1 from the vehicle.
- The left side of the AX1 will hang slightly lower than the right when suspended by the shop crane.

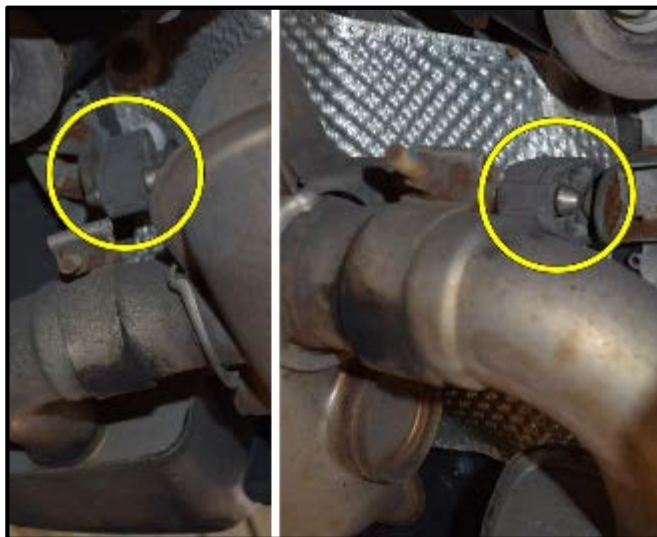
- Raise the vehicle on an appropriate hoist.
- Loosen two rearmost exhaust system hangers <circles>.
- Lower the exhaust system and allow it to hang freely.

The exhaust system hangers pictured here <circles> are located on each side of the rear muffler, directly above each tail pipe.

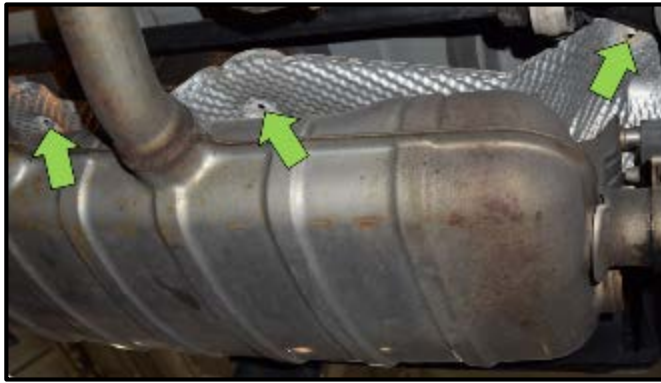
- Remove the mounting nuts <arrows> from the front edge of the exhaust heat shield.
- Place an appropriate wedge (i.e. wood block) above the heat shield to space it away from the floor pan of the vehicle.
- Lower the hoist.

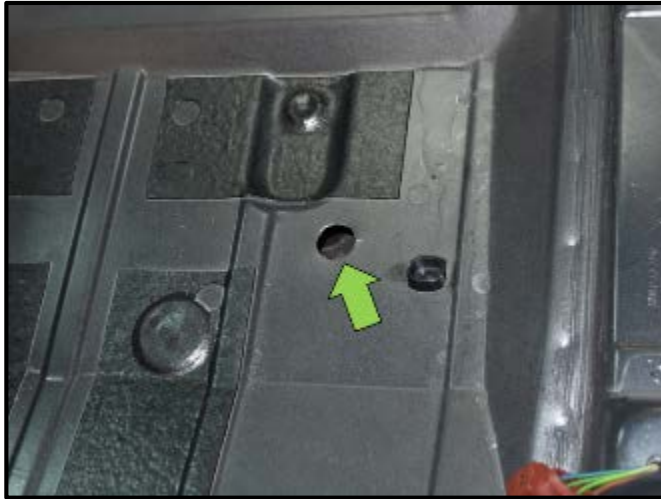
- In the following steps, a hole will be drilled on the right side of the battery tray floor where shown <arrow>.

The hole must be measured and drilled EXACTLY where shown in the following step.

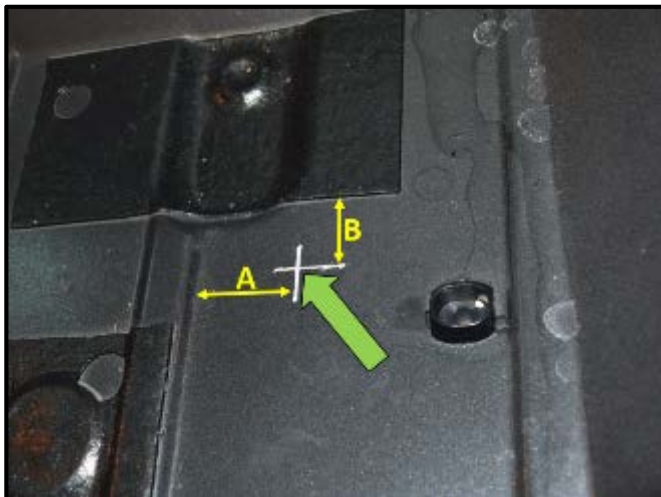
- Draw the lines as pictured using a paint pen (or equivalent).
 - Dimension A: 40.0mm
 - Dimension B: 30.0mm
- Using a stepped drill bit (or equivalent), drill a hole 25mm in diameter where the lines intersect <arrow>.

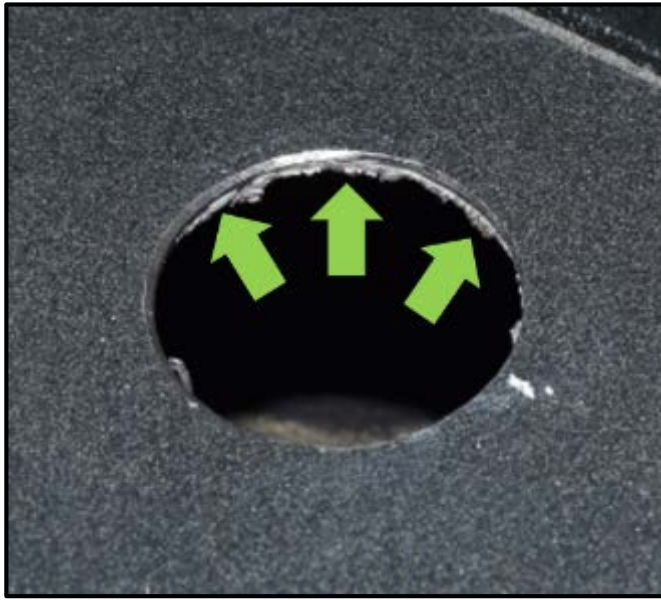
- Using an appropriate file or de-burring tool, clean any burrs or excess metal <arrows> from the outside edges of the hole.
- Clean any metal shavings or other debris from the battery tray area.
- Apply an appropriate primer/corrosion inhibitor (shop supply) to the exposed metal around the outside edges of the hole.
- Allow the primer to dry prior to proceeding to the next step.

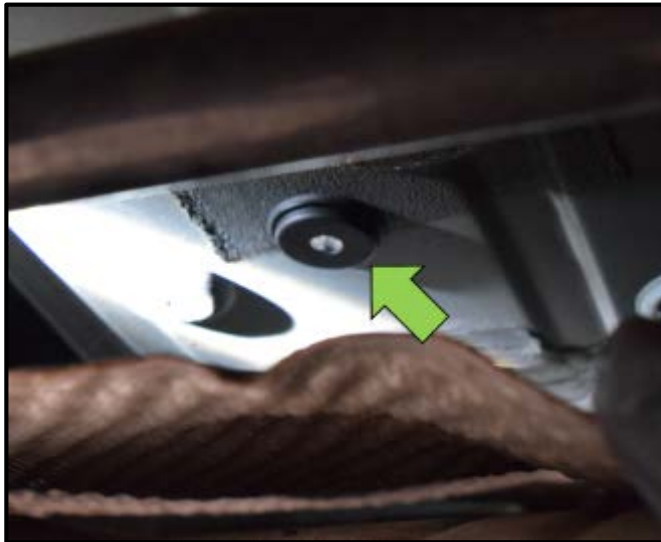
- Raise the hoist.
- Install the drain valve, P/N: 7P0899073, from the underside of the vehicle as shown <arrow>.
- Verify the drain valve locks firmly into place and sits flush against the bottom of the battery tray floor.

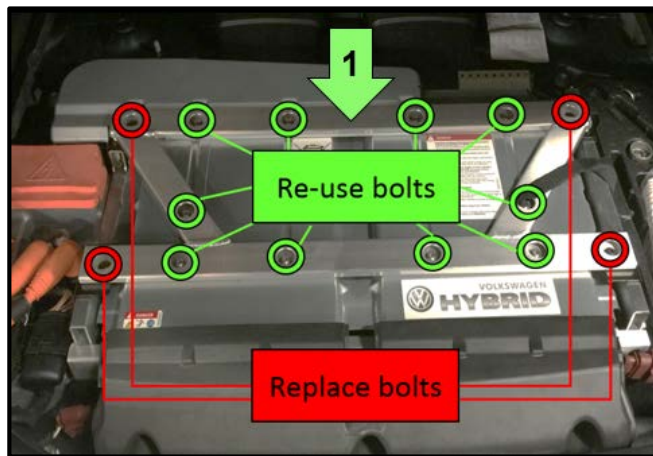
- Realign the cage <arrow 1> to the battery, reinstall the screws <green circles> that retain the cage <arrow 1> to the battery.
- Install 4 NEW bolts p/n (N 90780904) in the corner locations <red circles>.
- Torque all screws to **8Nm**.

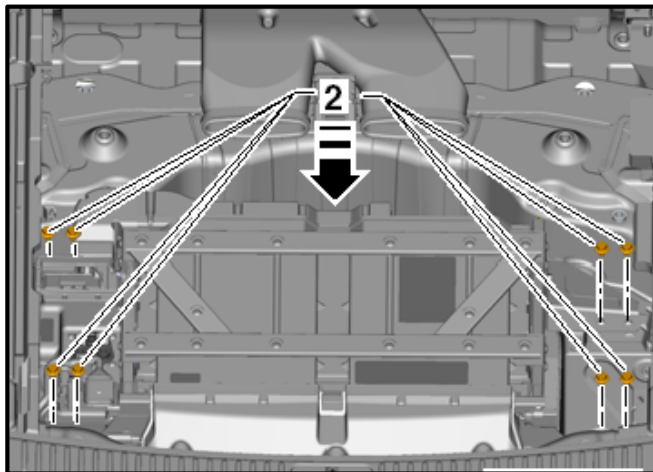
- Fully lower the AX1 into its installed position.
- Reinstall the eight mounting bolts <2> and torque to **23Nm**.
- Torque the previously installed mounting bracket bolts to **23Nm**.

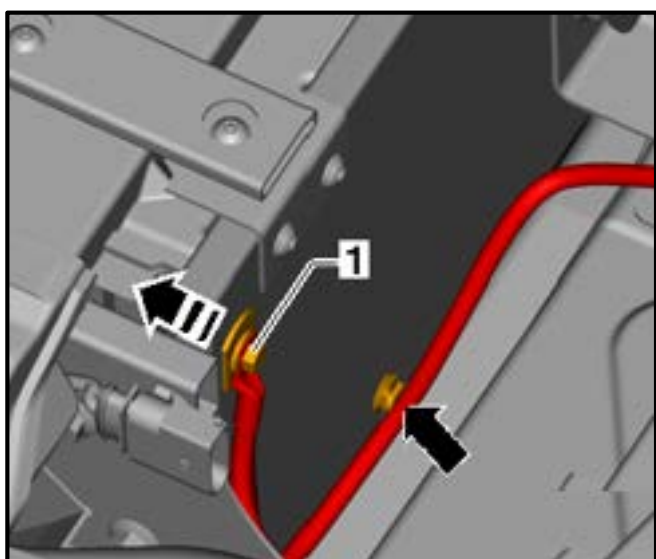
- Attach the ground cable to the AX1 as shown <direction of arrow>.
- Install the mounting bolt <1> and torque to **9Nm**.
- Refasten the ground cable to the retainer <arrow> using a cable tie (shop supply).

Inspect the contact surfaces on both the ground cable, and its mounting location on the AX1. The contact surfaces **MUST** be free of any grease or corrosion. Clean as necessary.
