# Safety Recall

## Code: 69M1

Subject	Side Airbag Inflators
Release Date	July 18, 2016
Revision Summary	<b>Q5 Hybrid-specific work procedure steps added.</b>
Affected Vehicles	<b>U.S.A. &amp; CANADA: 2015 MY Audi Q5</b> <i>Check Campaigns/Actions screen in Elsa on the day of repair to verify that a VIN qualifies for repair under this action. Elsa is the <u>only</u> valid campaign inquiry &amp; verification source.</i> <ul style="list-style-type: none"><li>✓ Campaign status must show "open."</li><li>✓ If Elsa shows other open action(s), inform your customer so that the work can also be completed at the same time the vehicle is in the workshop for this campaign.</li></ul>
Problem Description	The driver and right front passenger seat-mounted side airbags may contain a manufacturing defect that may result in an airbag inflator rupture during a crash where there is a side airbag deployment. If this happens, airbag inflator components could be propelled into the passenger compartment, possibly striking and causing serious injury or death to vehicle occupants.

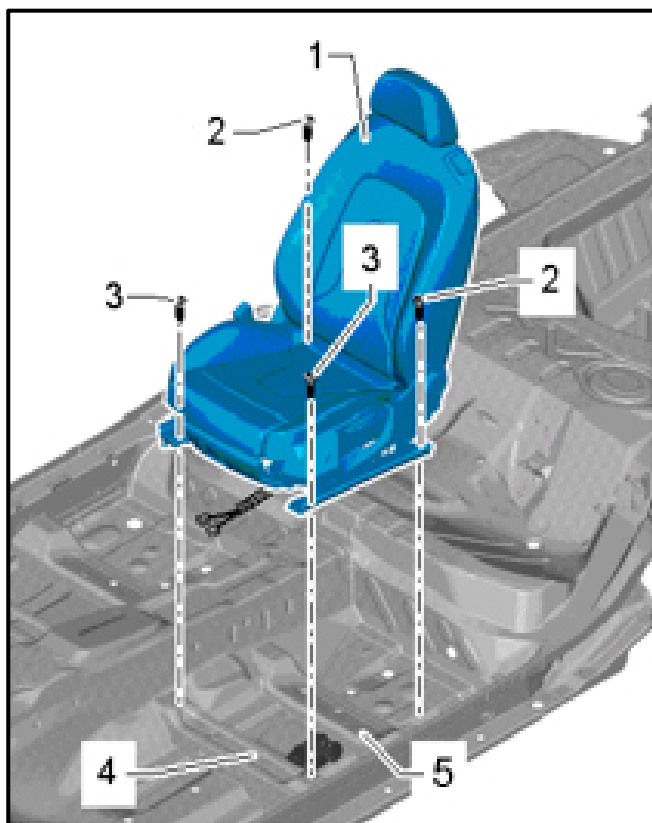
- Move the headrest to its lowest position.
- Move the seat <1> to the full-forward position.
- Remove the rear mounting bolts <2> from the bracket <5>.
- Move the seat to the full-rearward, fully raised position.
- Remove the front mounting bolts <3> from the console <4>.

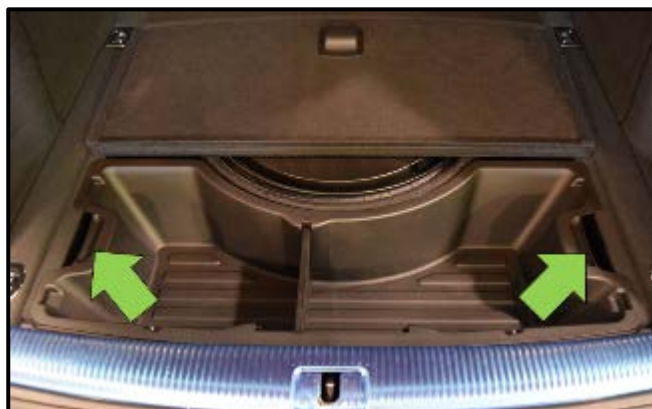
- Switch the ignition ON.
- Open the rear hatch.
- Open and remove the spare tire cover.
- If equipped, remove the luggage tray <arrows>.

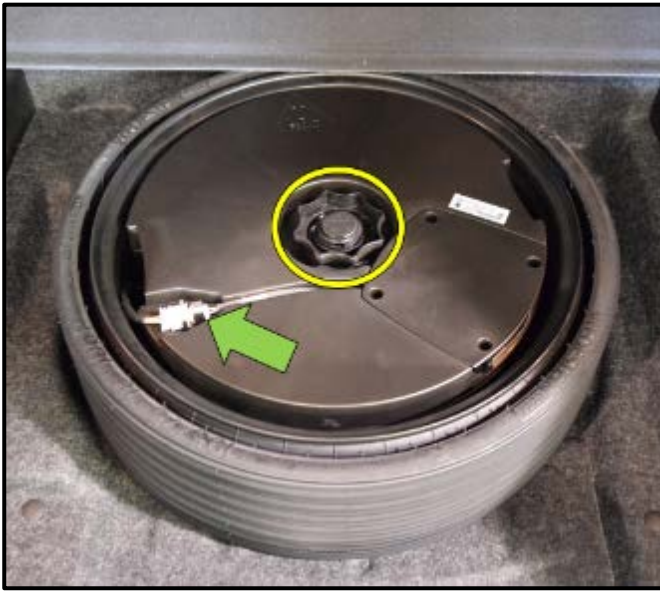
- Remove the spare tire retaining nut <circle>.
- If the vehicle is equipped with a subwoofer, disconnect the connector <arrow> and remove the subwoofer from the vehicle.
- Remove the spare tire.

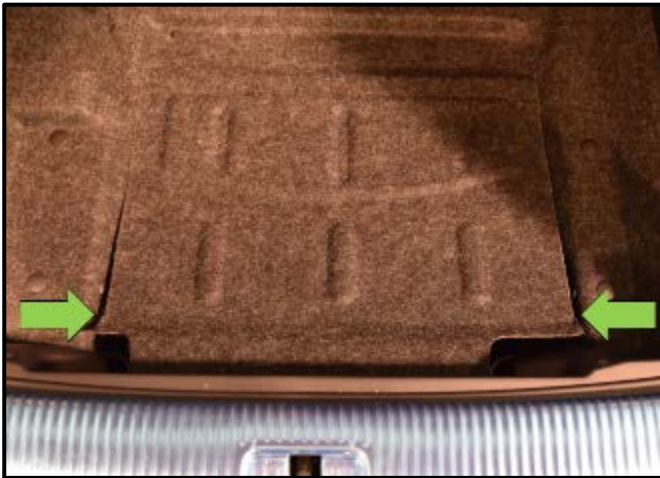
- Open the rear carpet cutaway <arrows>.

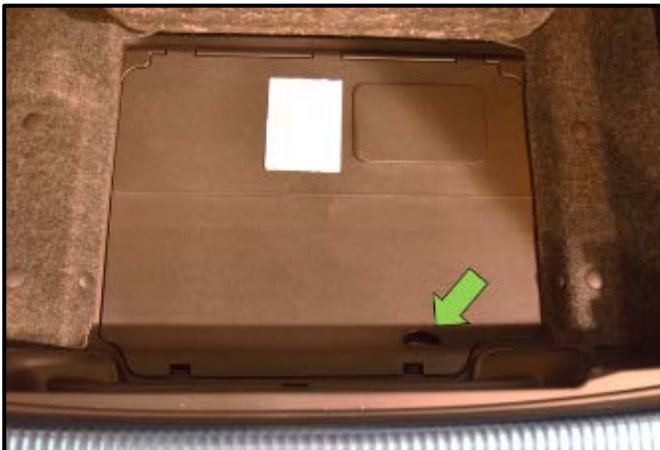
- Open the battery access cover <arrow>.

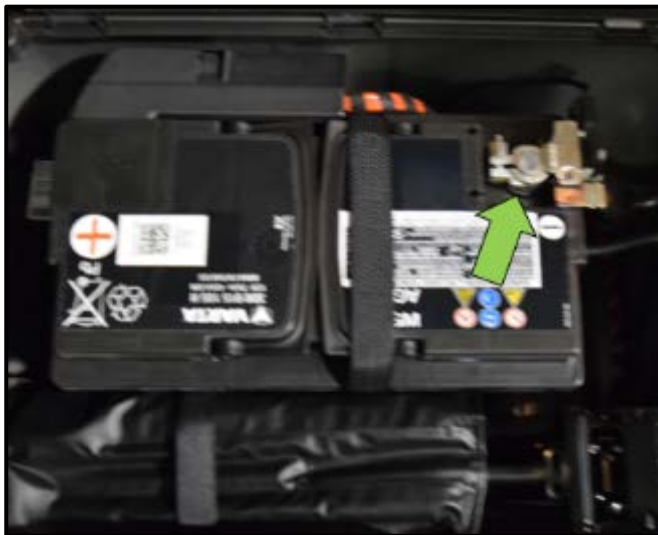
- Disconnect and isolate the negative battery cable <arrow>.

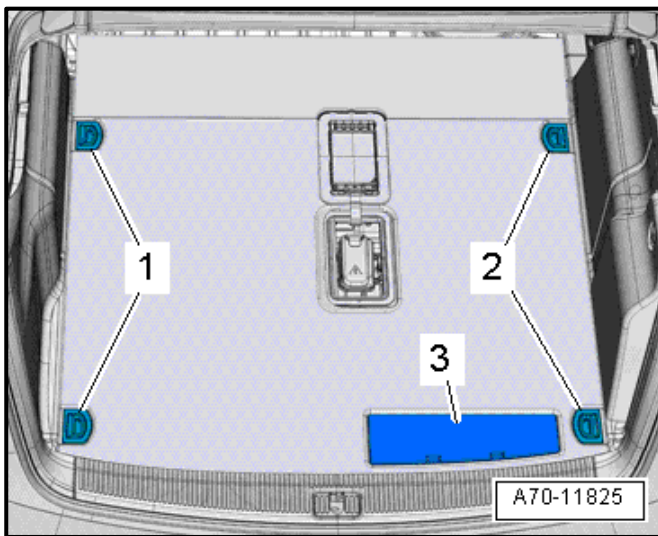
- Fold the backrests forward.
- Remove the tie downs <1> and <2> as instructed below.

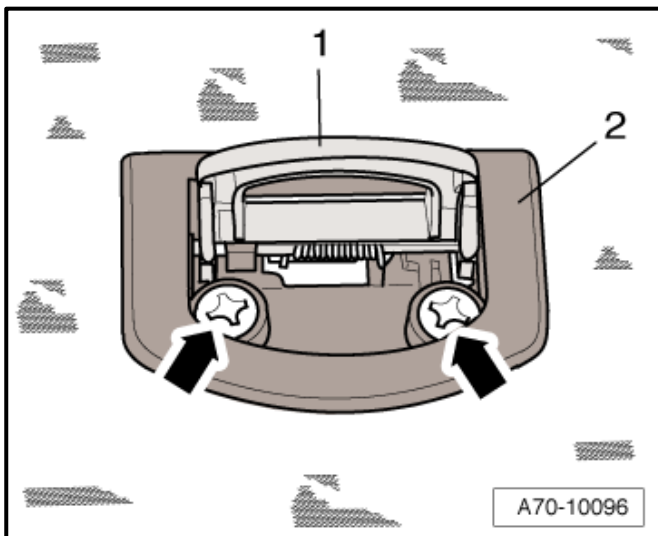
- Fold the tie-downs <1> upward.
- Remove screws <arrows> and remove tie-down mounts <2>.

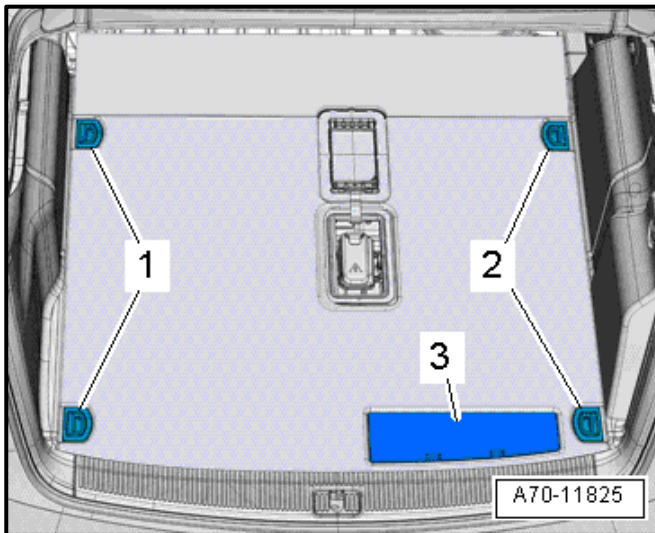
- Lift up and remove the luggage compartment floor panel and tool box <3> towards the rear.

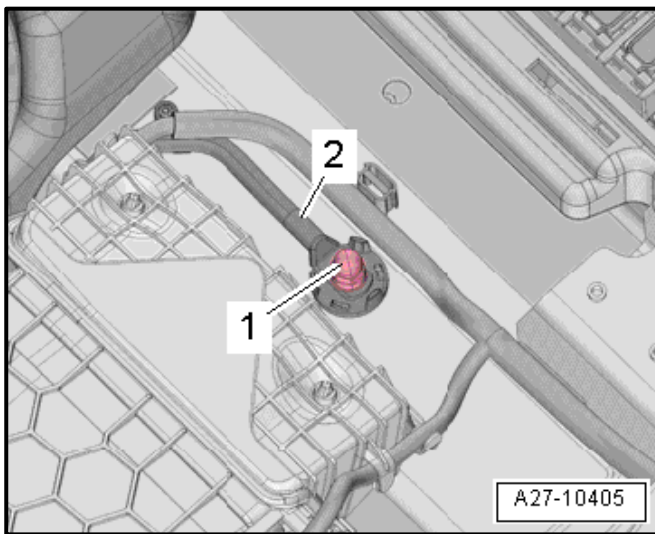
- Remove nut <1> at ground connection, and remove ground cable <2> for the Battery.

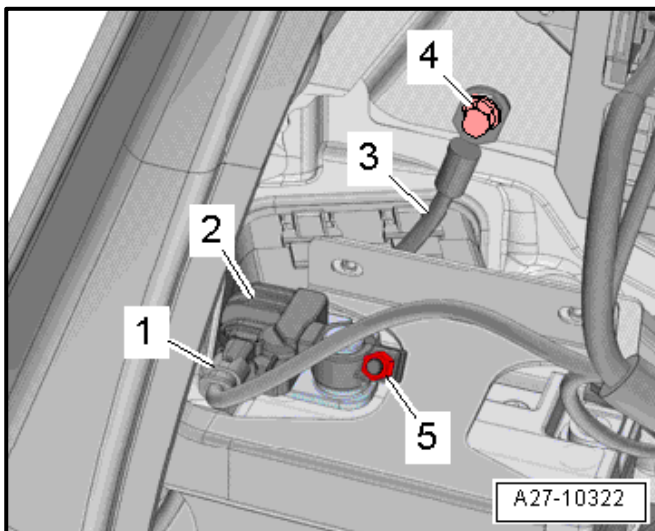
- Remove the luggage compartment left side trim panel cover.
- Loosen the nut <5> several turns and disconnect the battery ground cable terminal <2> from the battery negative pole.

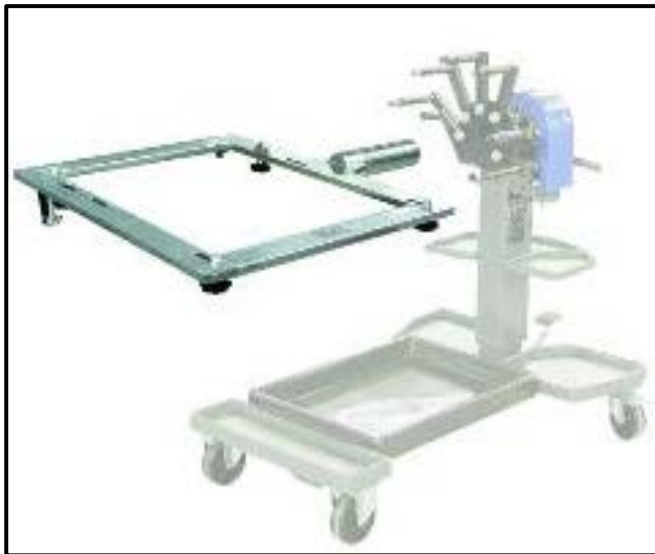
- Mount the Engine/Transmission Holder – Seat Repair Fixture VAS6136 on the Engine and Gearbox Bracket VAS6095.
- Secure the seat to the Engine/Transmission Holder – Seat Repair Fixture VAS6136.

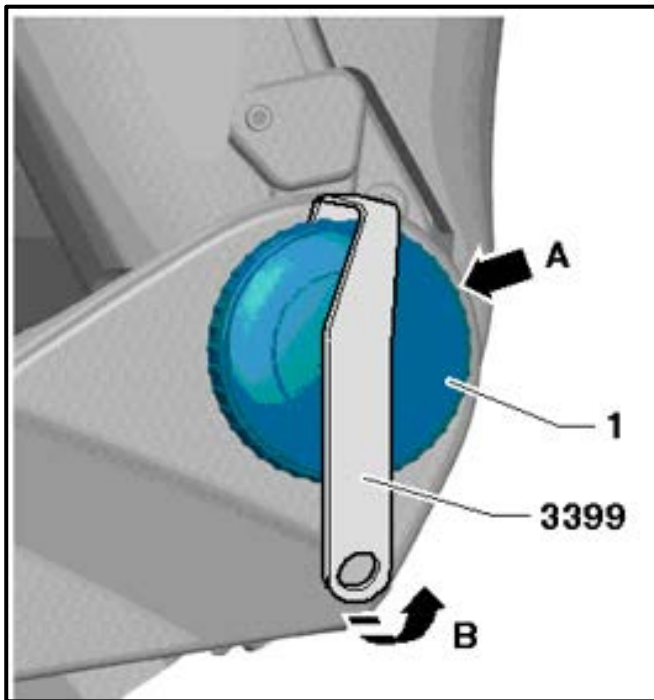
- If equipped, turn the seatback adjustment wheel <1> until a retainer is visible from behind <arrow A>. Use a flashlight if necessary.
- Using the Assembly Tool 3399, carefully pry the adjustment wheel off the seat <direction of arrow B>.
- Turn the seatback adjustment wheel 120° further and repeat the process until the wheel is able to be removed.
- Remove the seatback adjustment wheel.

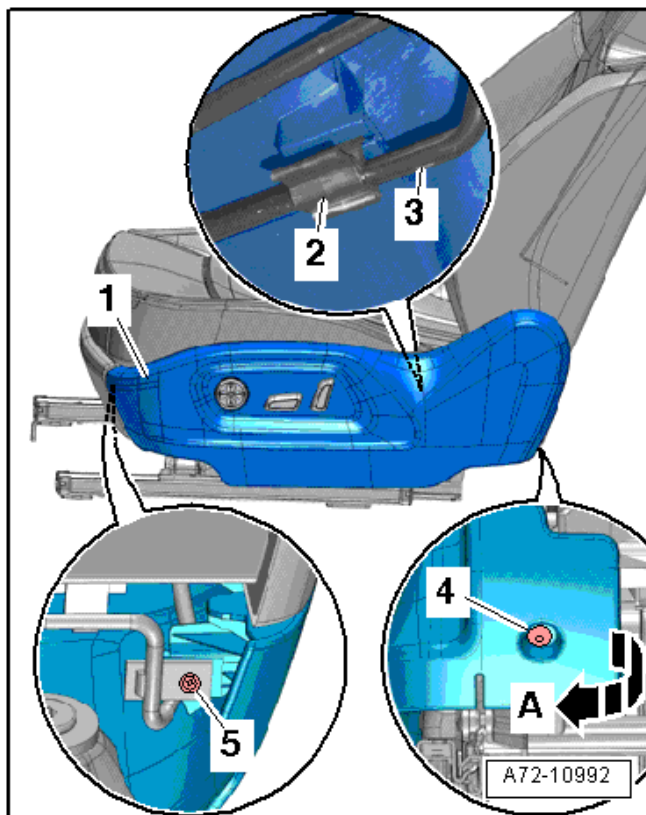
- Remove the screw <5> and then remove the seat side trim spreader clip <4>.
- Disengage the side trim <1> from the rear of the seat <arrow A>.
- Open the clip <2> on the seat side trim and disengage the bracket <3>, then carefully separate the seat side trim from the front seat.

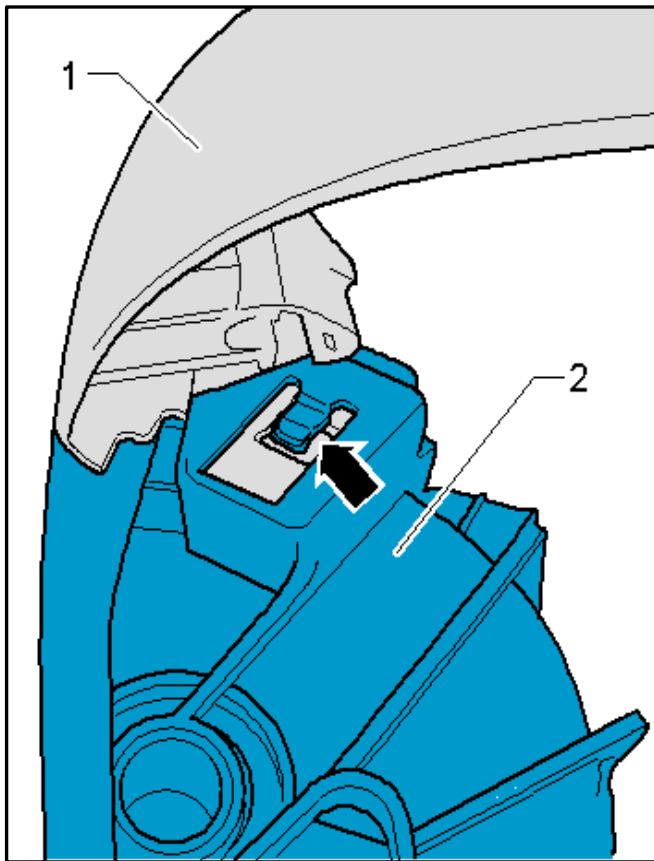
- Disconnect the retainer <arrow> between the storage compartment <2> and the seat side sill trim <1>.
- Disengage the seat side sill trim from the bracket and remove it forward.

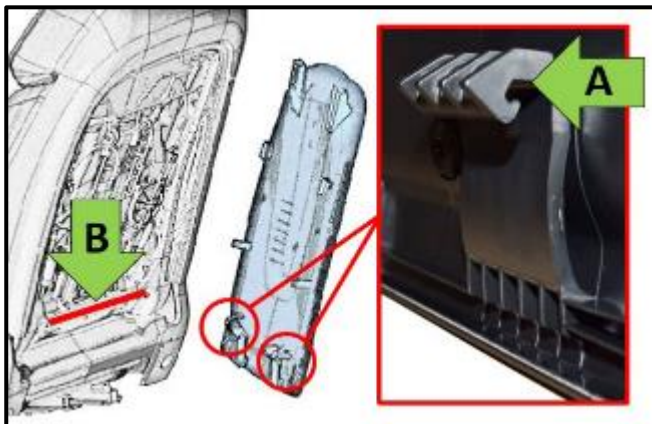
- The two lower seatback cover hooks <circles> have a surface <arrow A> that rests on a metal ridge in the seatback frame <B>. You must detach these lower hooks before detaching the side clips.
- Failure to do so may result in damage to the seatback cover.
- Follow the steps below exactly to remove the seatback cover without damage.

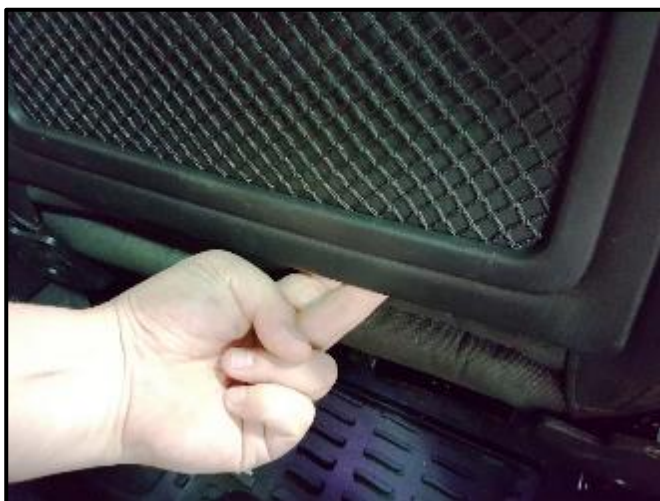
- Locate the seat backrest cover hooks by hand <as shown>.

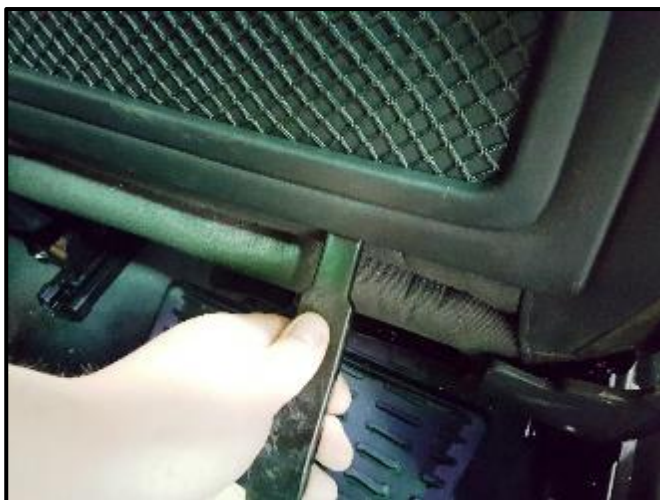
- Once the hooks are located, insert pry lever 80-200 (or equivalent) underneath the hooks <as shown>.

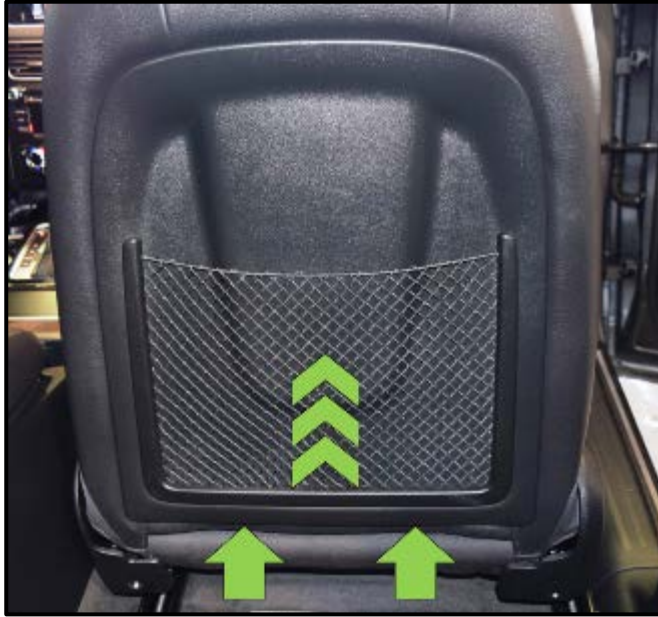
- Release the lower seat backrest cover hooks by lifting up on the cover in the direction shown <directional arrows> and gently prying the seat hooks <arrows> up and towards the rear of the vehicle using pry lever 80-200 (or equivalent).

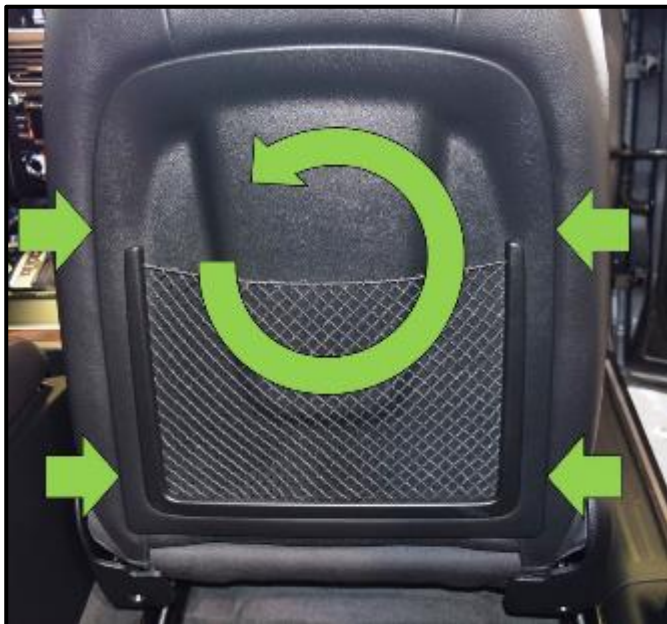
- Once the lower seat backrest cover hooks have been released, remove the seat backrest cover by gently rotating the cover as shown <circular arrow>. It may be necessary to release the four seat backrest cover side clips using pry lever 80-200 (or equivalent) prior to rotation.
- Remove the seatback cover from the seatback frame.

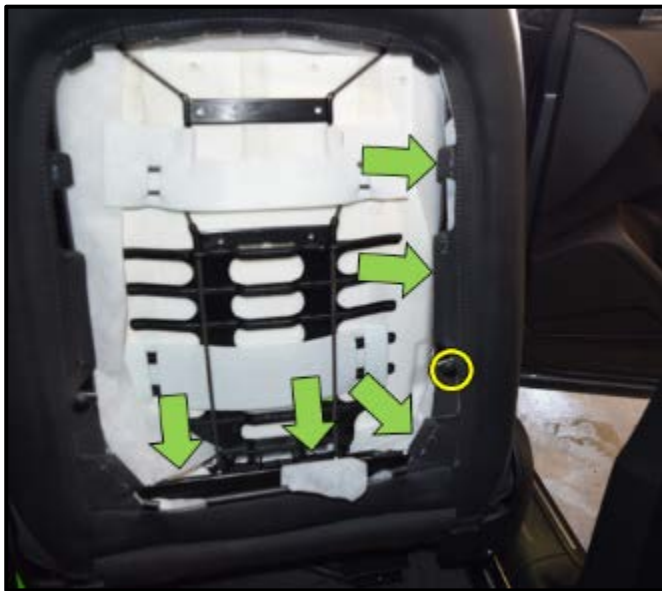
- Release the seatback cover retainers along the bottom and outboard edges of the seatback frame <arrows>.
- Remove the plastic fastener <circle>.

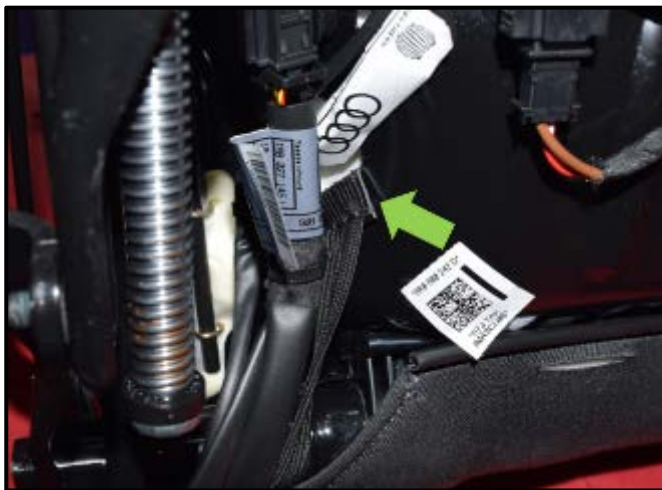
- On the underside of the seat, release the outboard side retaining strap <arrow> from the seat bottom pan.

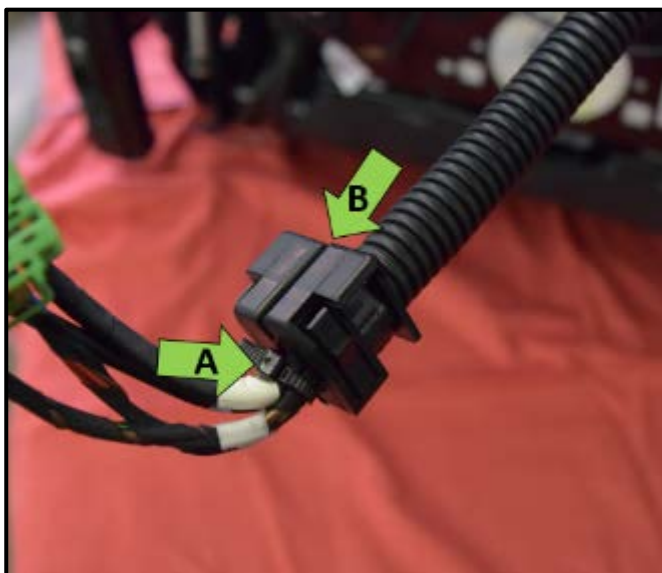
- Release the retainer <arrow B> from the lower end of the seat wiring pigtail.
- Carefully cut the tie wrap <arrow A>.

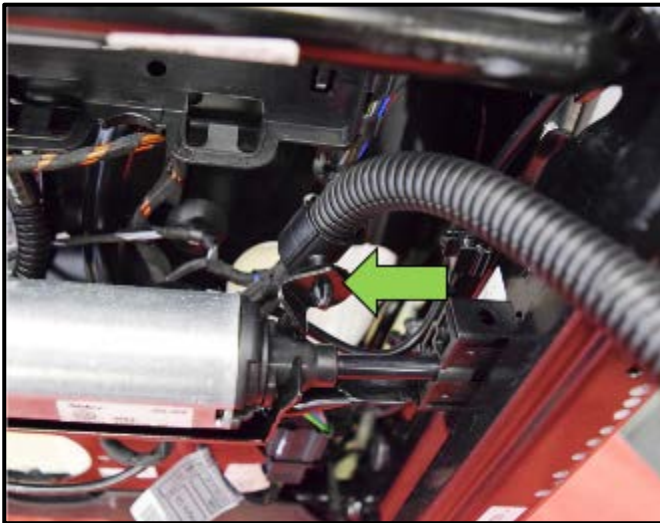
- Release the retainer securing the wiring harness to the seat frame <arrow>.

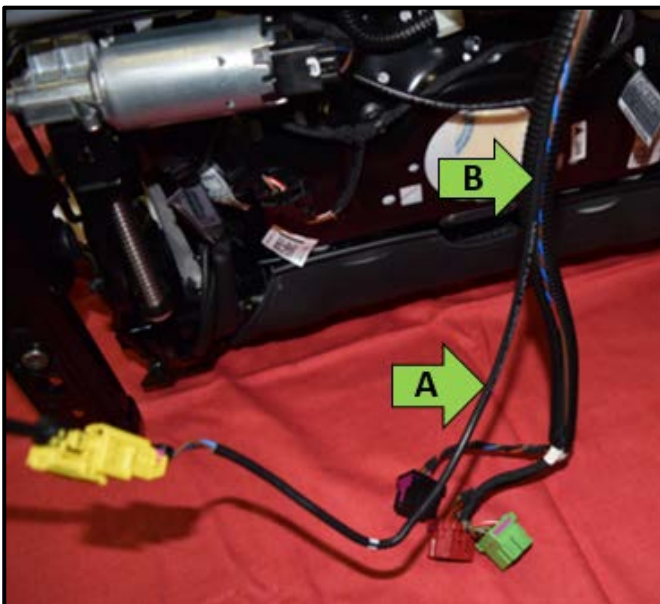
- Remove the airbag wiring harness <arrow A> from the seat wiring harness conduit <arrow B> and carefully disconnect the airbag wiring harnesses from the seatback frame.

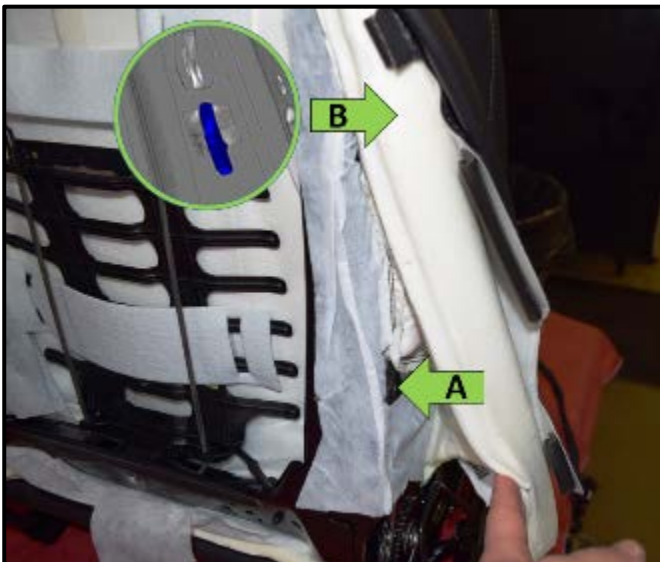
- Carefully remove the seat cover and padding until the side airbag bolt <arrow A> is accessible <as shown>.
- Remove and discard the bolt <arrow A>.
- Release the side airbag from the hook <arrow B> in the backrest frame.

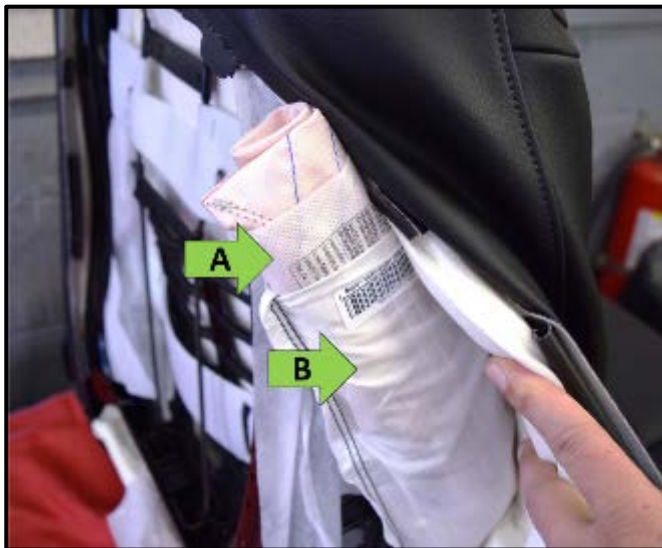
- Remove the side airbag <arrow A> from the sewn in pocket in the seat cover <arrow B>.

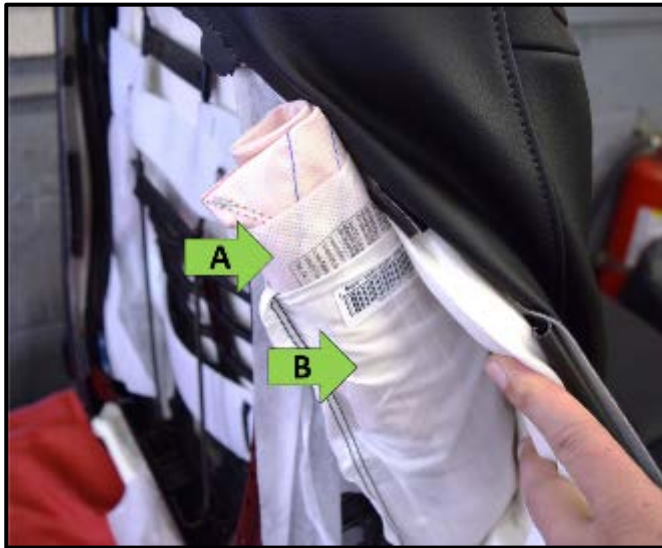
- Install the replacement side airbag <arrow A> into the sewn in pocket in the seat cover <arrow B>.

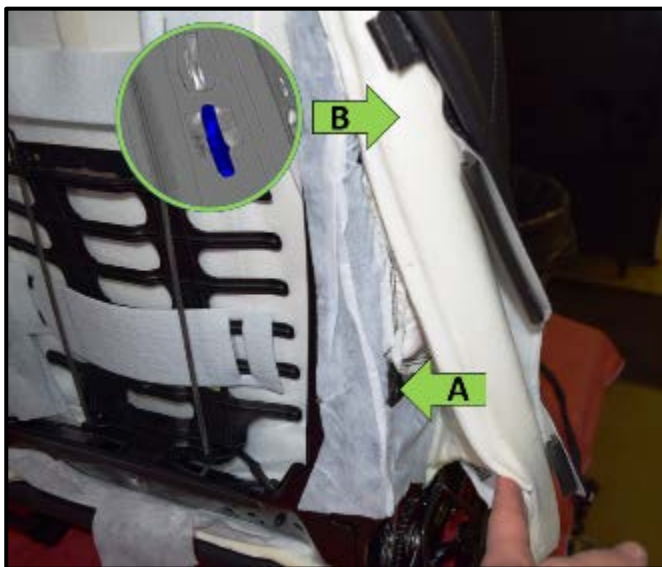
- Secure the side airbag on the hook <arrow B> in the backrest frame.
- Clean the threaded bolt hole <arrow A> with a thread tap (or equivalent).
- Install the NEW bolt <arrow A> and torque to 10 Nm using torque wrench VAG1783 (or equivalent).

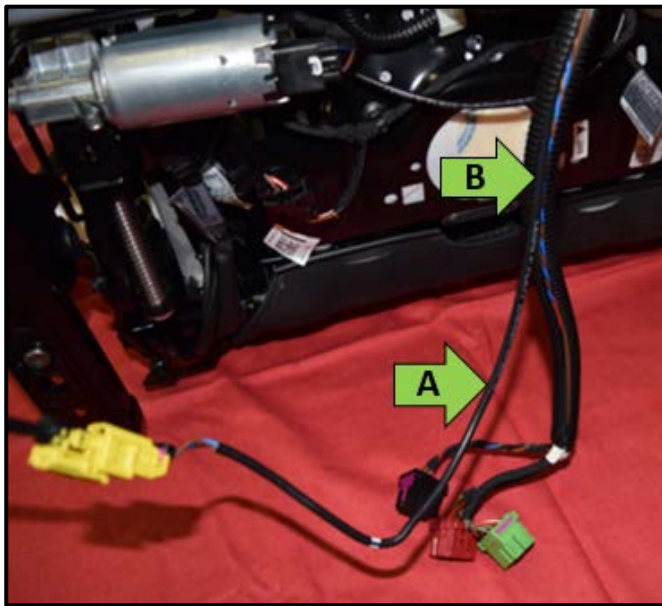
- Install the airbag wiring harness <arrow A> into the seat wiring harness conduit <arrow B>.

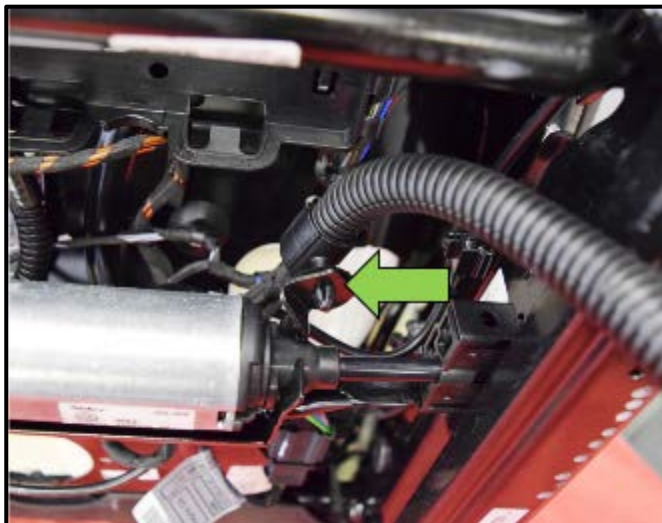
- Install the retainer securing the wiring harness to the seat frame <arrow>.

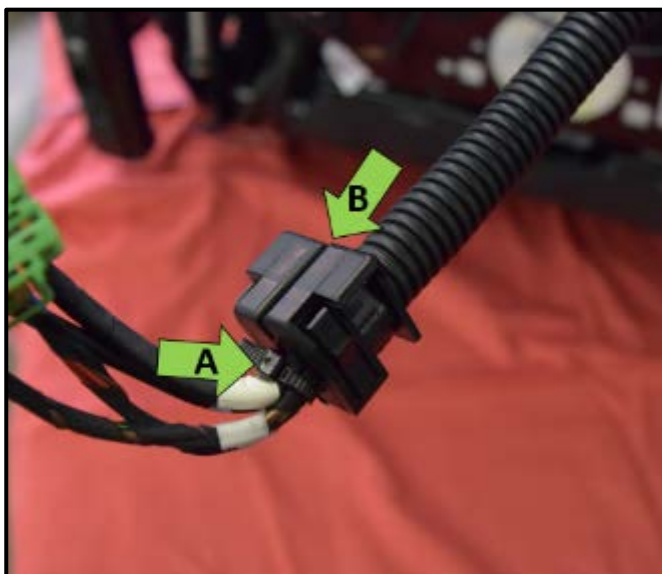
- Install the retainer <arrow B> to the lower end of the wiring harness.
- Secure the wiring harness at the location shown <arrow A> using a tie-wrap.

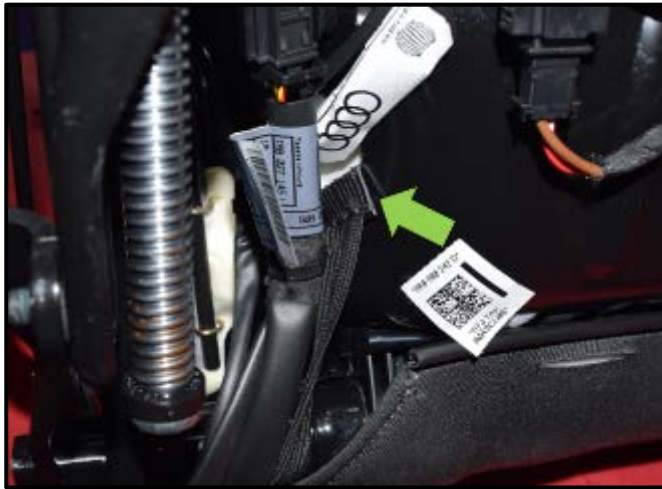
- On the underside of the seat, attach the outboard side retaining strap <arrow> to the seat bottom pan.

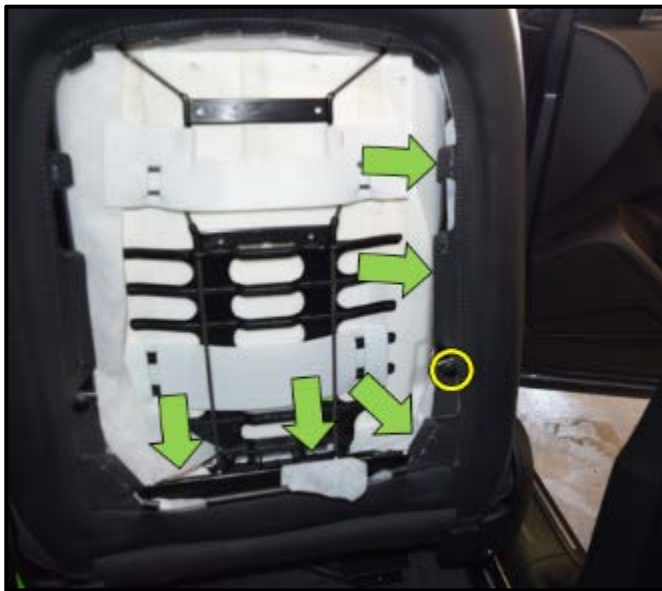
- Attach the seatback cover retainers along the bottom and outboard edges of the seatback frame <arrows>.
- Install the plastic fastener <circle>.

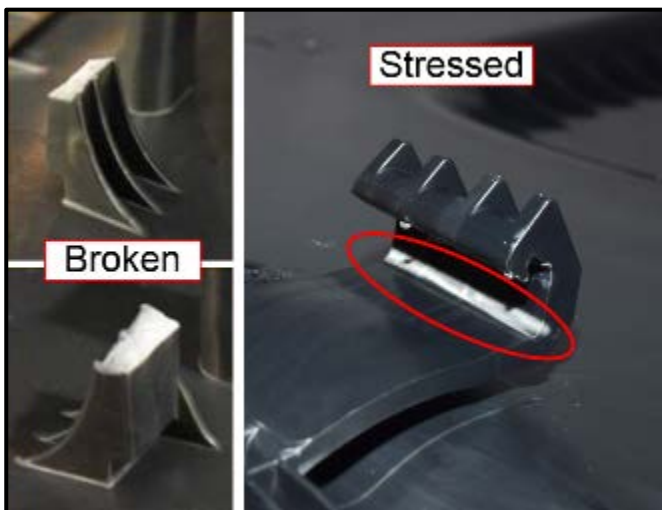
- Prior to reinstalling the seatback cover, inspect all attachment points for breakage or signs of stress <circle>.
- If breakage or stress is present, the seatback cover must be replaced.

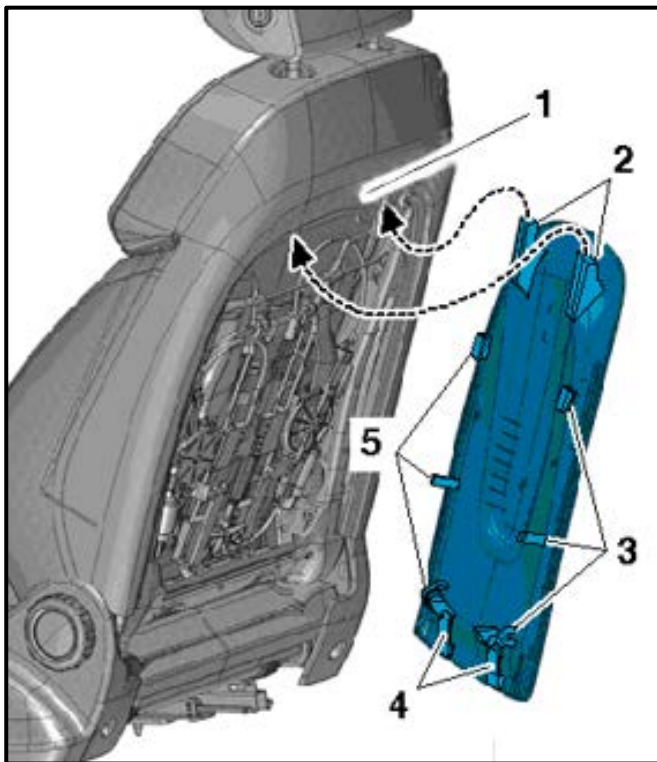
- Push the upper hook <2> under the upper backrest cross member <1>.
- Tilt the backrest cover down and engage the side retaining tabs <3> and <5> and the lower hooks <4>.
- Make sure the tabs on the side fit correctly into the backrest frame and the lower hooks <4> are seated correctly in the backrest frame.

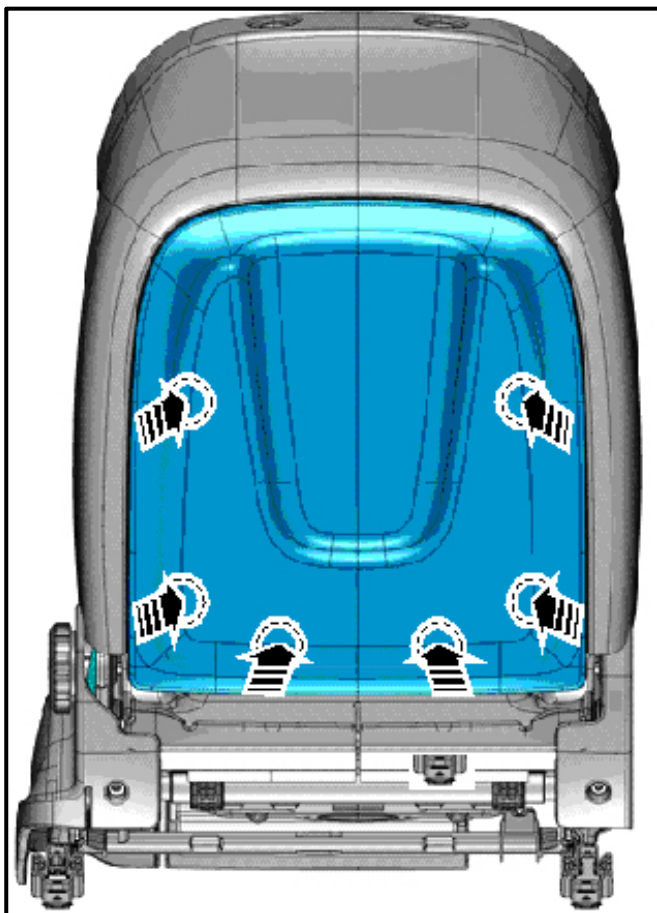
- Press the backrest cover firmly forward into the areas marked with circles <arrows>.
- Ensure the backrest cover is correctly locked at all attachment points (arrows).

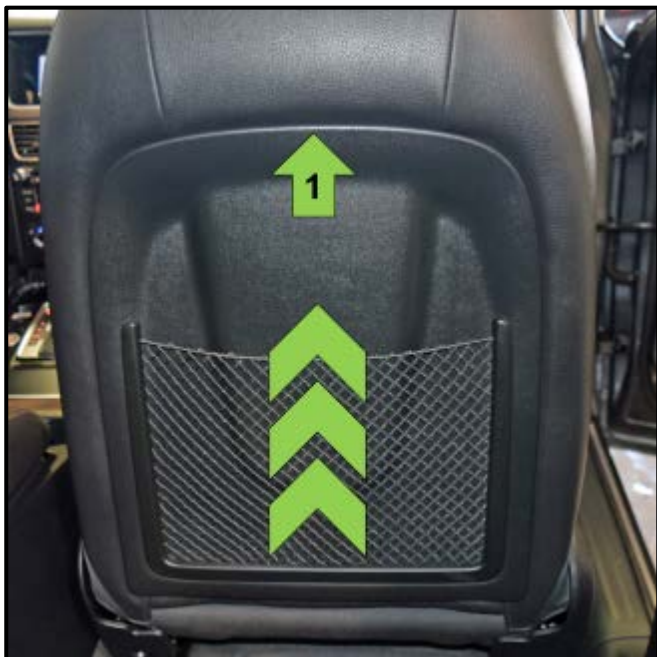
- Once installed, slide the backrest cover in the direction shown <directional arrows> and check for excessive play at the top <arrow 1>.
  - If the play observed is greater than 6mm (1/4 inch), the backrest cover is damaged and must be replaced.

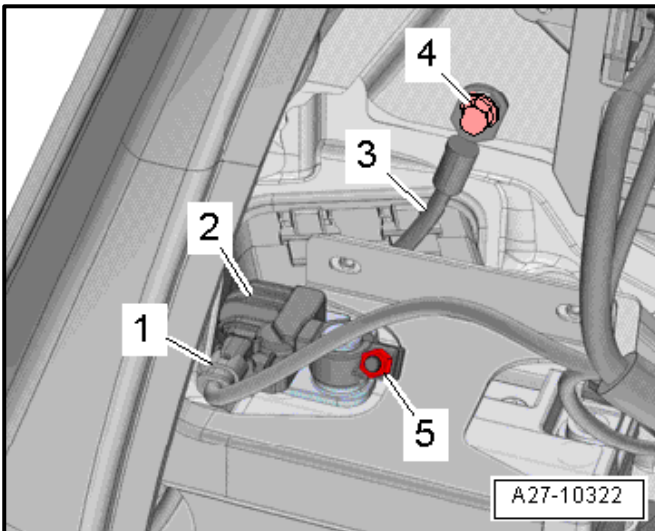
- Remove the insulating tape installed during cable disconnection.
- Reconnect the battery ground cable terminal <2> to the battery negative pole and tighten the nut <5> to 5 Nm.

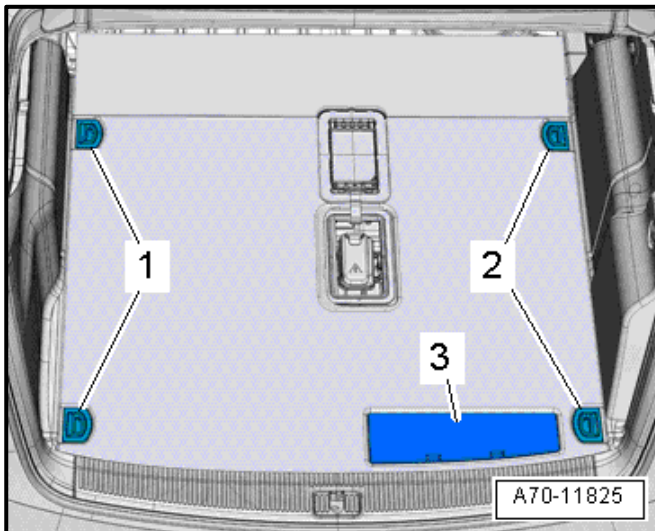
- Install tie-down mounts <2> and screws <arrows>. Tighten to 6 Nm.
- Fold the tie-downs <1> downward.
