**HYUNDAI**NEW THINKING.
NEW POSSIBILITIES.**Technical Service Bulletin**

16-01-012

TUCSON (LM)**SUBJECT:** AUTOMATIC TRANSAXLE OIL COOLER HOSE REPLACEMENT
(RECALL #139)*** IMPORTANT******* Retail Vehicles Only *****

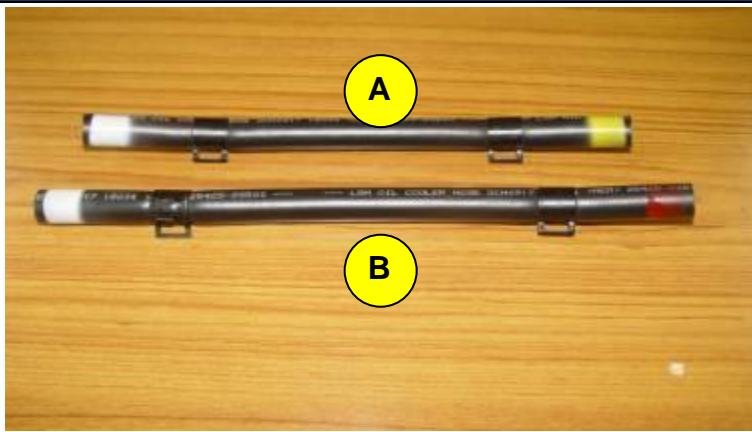
Part Name	Description	Remark
A/T oil cooler hose

- Yellow/Red mark: A/T side - White mark: Radiator side
	New Part Number	Description
	25420-2S500-QQH (A)	Feed hose (IN)
	25425-2S500-QQH (B)	Return hose (OUT)
