PRODUCT CAMPAIGN BULLETIN

APPLICABILITY: 2006-2014 model year Tribeca vehicles

SUBJECT: Tribeca Hood May Open While Driving

NUMBER: WQX-59

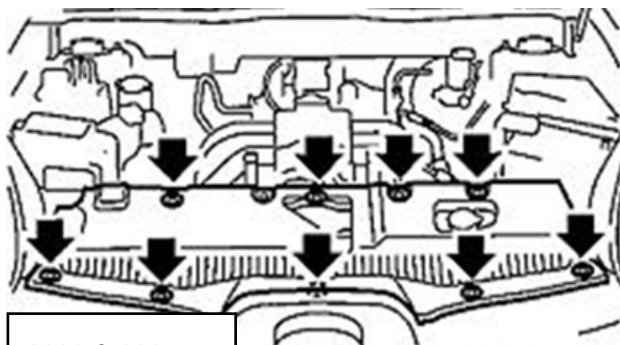
2006 & 2007MY

assembly. There are 9 clips on 2006-2007MY models and 11 on 2008MY and later models.

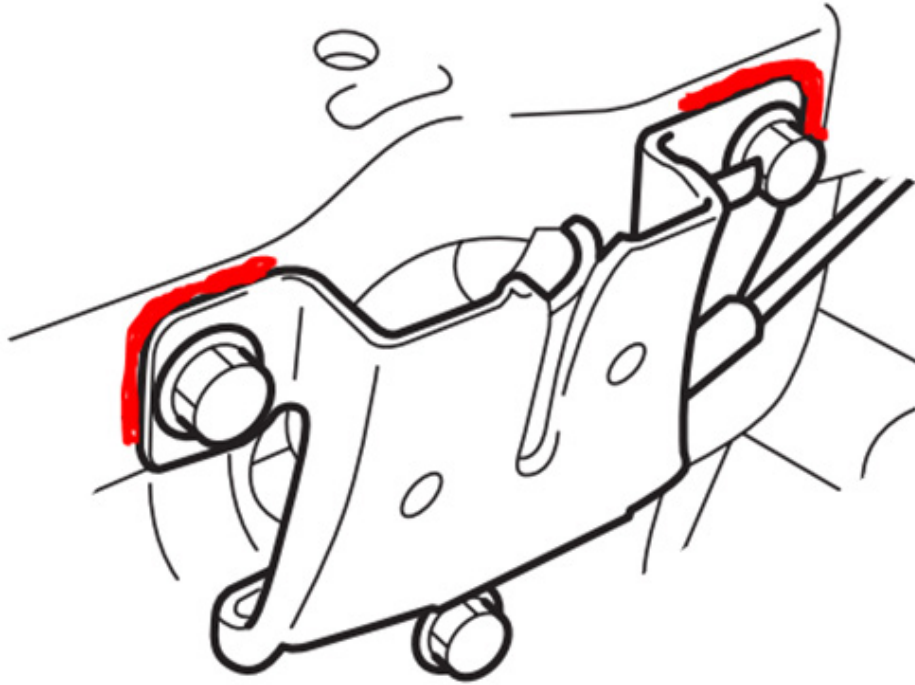
- **IMPORTANT:** Using a marker, trace the outline of the hood lock onto the radiator support (shown in red below) to use as a reference for proper positioning during reassembly.

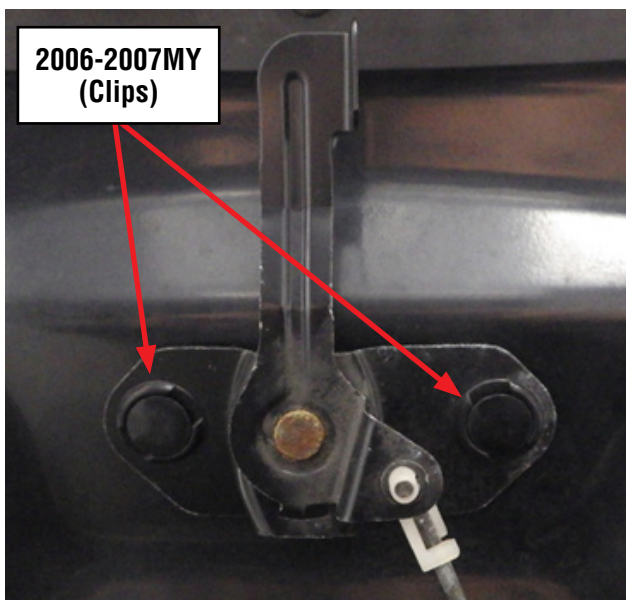
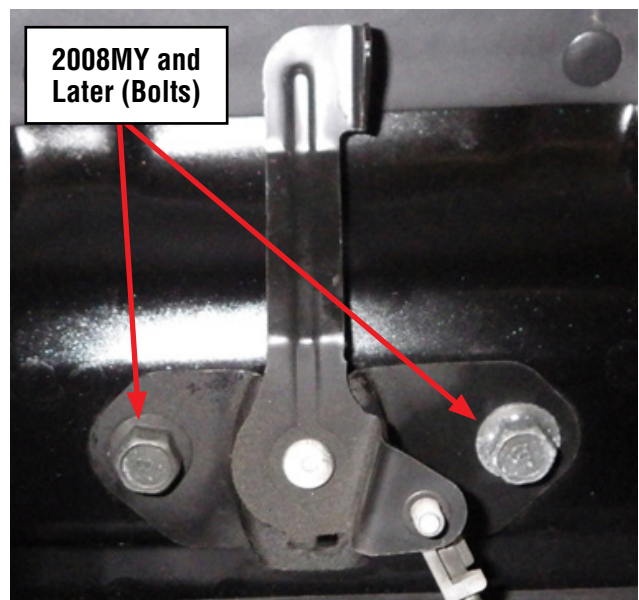
- Remove the 3 bolts securing the hood lock assembly to the radiator support and detach the release cable.
- **CAREFULLY** release the plastic clips to disconnect the link rod tying the release lever to the safety hook assembly..
- Remove the release lever and safety hook assemblies.
- **IMPORTANT:** On 2006 and 2007MY vehicles, the release lever assembly is secured to the hood with two plastic clips instead of the bolts used on 2008MY and later vehicles as shown below. These clips are **One-Time-Use** and must be replaced at reassembly. The bolts can be reused.

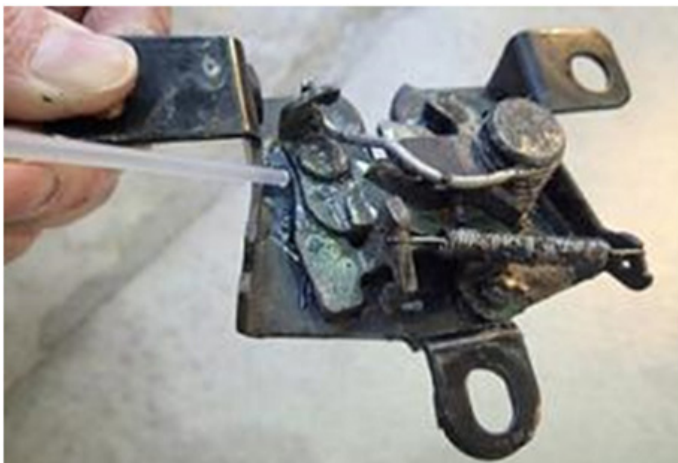
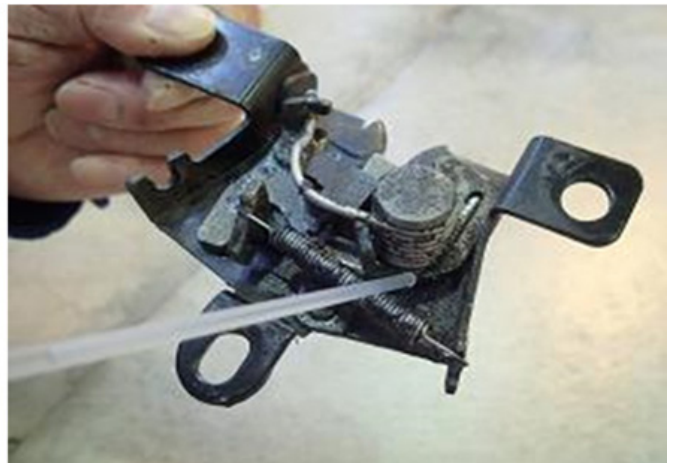
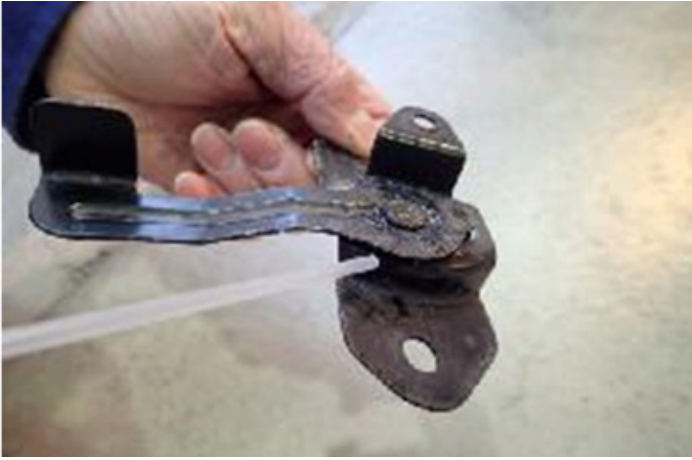
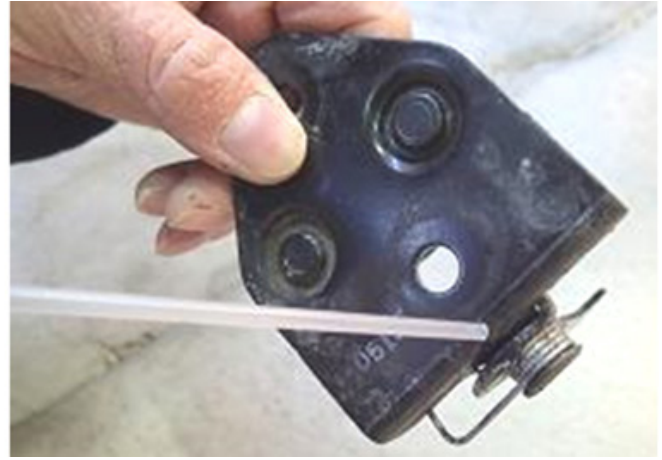
- After the hood lock, release lever and safety hook assemblies have been thoroughly cleaned and inspected, apply penetrating spray grease as shown in the photos below. Apply to the all pivot points, sliding parts and springs on both the hood lock, release lever and safety hook assemblies. Wherever possible, operate the moving parts of each component while applying the penetrating grease to help work it into the mechanism to ensure complete lubrication and eliminate any binding.

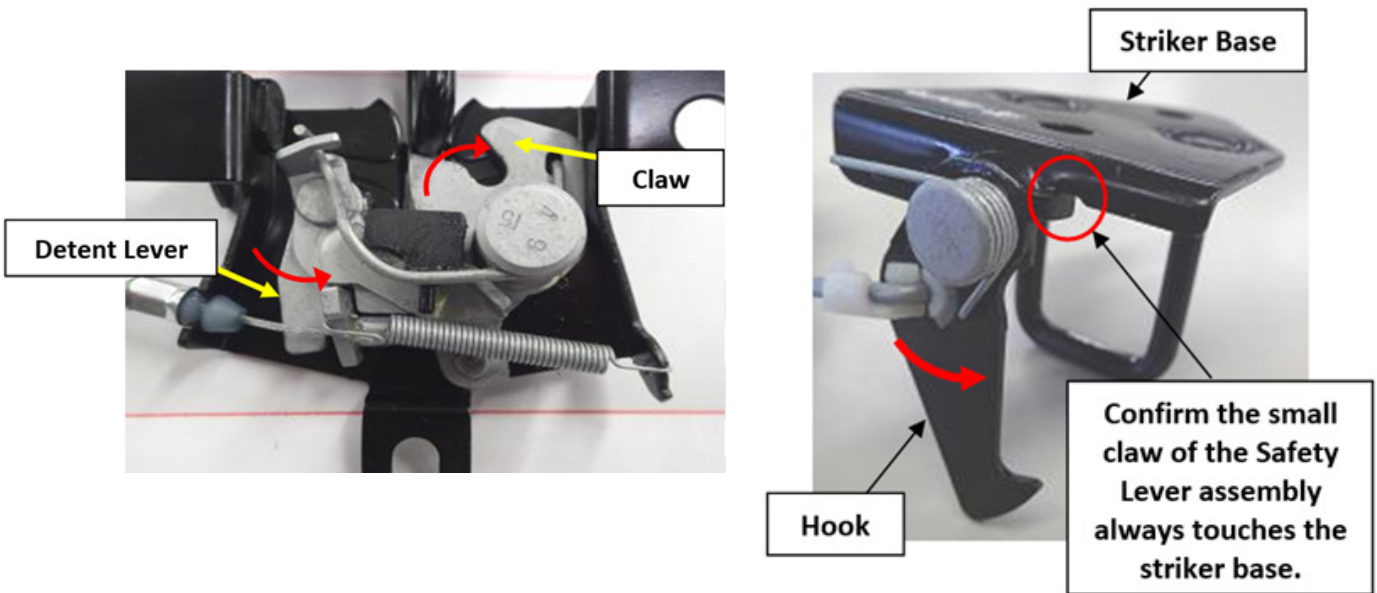
- Once all three components have been thoroughly lubricated with the penetrating spray grease, verify all moving parts operate smoothly with full range of motion and no binding. Pay close attention to the detent lever and claw portions of both the hood lock and safety lever.

NOTE: A replacement hood lock assembly should only be necessary in very rare cases. Even the most severe cases of this condition have been alleviated and the components made fully functional by cleaning and lubrication.
