February 17, 2017

05576 Version 1

Safety Recall: 2015–16 ILX and RDX Takata Driver’s Airbag Inflator

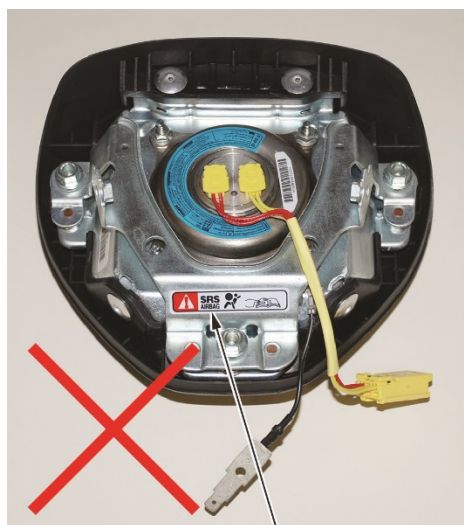
NON-STANDARD
SAFETY LABEL

- If there is nothing unusual about the airbag or the inflator, go to step 5.
- If there are any unusual markings, like an incorrect label or a model year written in marker, the airbag and inflator may not be the correct airbag and/or inflator for the vehicle or it may be a counterfeit part. For more information about counterfeit airbags, you can refer to safercar.gov, enter keywords **MANAGING COUNTERFEIT**, and select **Recommended Dealer Guidance for Managing Counterfeit Air Bags** from the list. **If you suspect that the airbag or inflator is counterfeit, do not continue this procedure.** Contact your DPSM for assistance.

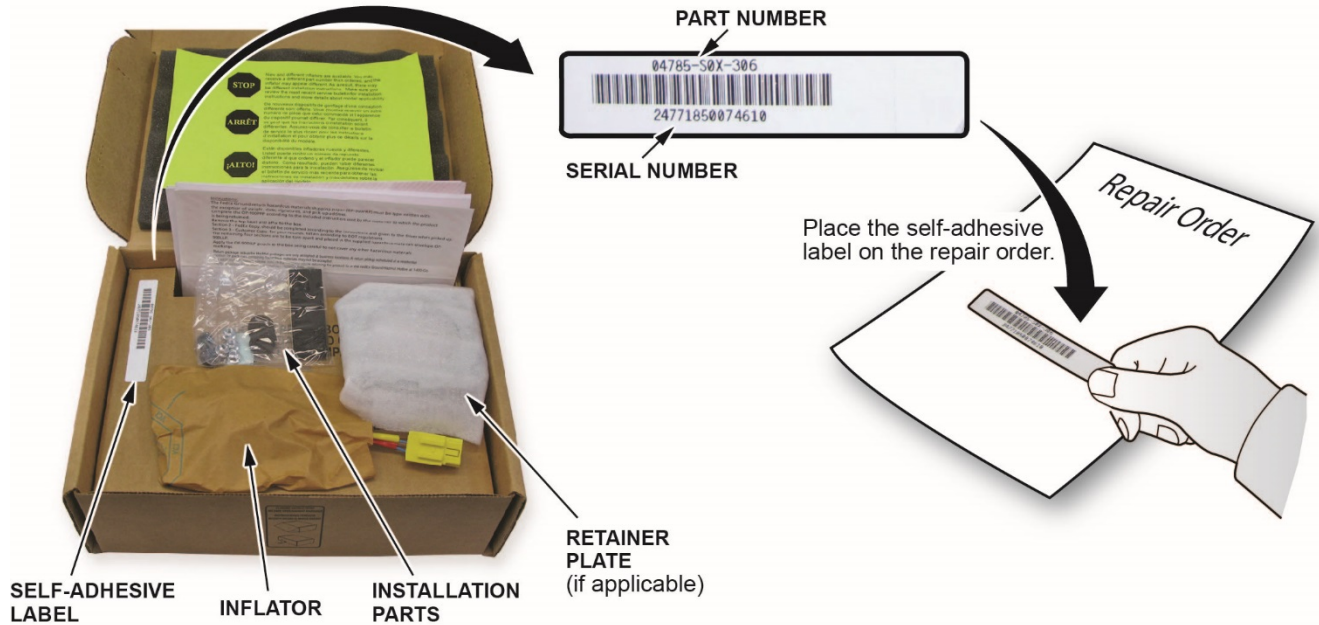
INFLATOR PARTS BOX

5. Peel the label located inside the inflator box from its backing and attach it to the RO. For the warranty claim to be paid, the **replacement inflator part number that you received** must be included in the warranty claim.

- The replacement part number is printed on the top part of the label and the serial number is printed on the bottom. **Make sure you attach the label to the RO and give it to the warranty clerk.**
- There may also be a colored sticker located in the kit; ignore it because it is not used.
- Not all inflator kits have a label included. In those cases, write the serial number and part number from the side of the inflator box on the RO. The part number always starts with 047.

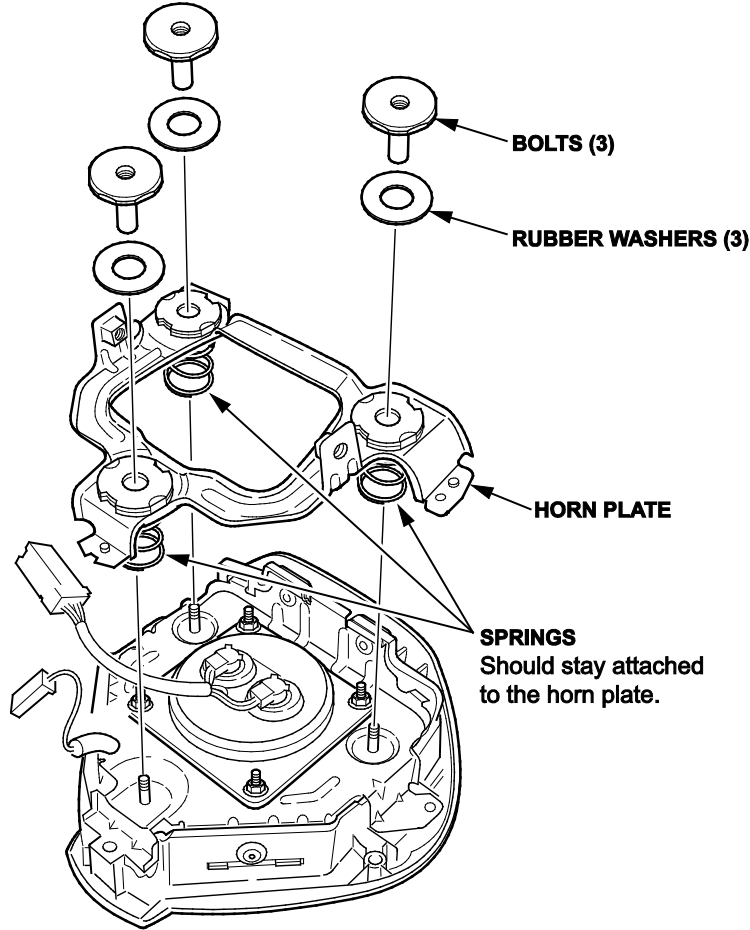
- Evenly loosen the three bolts using the 1-inch socket.

- Remove the 3 bolts. Make sure you do not drop or lose the 3 black rubber washers.
- Remove the horn plate. Be careful that the 3 springs stay attached to the horn plate. If the springs come loose, reinstall as needed and set aside the horn plate and components until reassembly.

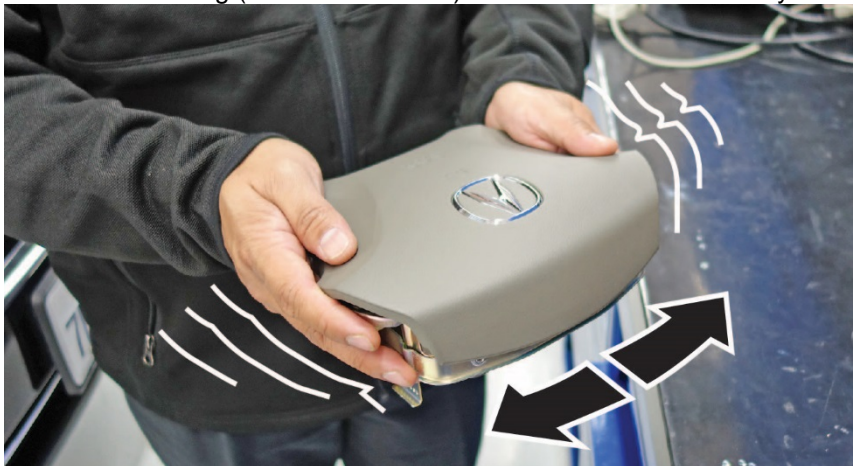
8. Use shop air to clean any debris that may be on the inflator, then remove the inflator from the airbag.

- Do not allow any debris to enter the inflator opening in the airbag.
 - Do not deploy the inflator. The inflator must be returned to its supplier in the box the new inflator came in. Follow the shipping instructions supplied with the inflator kit. If you have any questions about shipping, call Warranty Parts Inspection (WPI) at **937-642-2737**.
9. Turn over the airbag (inflator side down) and shake it to remove any debris from the inflator opening.

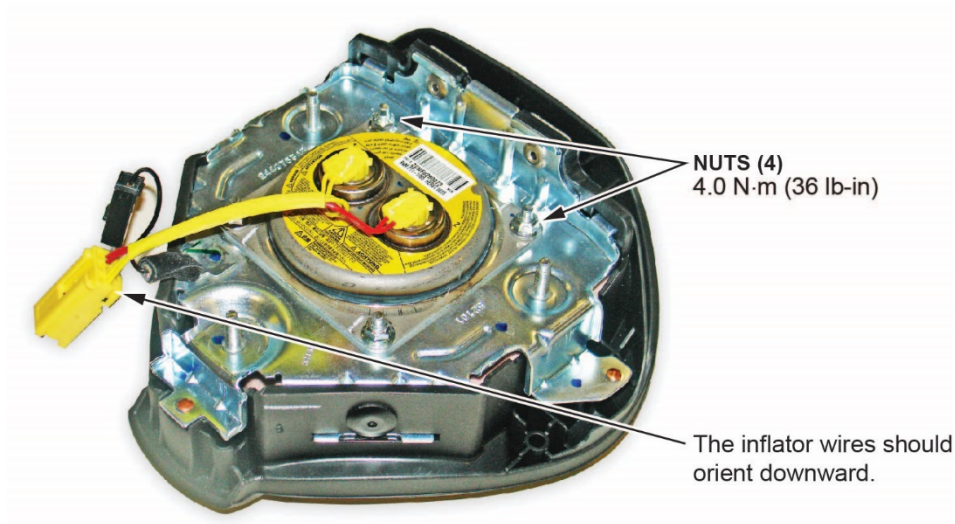
- If an airbag inflator label is included in the kit, make sure you affix the new label to the airbag module as shown.
- There may be some minor surface rust or corrosion on the new inflator; this is OK.
- Insert the inflator into the opening.

- Make sure the inflator wires are positioned toward the bottom of the airbag. If you install the inflator incorrectly, you may not be able to reconnect the SRS airbag harness.
- The image shows the horn bracket removed like on the 2015–16 ILX and 2015–16 RDX. The other vehicles are similar.

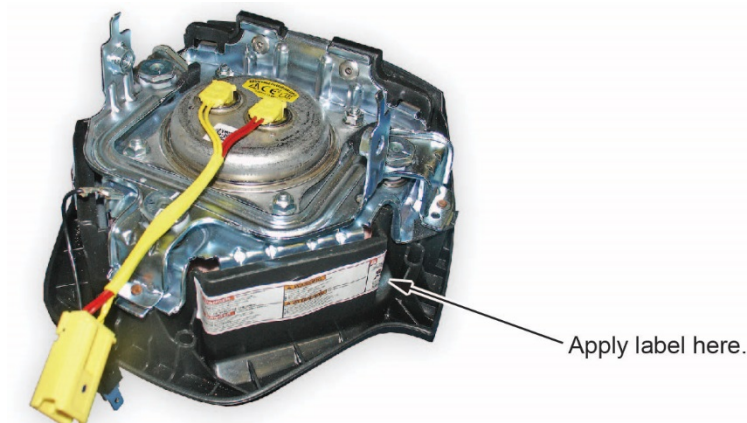
- Install and torque the new locknuts to **4.0 N·m (3.0 lb-ft, 36 lb-in)**.
- Attach the label in the inflator kit to the airbag module as shown.

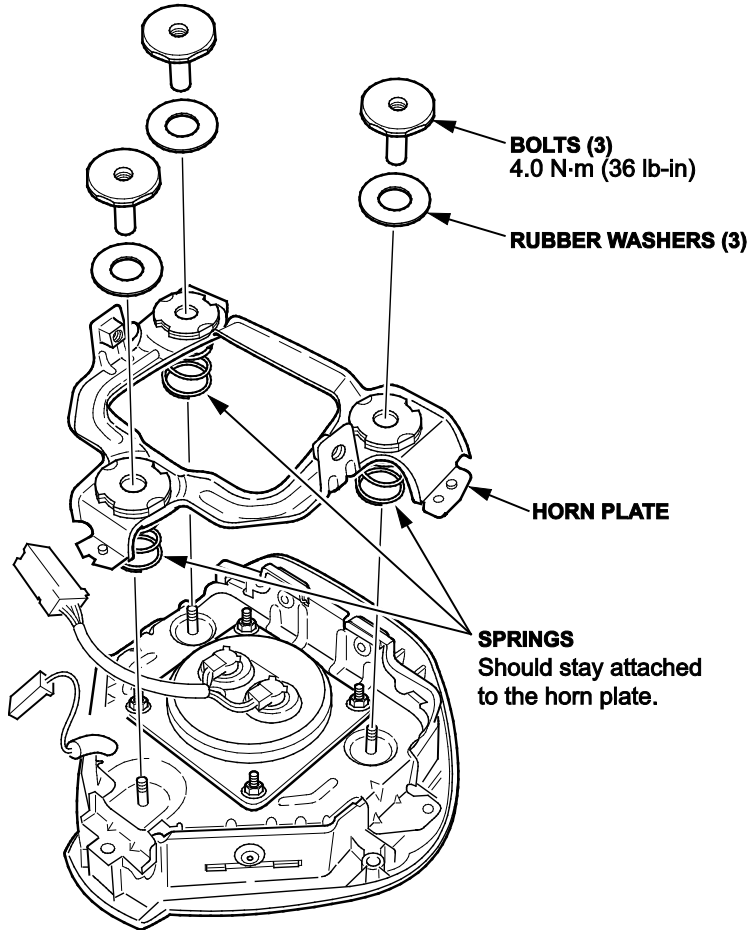
- Make sure the three springs are mounted to the back side of the horn plate as shown. Make sure the rubber washers are installed on their respective bolts.

- Install the horn plate on the airbag.
- Install the 3 bolts and evenly tighten to **4.0 N·m (3.0 lb-ft, 36 lb-in)**.
NOTE: **Do not over-tighten the bolts** because you can break the studs and you will have to replace the airbag module.
