April 28, 2016

03187 Version 5

## Safety Recall: Takata Driver's Airbag Inflator

Supersedes 16-016, dated April 15, 2016, to revise the information highlighted in **yellow**

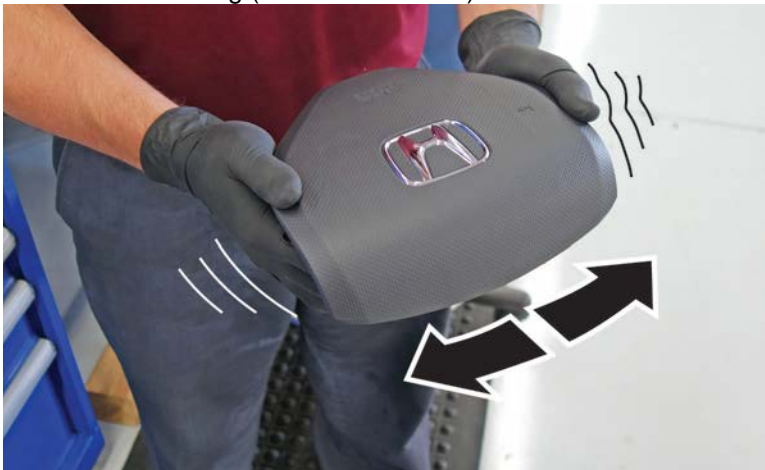
8. Use shop air to clean any debris that may be on the inflator, then remove the inflator from the airbag.

- Do not allow any debris to enter the inflator opening in the airbag.
  - Do not deploy the inflator. The inflator must be returned to its supplier in the box the new inflator came in. Follow the shipping instructions supplied with the inflator kit. If you have any questions about shipping, call Warranty Parts Inspection (WPI) at **937-642-2737**.
9. Turn over the airbag (inflator side down) and shake it to remove any debris from the inflator opening.

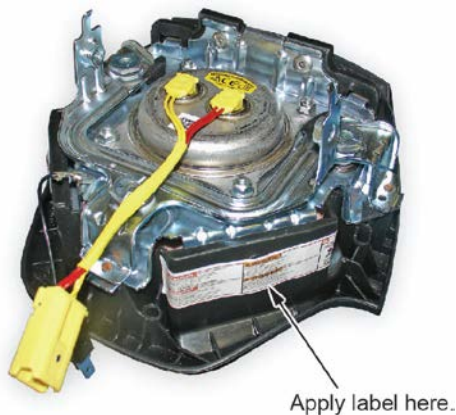
- Install and torque the new locknuts to **4.0 N·m (3.0 lb-ft, 36 lb-in)**.
- If the inflator kit came with a label, attach it to the airbag assembly as shown.
