June 8, 2016

03187 Version 6

Safety Recall: Takata Driver's Airbag Inflator

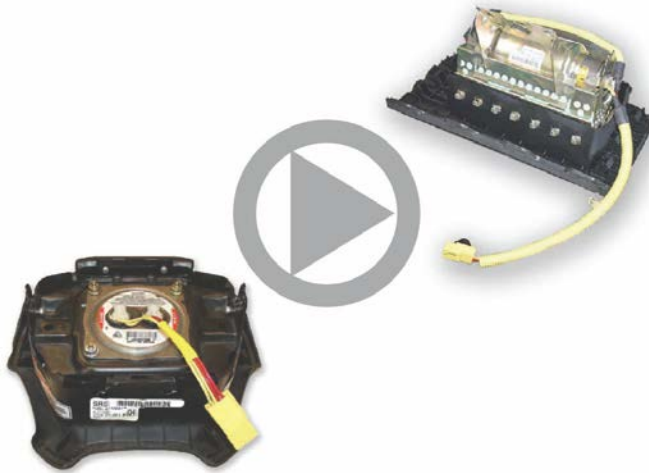
6. CR-V, CR-Z, Fit, FIT EV, and Insight - Cut the horn plate.

2007-14 Ridgeline – You do not have to remove the horn bracket. Go to step 7.

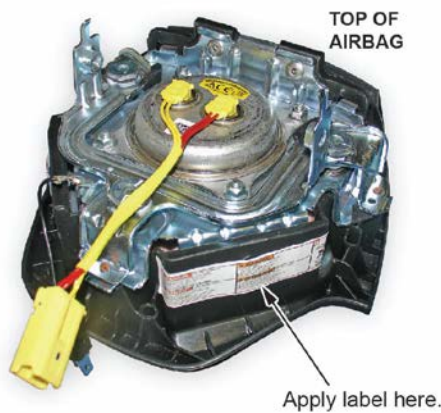
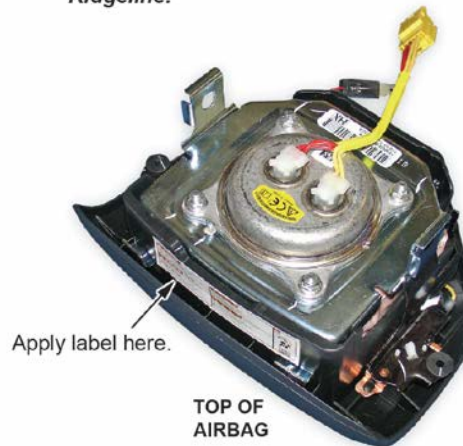
- Install and torque the new locknuts to **4.0 N·m (3.0 lb-ft, 36 lb-in)**.
- If the inflator kit came with a label, attach it to the airbag assembly as shown.
CR-V, CR-Z, Fit, Insight: Ridgeline:
