February 17, 2017

05573 Version 7

Safety Recall: Takata Driver's Airbag Inflator**Supersedes 16-016, dated June 8, 2016; See REVISION SUMMARY****AFFECTED VEHICLES**

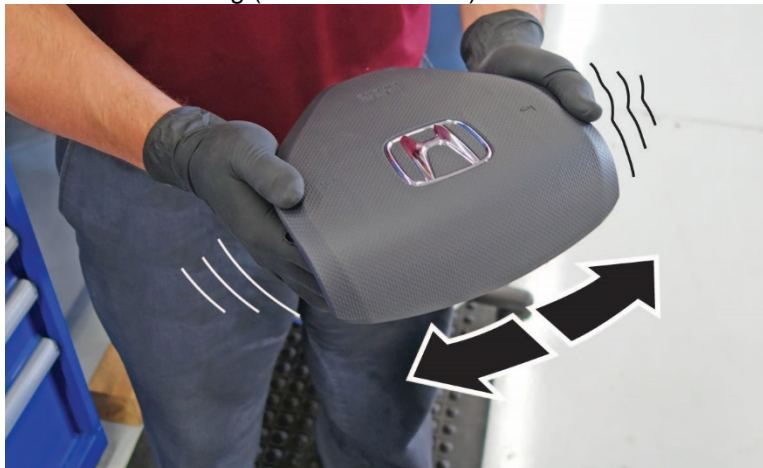
8. Use shop air to clean any debris that may be on the inflator, then remove the inflator from the airbag.

- Do not allow any debris to enter the inflator opening in the airbag.
- Do not deploy the inflator. The inflator must be returned to its supplier in the box the new inflator came in. Follow the shipping instructions supplied with the inflator kit. If you have any questions about shipping, call Warranty Parts Inspection (WPI) at **937-642-2737**.

9. Turn over the airbag (inflator side down) and shake it to remove any debris from the inflator opening.

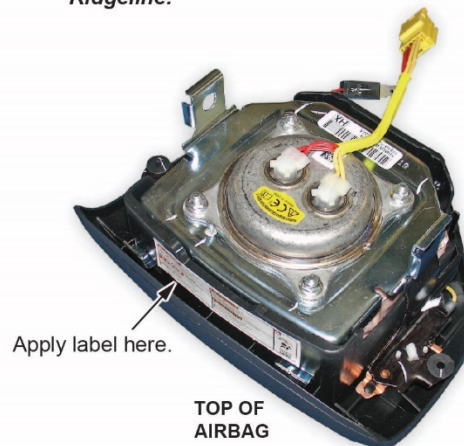
- Install and torque the new locknuts to **4.0 N·m (3.0 lb-ft, 36 lb-in)**.
 - If the inflator kit came with a label, attach it to the airbag assembly as shown.
- CR-V, CR-Z, Fit, Insight:* *Ridgeline:*
