GROUP Safety Recall Campaign	MODEL 2011 MY Forte (TD)
	NUMBER SC 129 (REV 1, 6/29/2016)	DATE March 2016
VOLUNTARY SAFETY RECALL CAMPAIGN		
SUBJECT: A/T FLUID COOLER HOSE REPLACEMENT (SC 129)

A/T FLUID COOLER HOSE REPLACEMENT (SC 129)

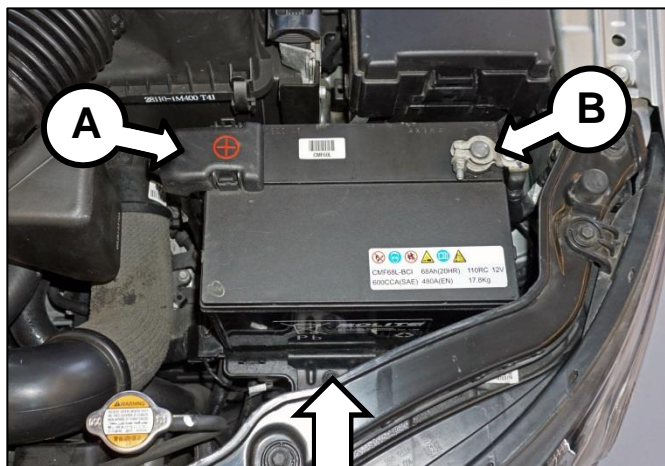
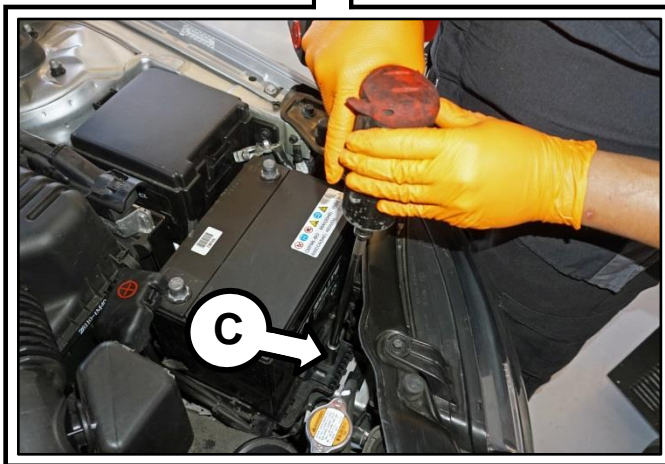
1. Turn ignition switch to the OFF position.
2. Record the customer's radio presets.
3. Disconnect the Positive (+) terminal (A) and Negative (-) terminal (B) from the battery.
4. Remove one (1) bolt securing the battery mounting bracket (C) to the chassis.

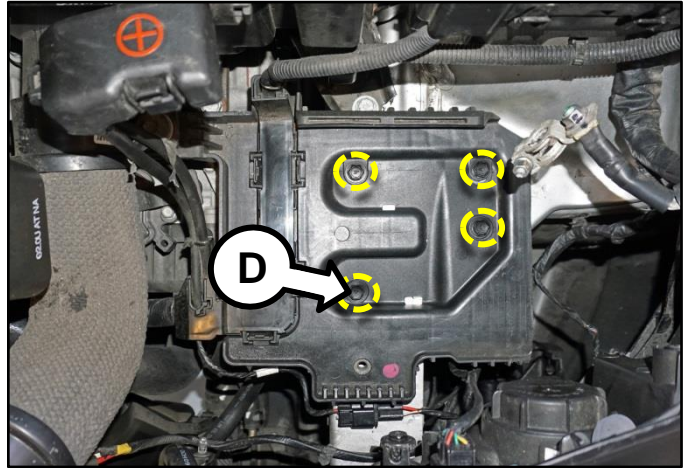
5. Remove four (4) bolts (D) securing the battery tray to the chassis.

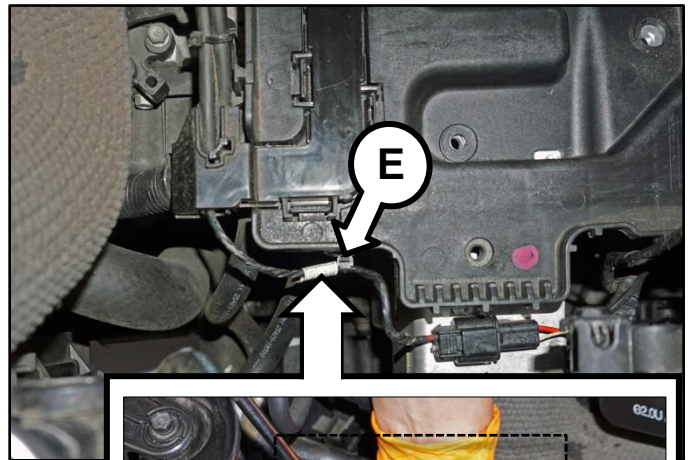
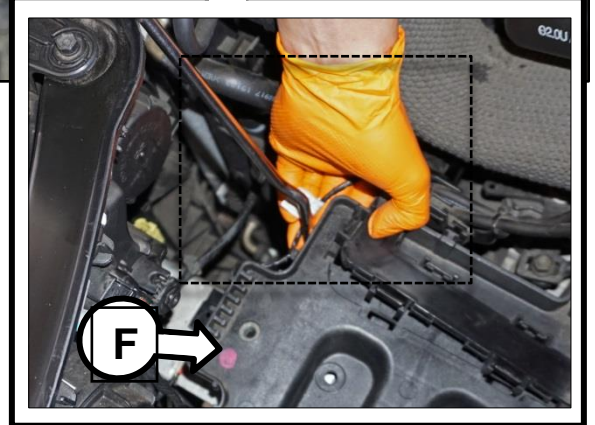
6. Undo the battery connector attachment point (E) on the battery tray (F), as shown.

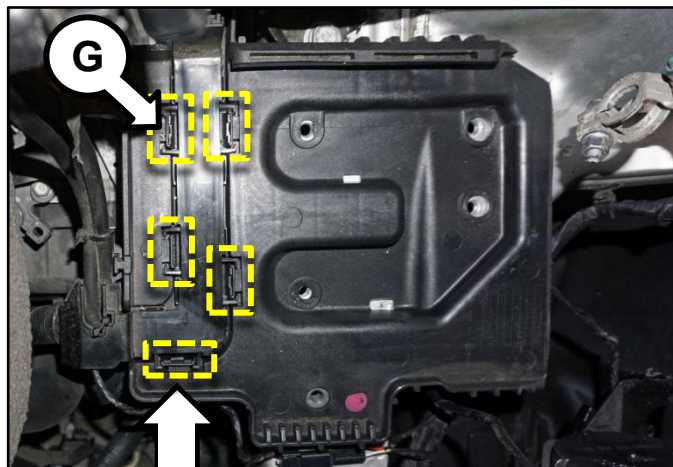
7. Locate the five (5) mounting locations (G) for the harness channel.

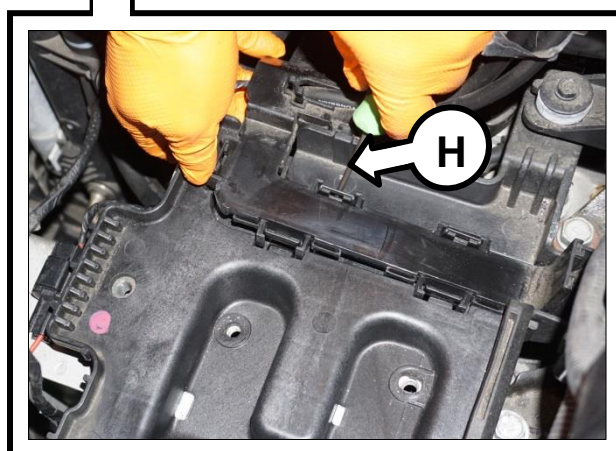
8. Use a pick tool tool (H) to undo each mounting location, as shown.

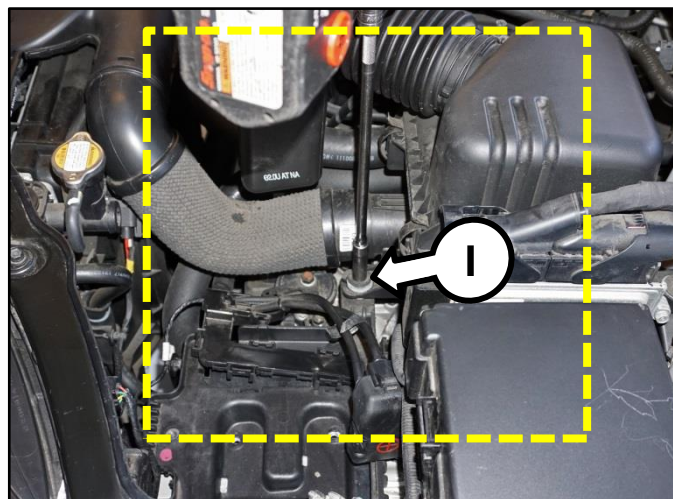
9. Remove the final battery tray mounting location (I), as shown.

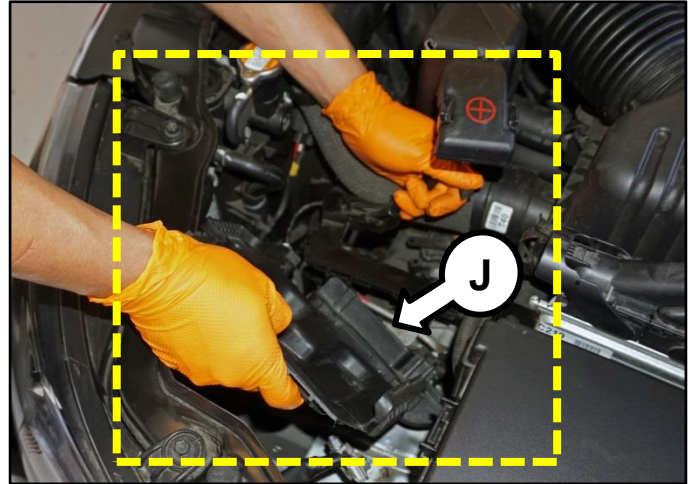
10. Remove the battery tray (J), as shown.

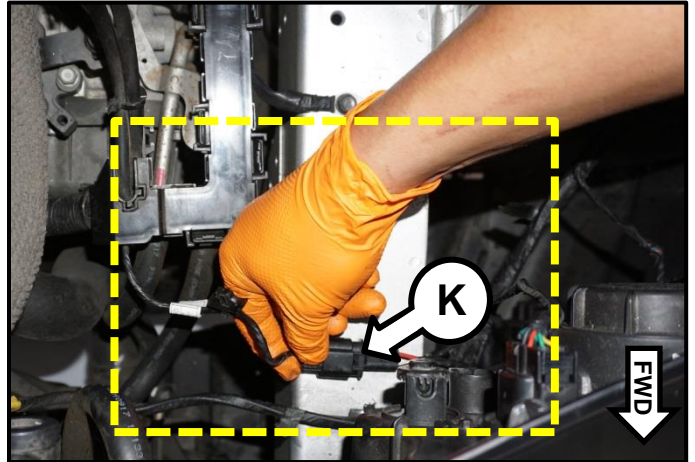
11. Disconnect the battery sensor connector (K), as shown.

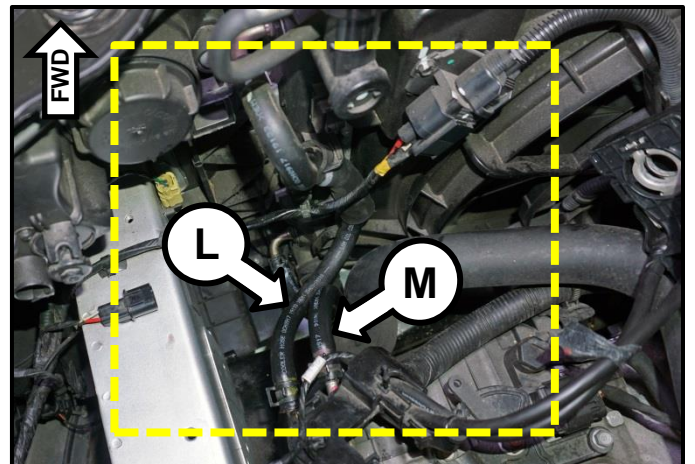
12. Locate the upper (L) and lower (M) A/T cooler hoses.

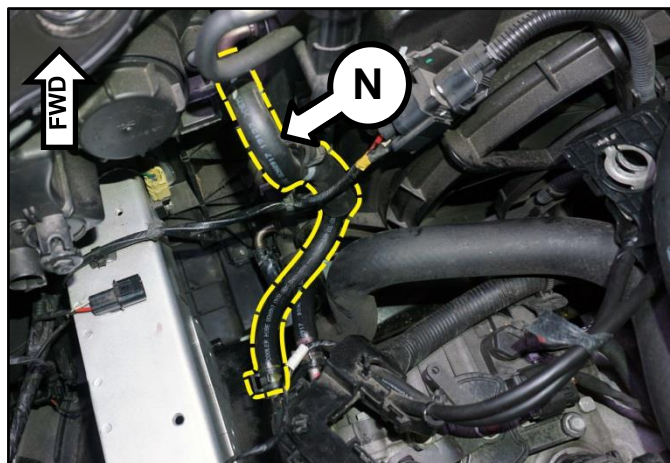
13. Remove the upper A/T cooler hose (N).

15. Install the replacement lower A/T cooler hose and secure with clamps.
16. Install the replacement upper A/T cooler hose and secure with clamps.
17. Reinstall all other removed components by reversing the order of removal.
18. Restore the customer's radio presets as recorded in step 2.
19. Start the vehicle, check for possible transaxle leaks and correct fluid level.

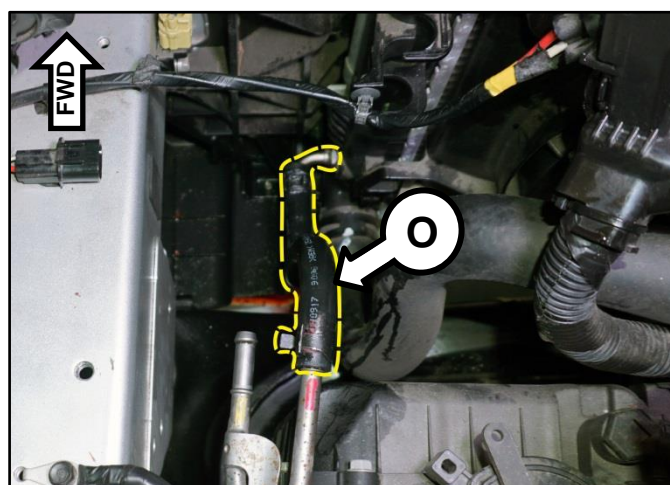
14. Remove the lower A/T cooler hose (O).
