Recall Campaign 16V-071: Driver's Front Air Bag Module E82 E88 E90 E91 E92 E93

This Service Information bulletin supersedes SI B65 16 16 **dated January 2017**.

BMW AG is conducting a Voluntary Safety Recall involving the driver's front air bag module on certain BMW vehicles that are equipped with non-desiccated Takata PSDI-5 inflators. These vehicles, covering model years 2006-2015 have not been part of earlier Takata air bag recalls.

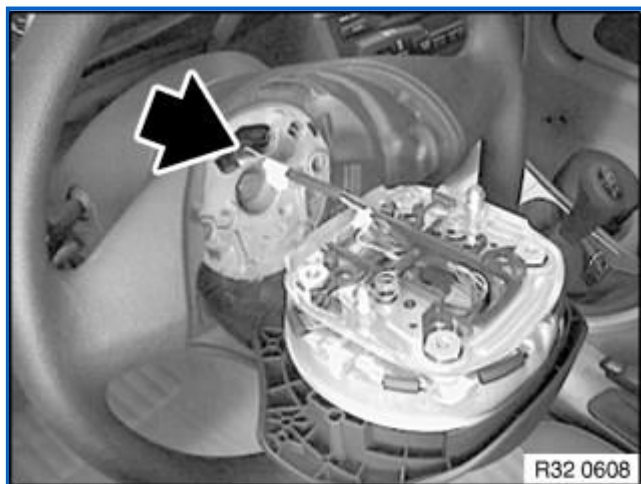
Tilt airbag unit towards rear.

Disconnect plug connection and remove airbag unit.

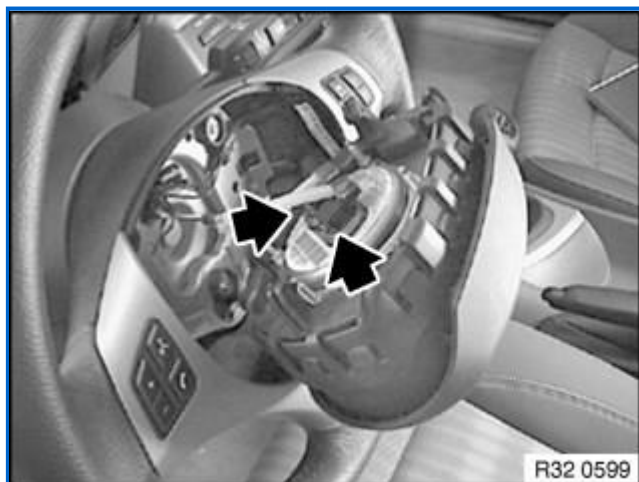
Tilt airbag unit forwards.

Disconnect plug connections and remove
airbag
