SI B65 16 16
Audio, Navigation, Monitors, Alarms, SRS

Recall Campaign 16V-071: Driver's Front Air Bag Module E82 E88 E90 E91 E92 E93

This Service Information bulletin Replaces SI B65 04 16 **dated May 2016** for E82 E88 E90 E91 E92 E93 vehicles

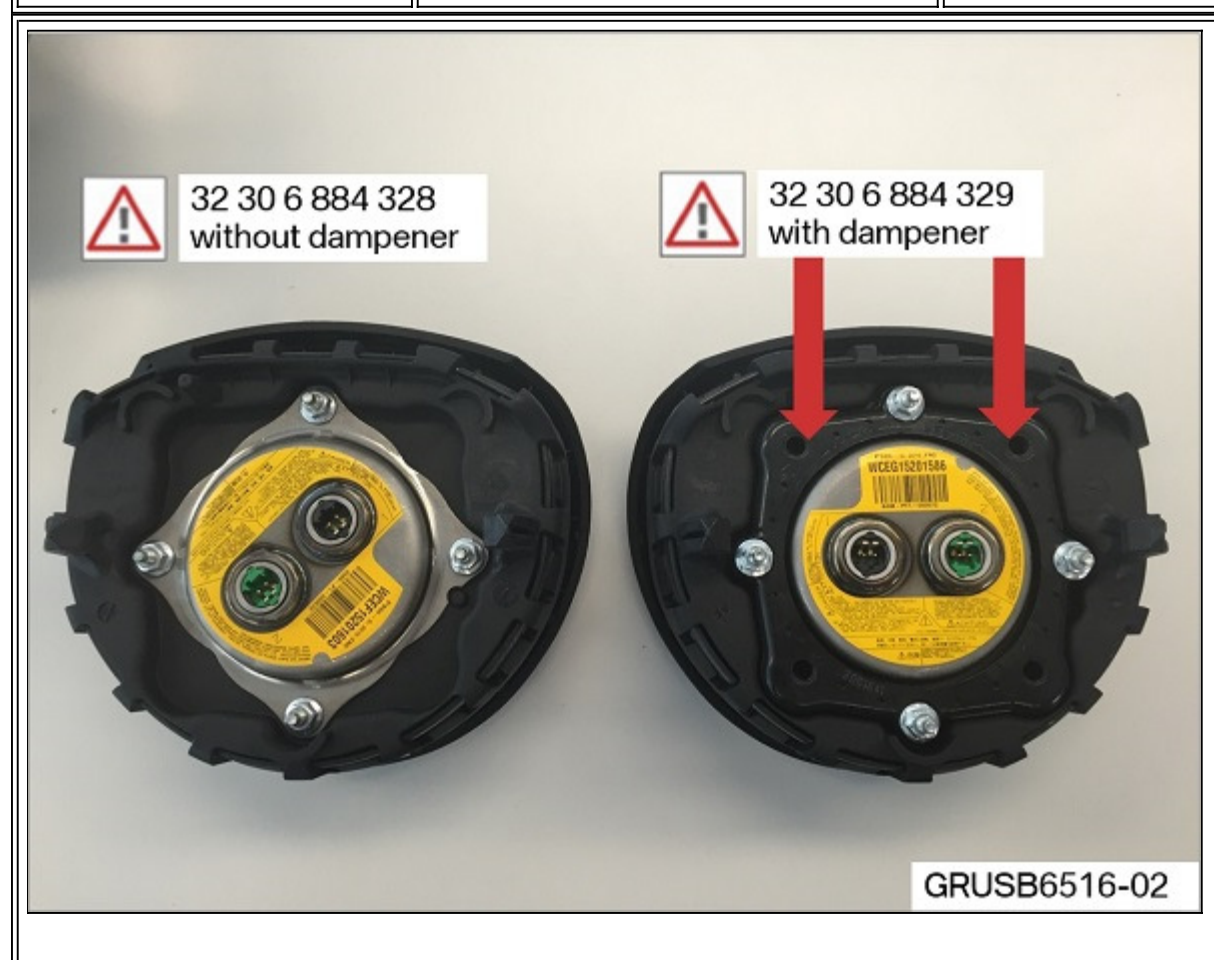
It is important that the correct airbag module is installed. If an airbag module with dampener is removed, the new part with dampener must be installed. Do not mix up the two parts. Refer to the photos above. Printing this SI in color will make it easier to see the difference in the parts.

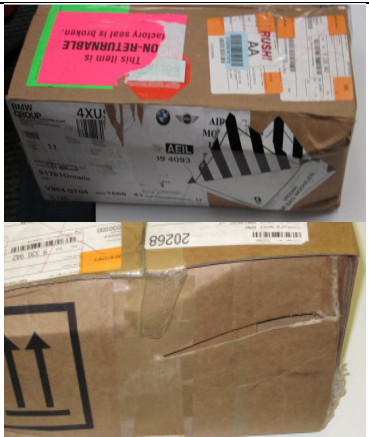
PACKAGE REFERENCE GUIDE Is This Package Acceptable?

Hazardous materials packaging "Damage" can be classified into one or more of the following different types. They include:

Damage Type	NO
L	Labeling Packages with improper labeling are NOT acceptable, particularly, If the labels obscure other required marks and labels.

I	Improper Packing Improper packing is always unacceptable. The packages must be properly packaged to prevent movement in all directions.

O	Other Damages Multiple damages, such as those may affect the integrity of the package. Others are not as severe and may be acceptable. If questionable, repackage the material.

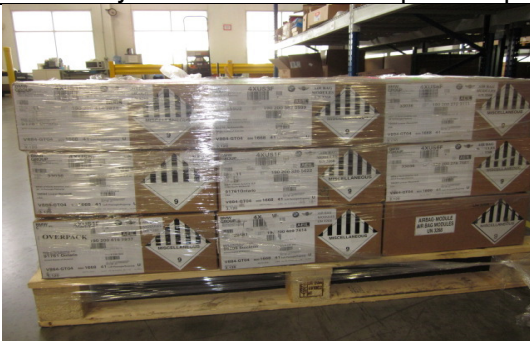
<p>1 Stacking:</p> <p>Place the safety device and shrink-wrap them on the pallet.</p> <p><u>(no more than 60 inches in height).</u></p>

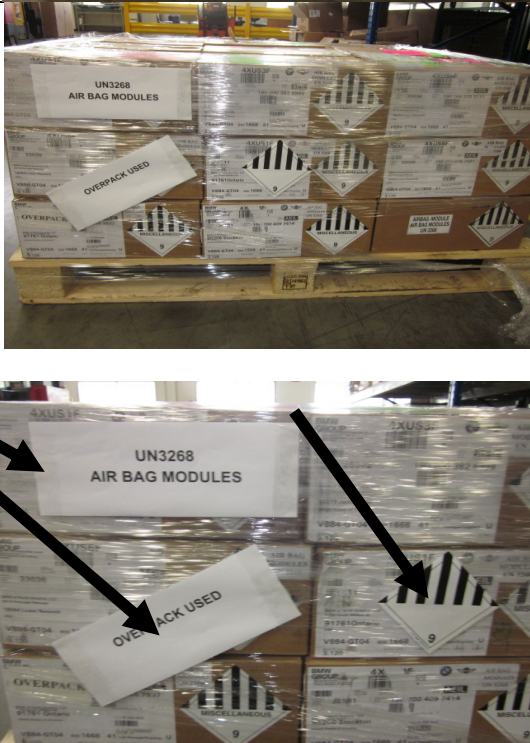
<p>2 Labeling:</p> <p>Put the following labels on both sides of the skid:</p> <ul style="list-style-type: none"> • Class 9 • UN3268 (Air Bag Modules)* • OVERPACK USED* <p>*Can be printed on Letter Size paper using Microsoft Word</p>

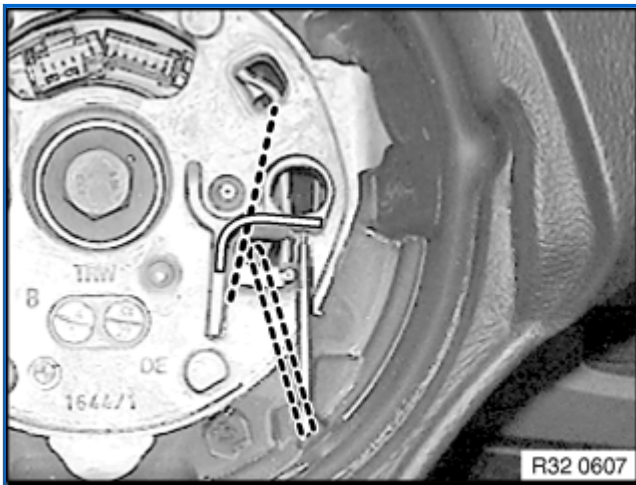
Insert Torx screwdriver (T20) roughly straight from below into opening on reverse side of steering wheel up to stop (approx. 5.5 cm).

Swing Torx screwdriver (T20) with handle sideways until airbag unit is unlocked.

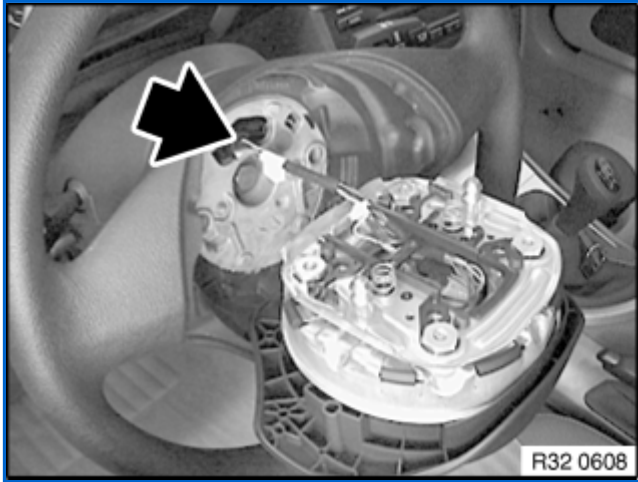
Tilt airbag unit towards rear.

Disconnect plug connection and remove airbag unit.

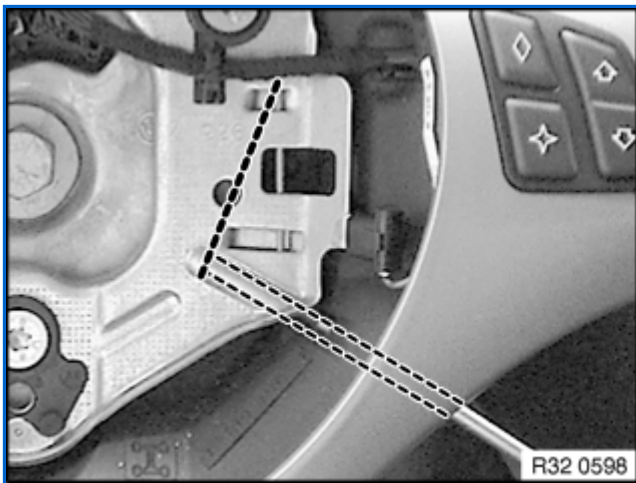
Insert Torx screwdriver (T25) at an angle into concealed opening on reverse side of steering wheel until a spring resistance is felt (approx. 1.5 cm).

Increase pressure on spring leg (concealed) using Torx screwdriver (T25) until airbag unit is unlocked.
