Safety Recall: Piston Pin Snap Ring Inspection

Year	Model	Trim	VIN Range
2016	Civic with 2.0L engine	ALL	Check the iN VIN status for eligibility

A small number of engines were produced with piston pin snap rings that may not be completely seated. If the snap ring is not completely seated, the piston pin can move from its original location in the piston, resulting in engine failure.

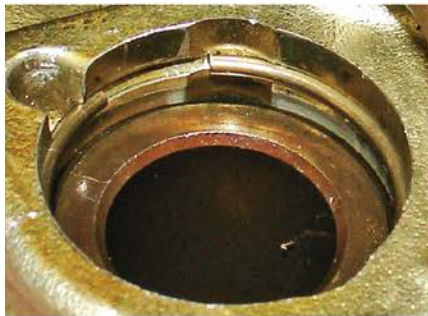
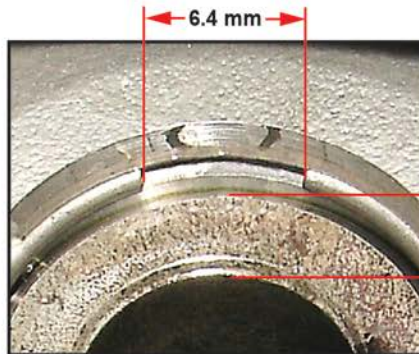
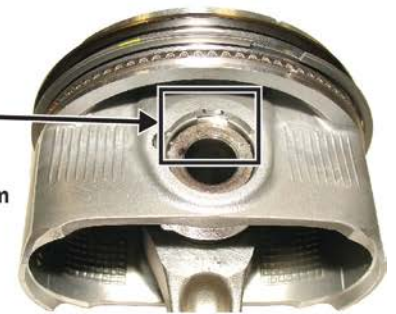
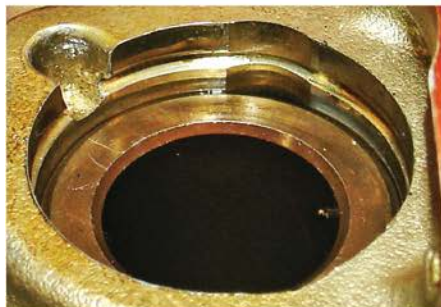
16. Using the Snap-on BK5600 with the 90-degree tip installed, rotate the engine so the No.1 cylinder is at TDC. Carefully insert the tip of the borescope and inspect cylinders No.1 and No.4. Then, rotate the engine so the No.2 cylinder is at TDC and repeat the process with cylinders No.2 and No.3.

17. Rotate the probe to confirm that the snap ring is fully engaged in the piston pin groove. A properly seated snap ring will have a 6 mm gap at the ends of the snap ring, as shown above. A misset snap ring will have a much smaller gap, around 2 mm.
18. Take a photo of each snap ring. Focus on getting a clear picture of each snap ring gap. You will need to take a picture of each side of all four pistons for a total of eight pictures.

19. Repeat for the remaining three pistons.
 - If all snap rings are installed properly, no further action is necessary. Reassemble in the reverse order of disassembly.
 - If the snap ring is misset, take a clear picture of the misset snap ring and contact Tech Line to assist you with obtaining replacement piston assemblies.
 - If a snap ring is missing and the engine cylinder wall does not have any damage, take a clear picture of the piston pin with the missing snap ring and contact Tech Line. They will assist you with obtaining the replacement piston assemblies.
 - If the snap ring is missing and the engine has cylinder wall damage, order a replacement short block.

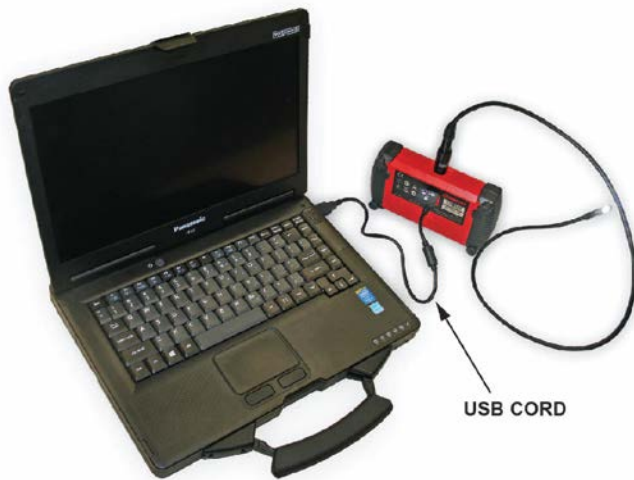
20. After all photos are taken, save them to your computer by connecting the borescope to it using the included USB cable. Give the photos to your warranty administrator for the warranty claim to be paid. Eight images of the snap rings must be included in the warranty claim or it may be rejected.
