# Safety Recall

## Code: 69M9

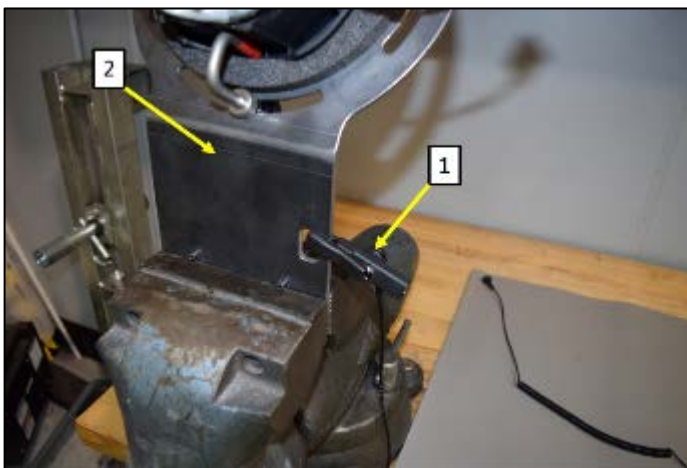
- Clamp Airbag Support T10568 <2> into the vice.
- Connect crocodile clip <1> to airbag support <2> and ESD workplace -VAS 6613-.

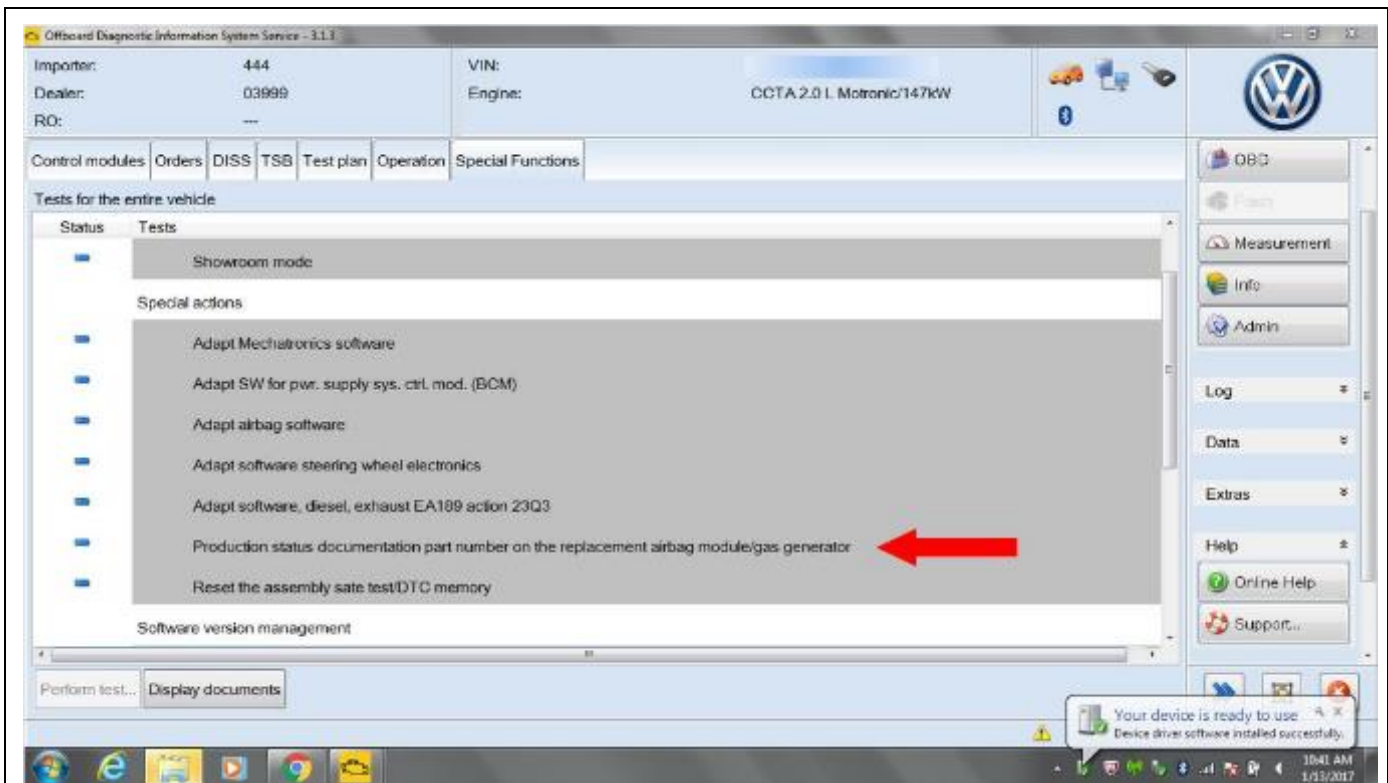
- In operating mode Special Functions, Select “**Production status documentation part number on the replacement airbag module/gas generator**” <arrow>.

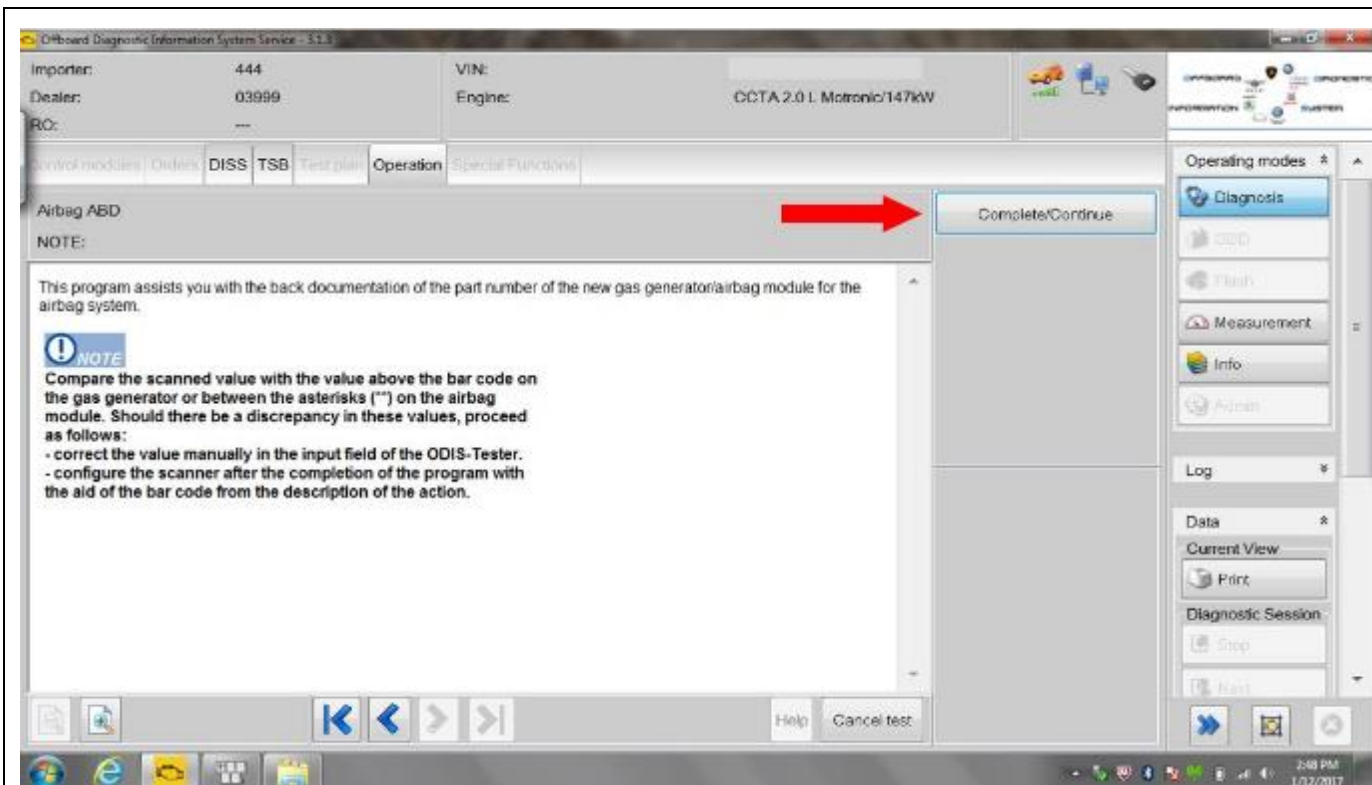
- Scanning the bar code during this test plan step calibrates the scanner to avoid error messages.
- Scanning the calibrating bar code may not have to be done every time (only when the scanner requires calibration). You will know if the scanner needs calibrating if the scanner does not scan the inflator's bar code.
- If the inflator bar code cannot be scanned, then print out the barcode shown below and scan the printout.

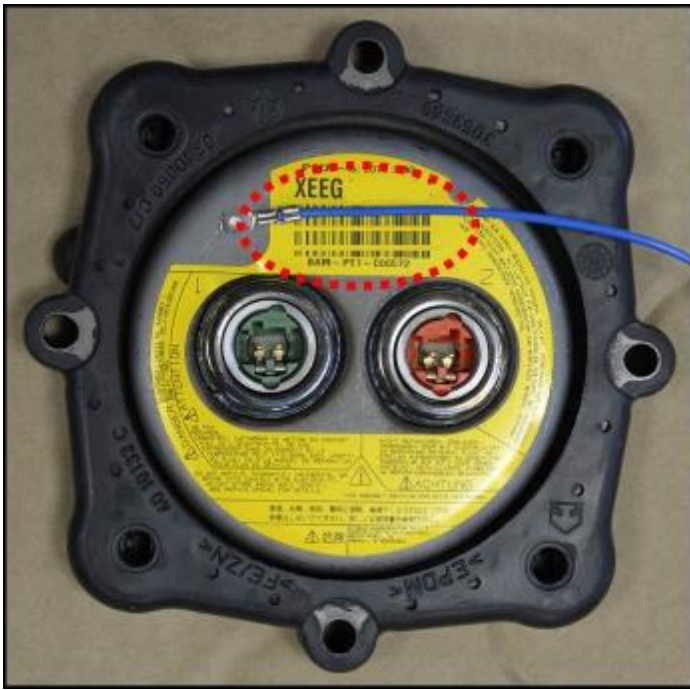
- Place the new inflator on the ESD mat.
- Scan the bar code of the new inflator at a distance of about 15 cm.

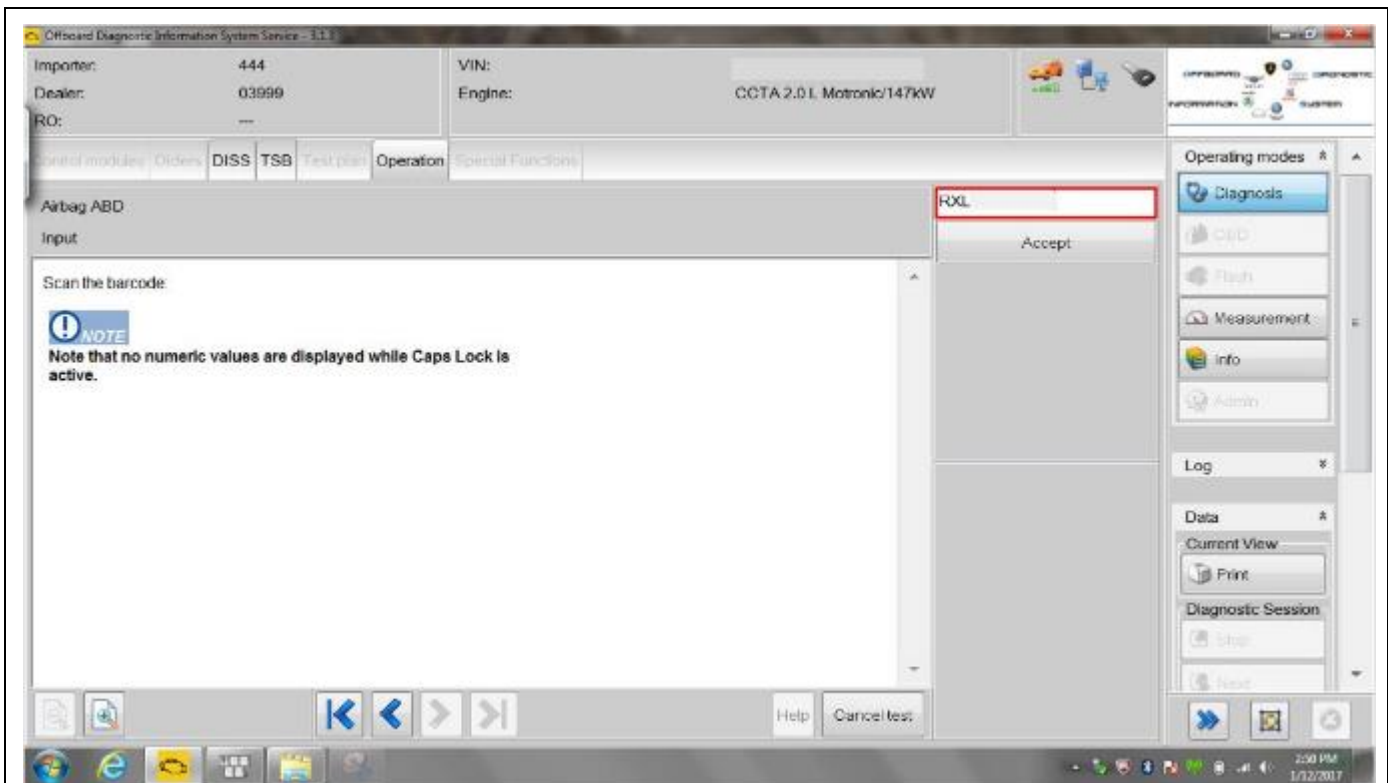
- Once the new inflator has been successfully scanned, press **“Accept”**

- Compare the scanned value with the value shown above the bar code on the new inflator.
- If there is a discrepancy, manually enter the value from the new inflator in the input field.
- If no value appears, recalibrate the scanner.

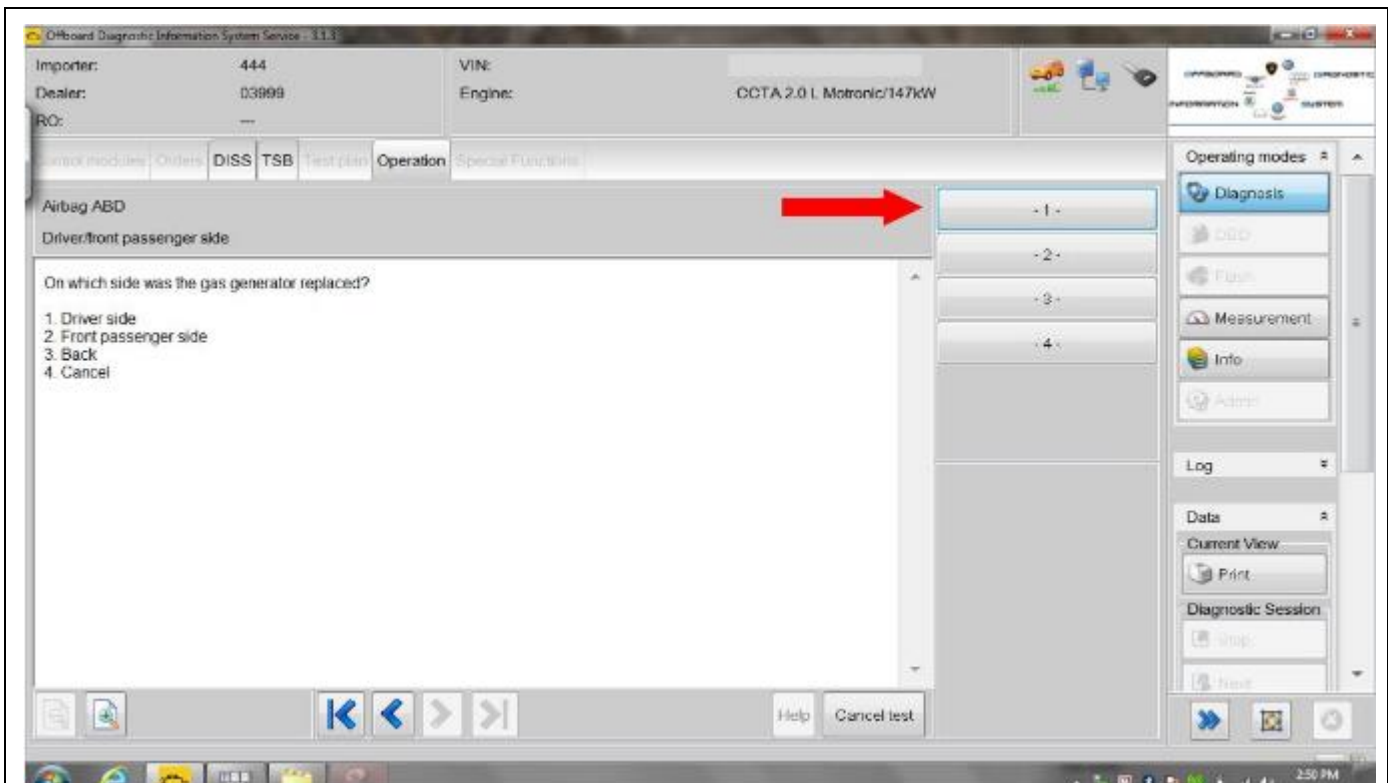
- Select option 1 indicating that the Driver side inflator was replaced.
- After selecting option 1, a valid GeKo ID will need to be entered in order to upload the new inflator identification.

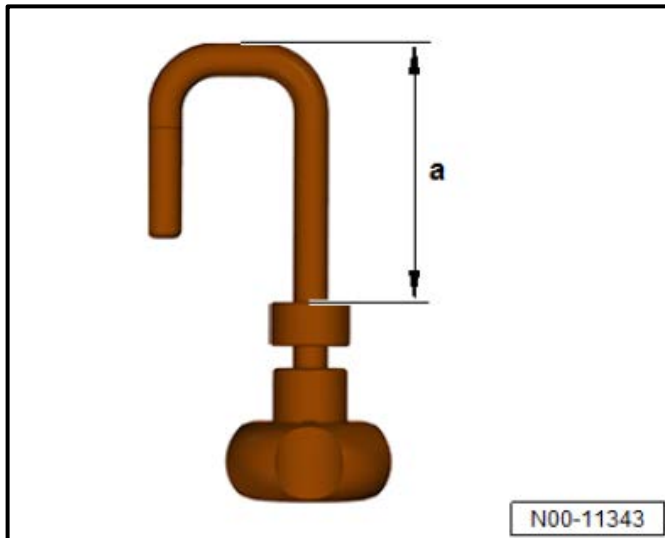
- The three spoke steering wheel has three mounting points.
- Tighten mounting by hand to prevent damage.
- Adjust three knurled nuts of securing hooks to <dimension a> 50mm.

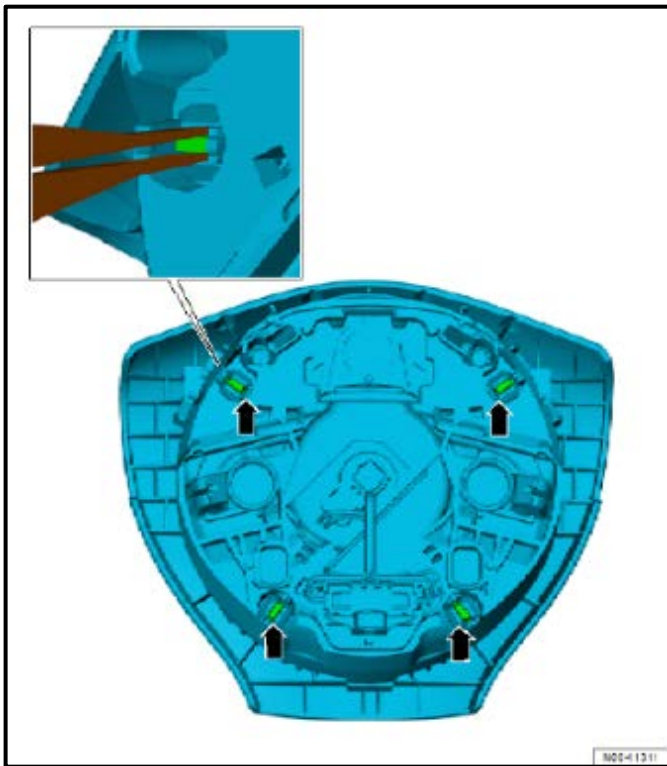
- Remove locking pins <arrows> for horn ring with aid of longnose pliers.

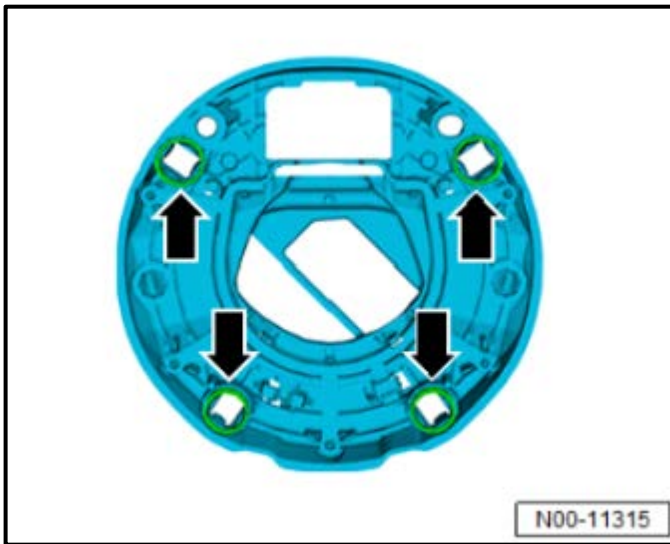
- Apply lever -T10571- <1> in shaded area <3>. At the same time, apply removal wedge -3409- on the other side <2> and lever off horn ring.
- Repeat work steps on other side.

Use extreme care when removing the horn ring. If horn ring is damaged during remove, airbag replacement will be necessary. Replacement of the airbag due to damage during horn ring removal will not be covered under this action.

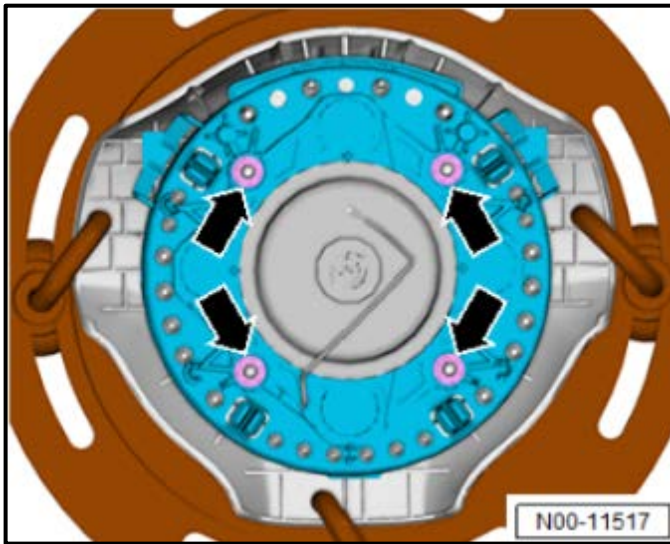
- Remove horn ring with springs <arrows>.

- When removing the horn ring, take care that the springs are not lost as they are not available separately.
- **ONE** replacement spring is included in the inflator kit in the event a spring is lost or damaged.
- If more than one spring is lost, replacement of the airbag is required. Replacement of the airbag is required if a spring is lost and is not covered under this action.

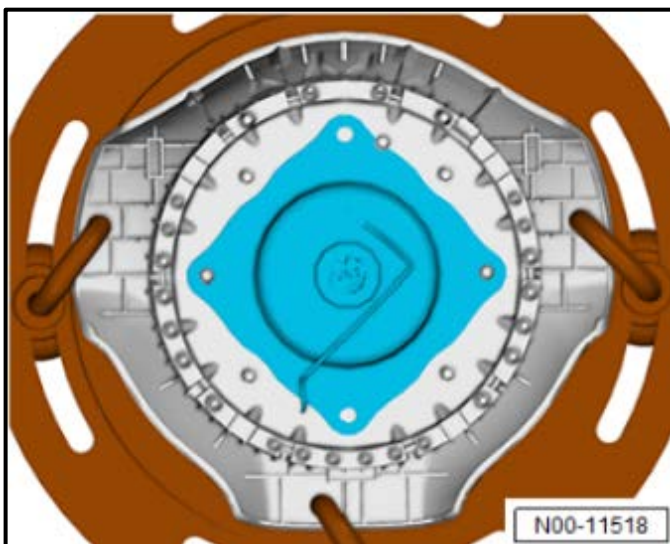
- Remove the inflator and place in the original packaging.

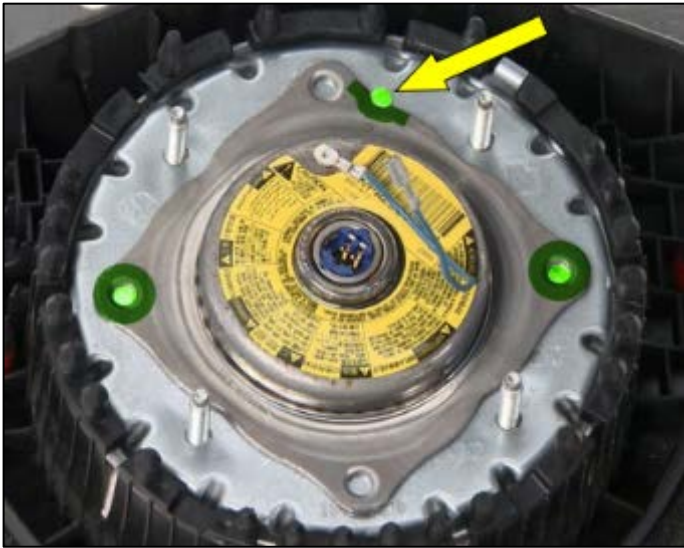
- Insert the new inflator as shown. Note the recess <arrow>.

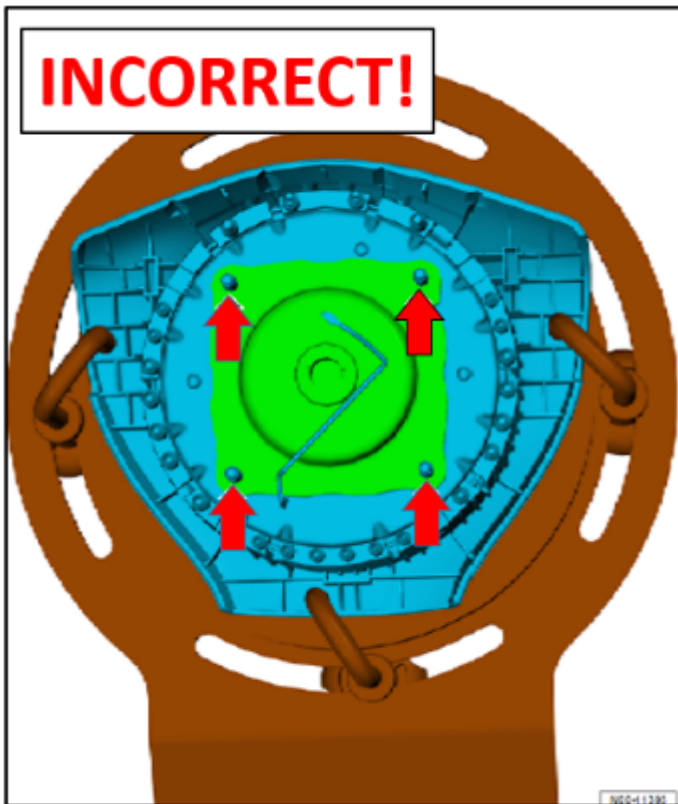
**Note installation position:**  
The inflator must **NOT** be placed on the studs <arrows>.

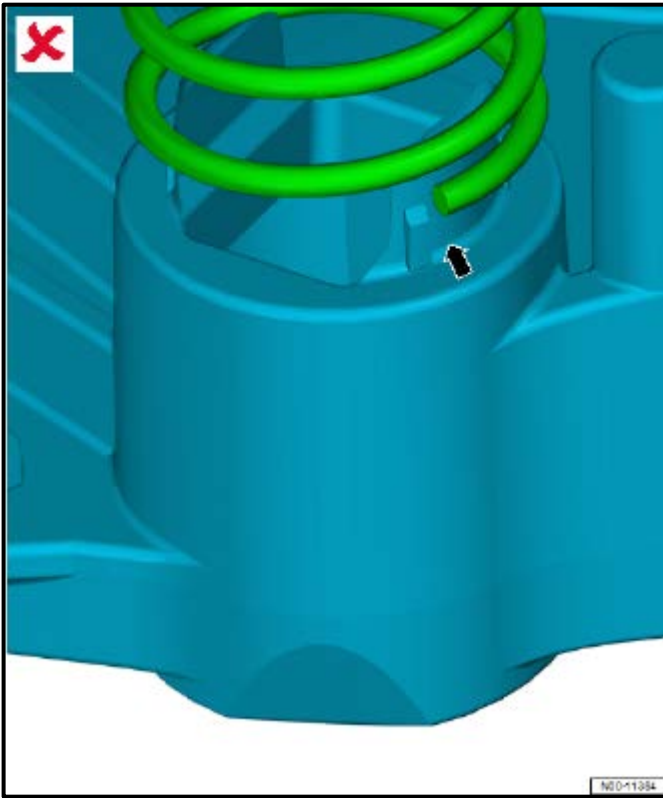
- If one of the springs is damaged or has been lost, it can be replaced with a spring from the bag of spares included.
- Note the examples shown for reference of proper spring seating.

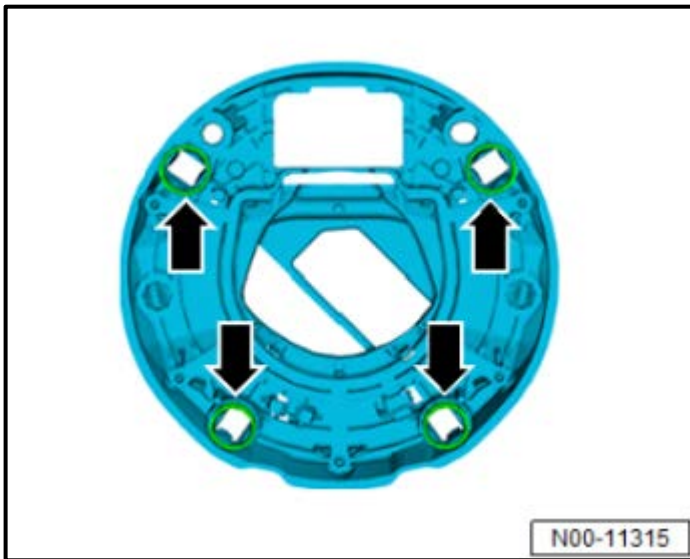
- Fit springs -arrows- for horn ring again and allow to engage audibly.

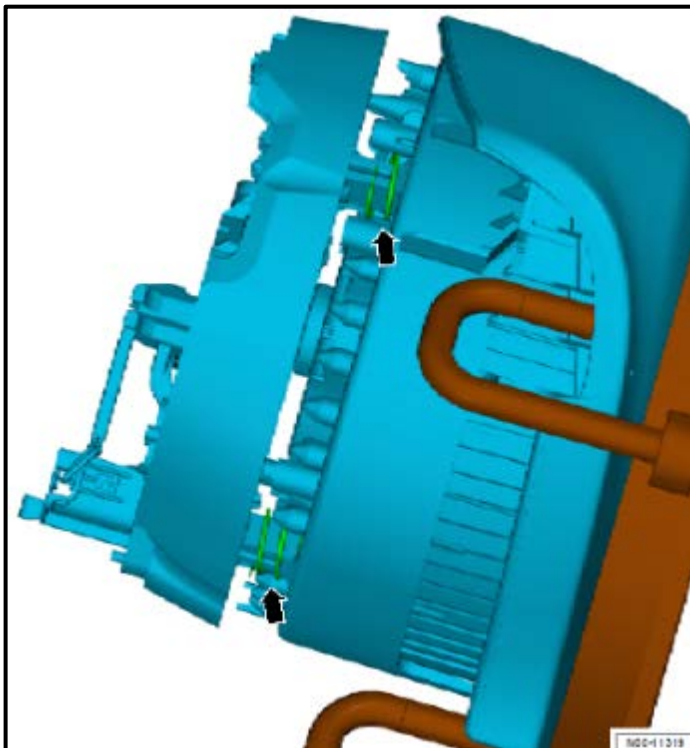
- Position horn ring -arrows- with springs on securing clips and press firmly in place. Ensure that springs are seated correctly on both sides.

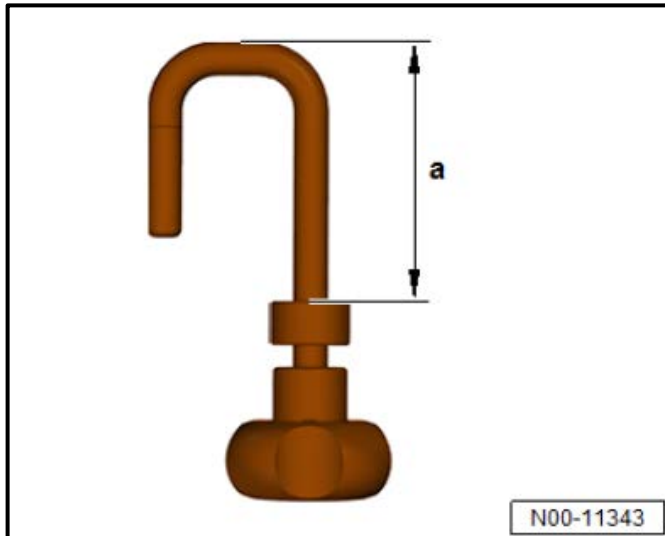
- The three spoke steering wheel has three mounting points.
- Tighten mounting by hand to prevent damage.
- Adjust three knurled nuts of securing hooks to <dimension a> 50mm.

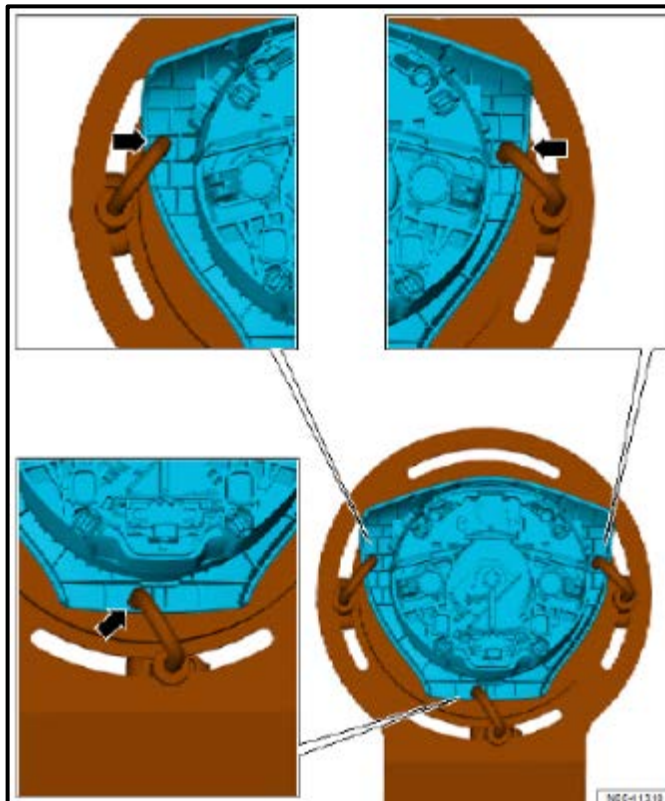
The clamps must be placed in the positions shown <arrows> to prevent damage to the airbag. Damage to the airbag is not covered under this action.

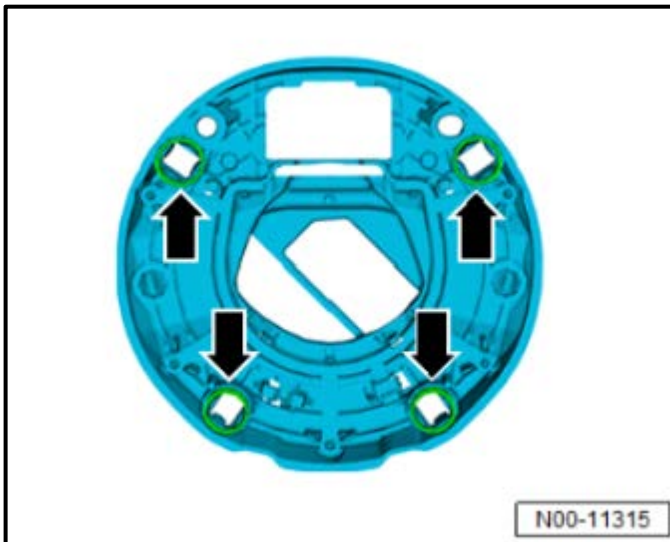
- Remove horn ring with springs <arrows>.

- When removing the horn ring, take care that the springs are not lost as they are not available separately.
- **ONE** replacement spring is included in the inflator kit in the event a spring is lost or damaged.
- If more than one spring is lost, replacement of the airbag is required. Replacement of the airbag is required if a spring is lost and is not covered under this action.

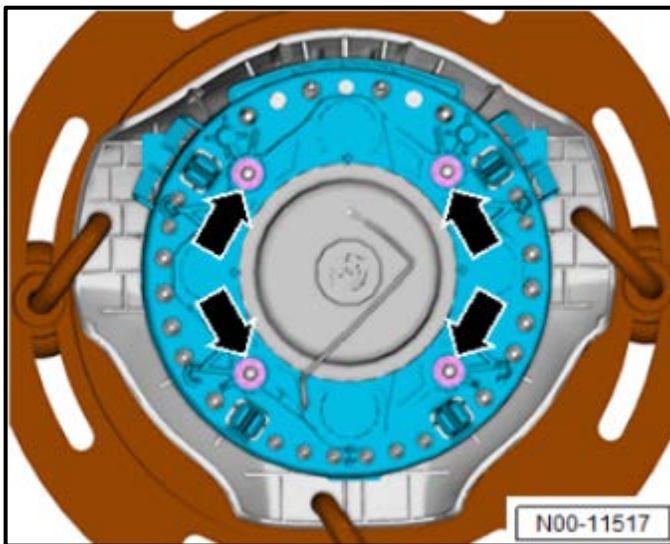
- Remove and discard nuts <arrows>.

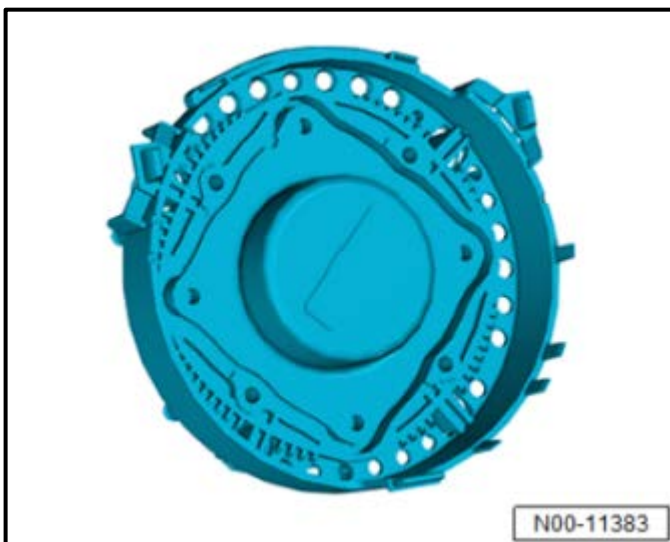
- Remove the inflator and place in the original packaging.

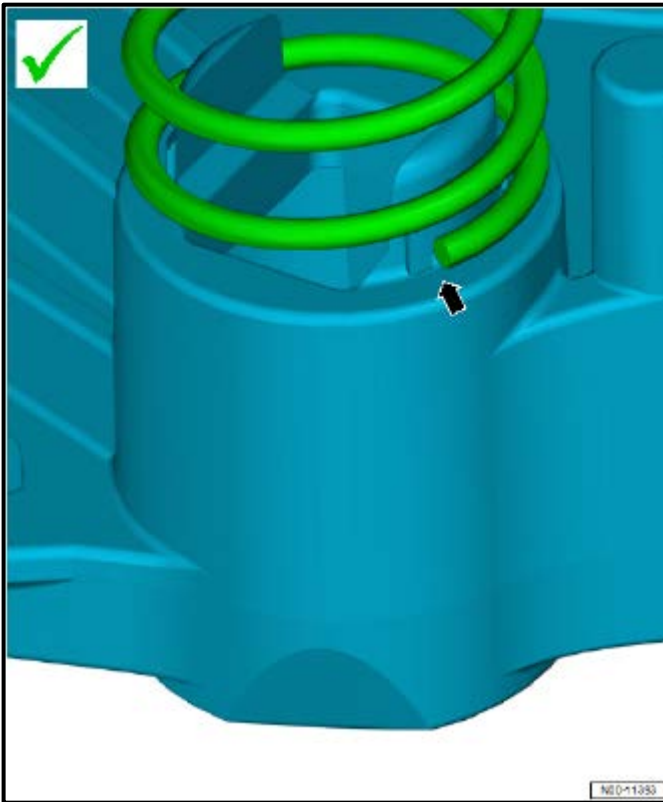
- Spring seated **incorrectly** <arrow>.

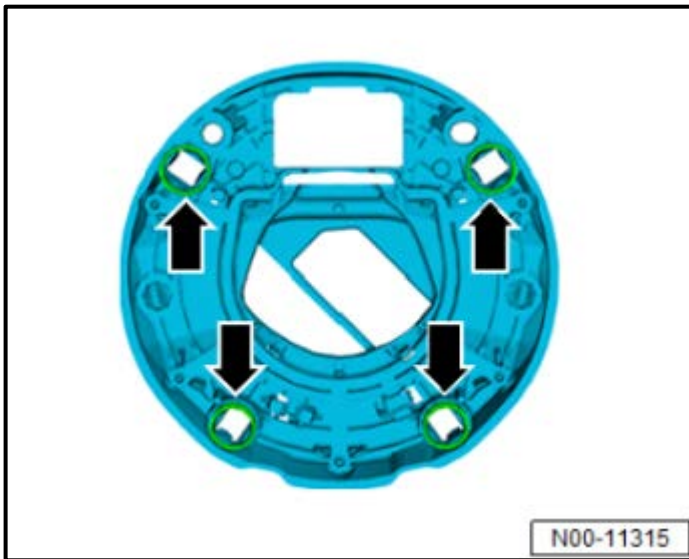
- Fit springs <arrows> for horn ring again and allow to engage audibly.

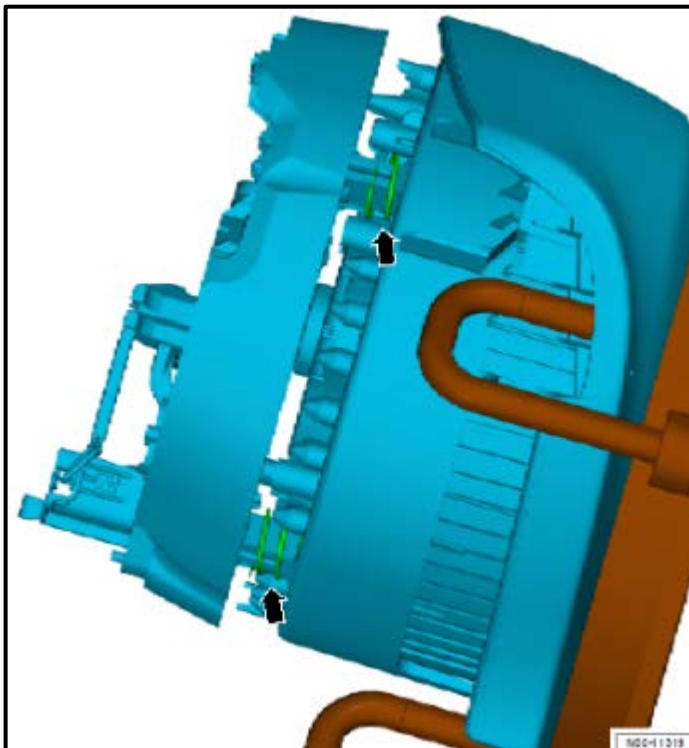
- Position horn ring <arrows> with springs on securing clips and press firmly in place. Ensure that springs are seated correctly on both sides.

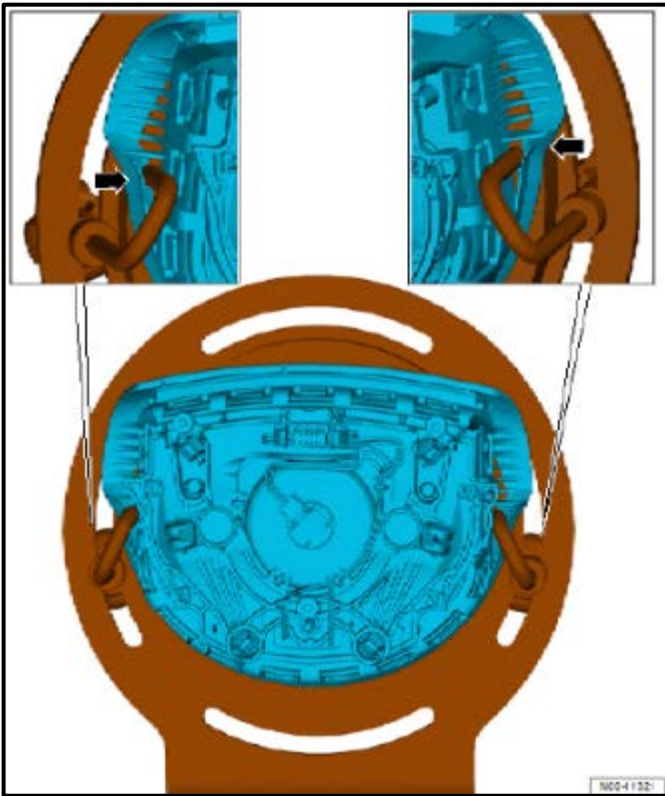
- Clamp airbag centrally in airbag support. Securing points on the sides <arrows> and parallel, opposite each other.

The clamps must be placed in the positions shown <arrows> to prevent damage to the airbag. Damage to the airbag is not covered under this action.

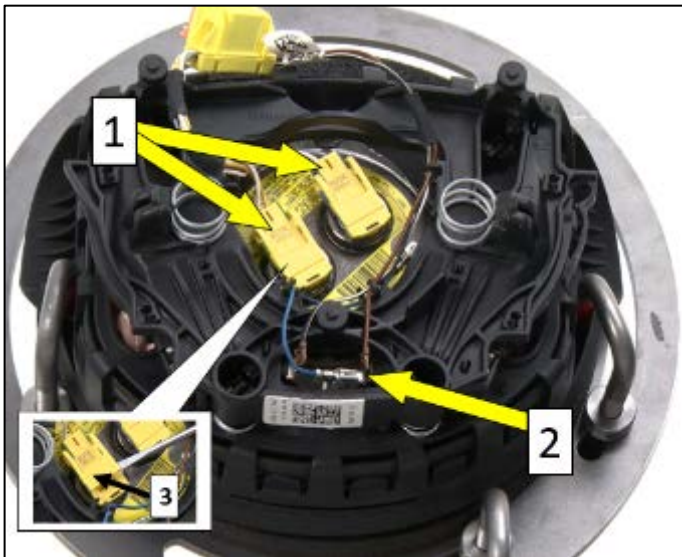
- Remove connector(s) <1> using a small flat bladed screwdriver to disengage connector lock <3>.
- Remove ground cable <2>.

The photo is for reference only. The inflator that is installed may be either a single stage or dual stage inflator.

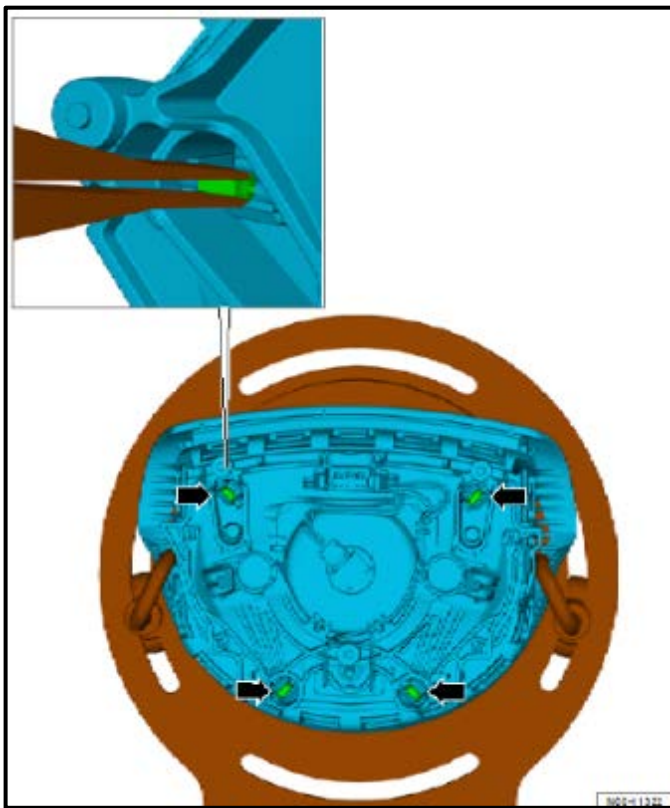
- Remove locking pins <arrows> for horn ring with aid of longnose pliers.

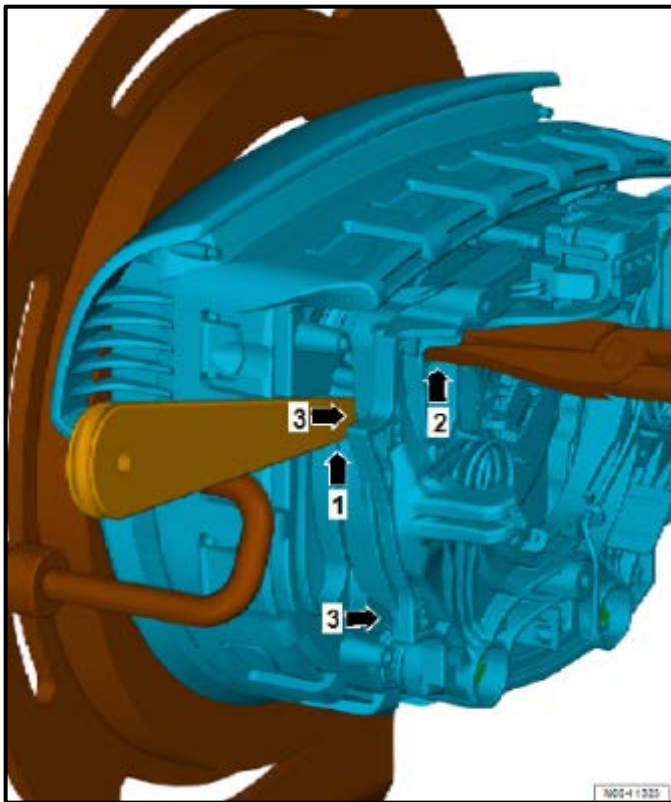
- Apply removal wedge -3409- between horn ring and inflator <1> and press together locking elements using longnose pliers <2>. Lever off horn ring at plastic lugs <3>.

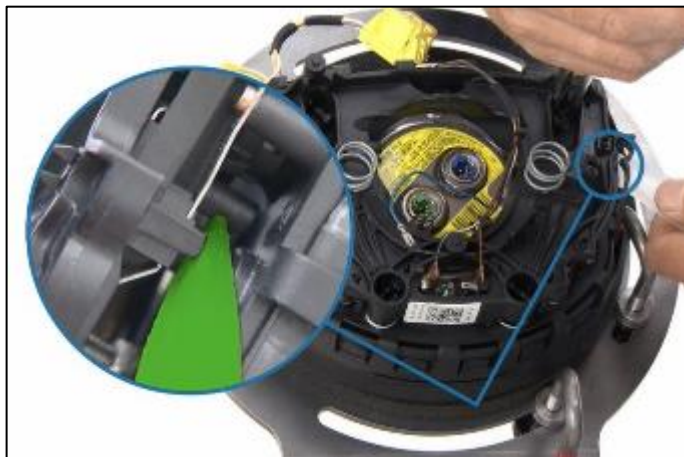
- Position the removal wedge -3409- on the plastic lugs to prevent damage to the conductor strip.
- Insert the removal wedge -3409- between the inflator and horn ring to prevent the horn ring from engaging again.
- Repeat work steps on other side.

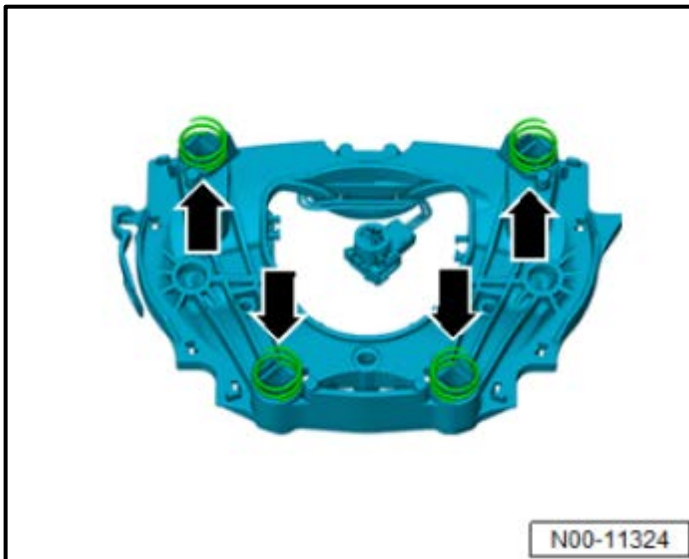
- Remove horn ring with springs <arrows>.

- When removing the horn ring, take care that the springs are not lost as they are not available separately.
- **ONE** replacement spring is included in the inflator kit in the event a spring is lost or damaged.
- If more than one spring is lost, replacement of the airbag is required. Replacement of the airbag is required if a spring is lost and is not covered under this action.

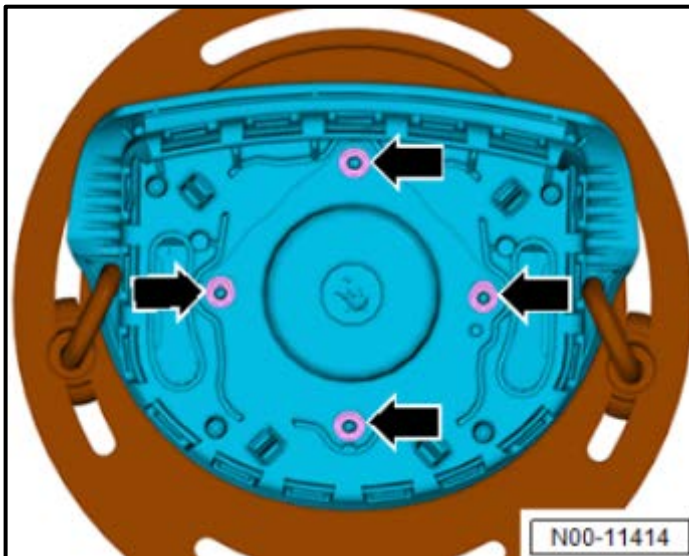
- Remove and discard nuts <arrows>.
- Remove the inflator and place in the original packaging.

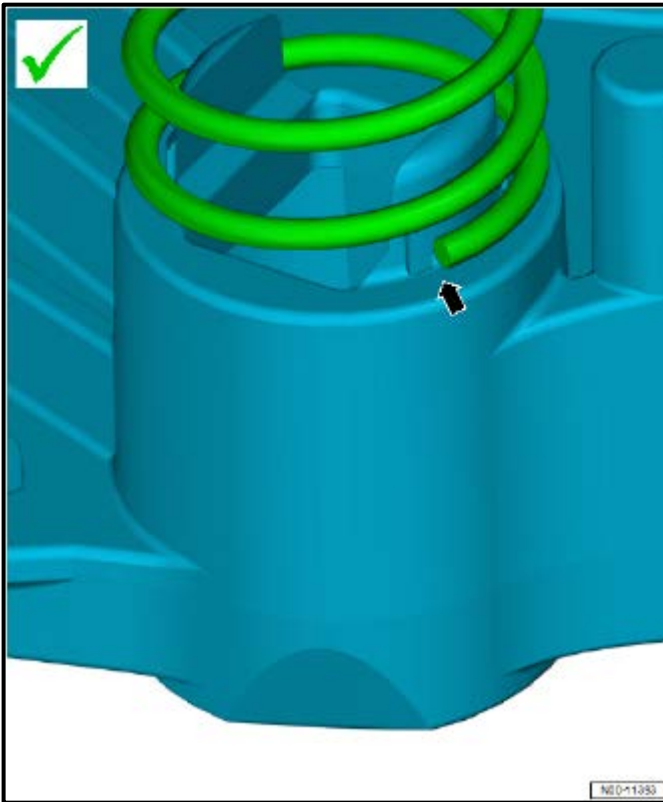
- Spring seated **incorrectly** <arrow>.

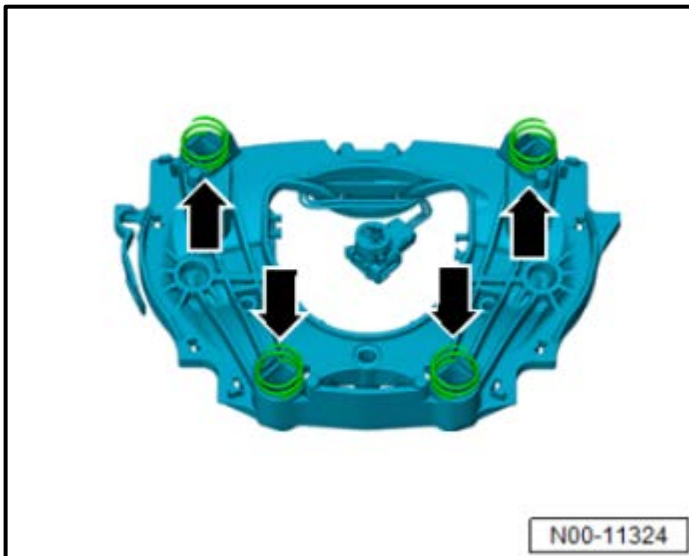
- Fit springs <arrows> for horn ring again if necessary.

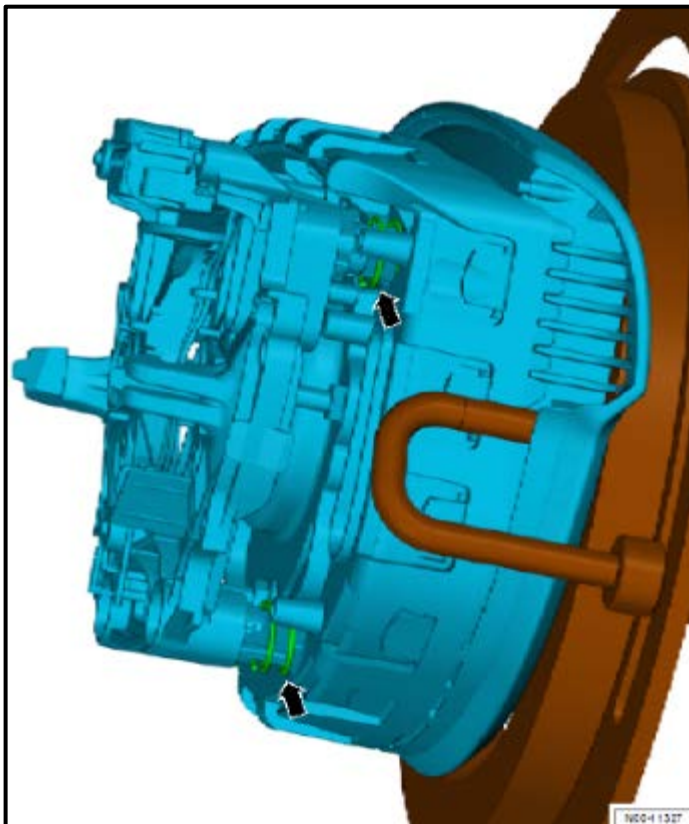
- Position horn ring with springs on securing clips and press firmly in place. Ensure that springs are seated correctly on both sides <arrows>.

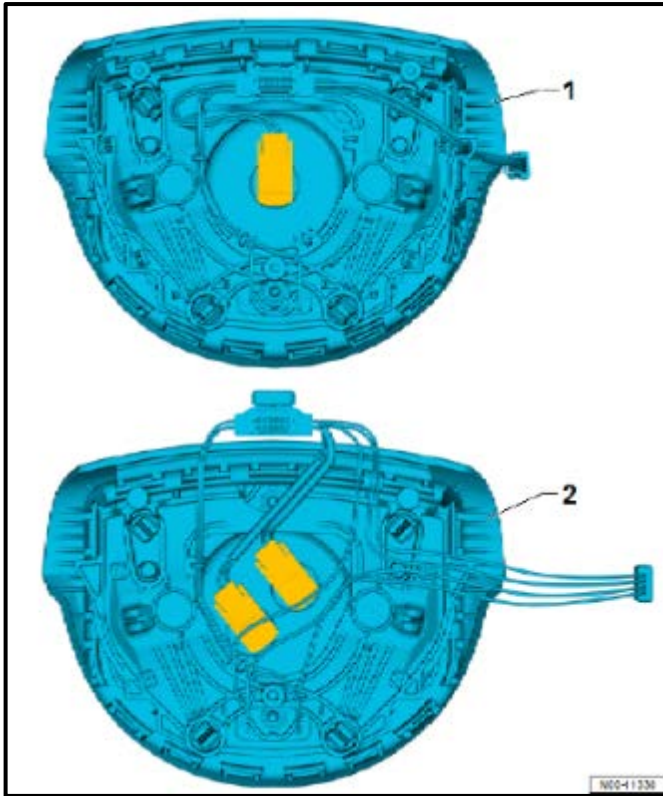
- The inflator comes as a single-stage <1> or two-stage <2> version. The work steps for inflator renewal are the same.
- Tighten mounting by hand to prevent damage.

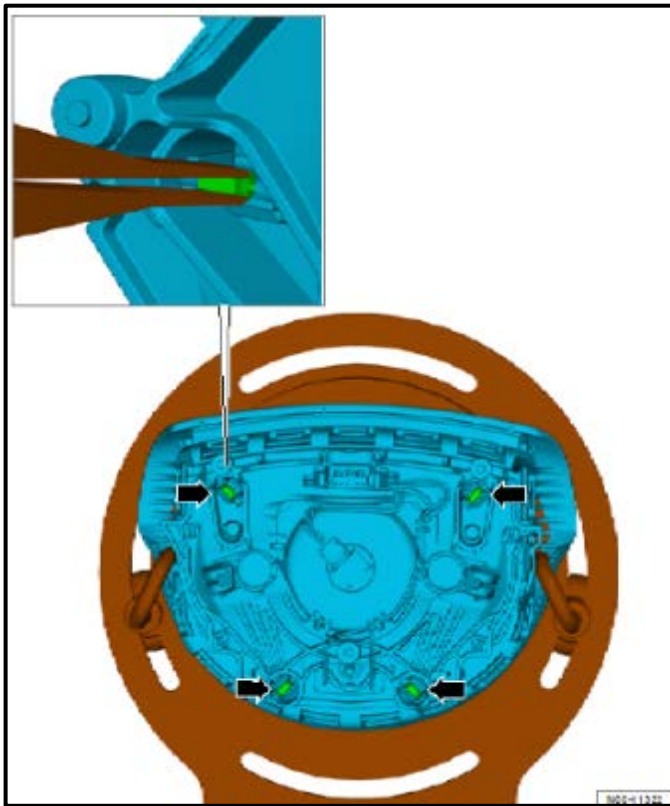
- Remove locking pins <arrows> for horn ring with aid of longnose pliers.

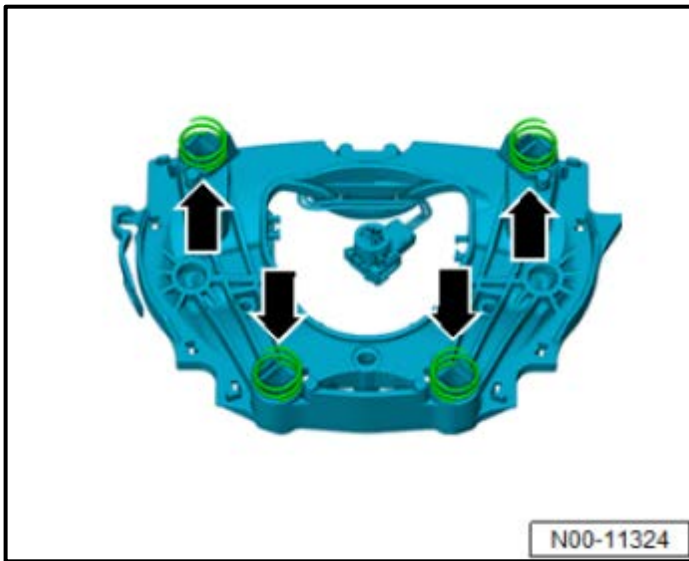
- Remove horn ring with springs <arrows>.

- When removing the horn ring, take care that the springs are not lost as they are not available separately.
- **ONE** replacement spring is included in the inflator kit in the event a spring is lost or damaged.
- If more than one spring is lost, replacement of the airbag is required. Replacement of the airbag is required if a spring is lost and is not covered under this action.

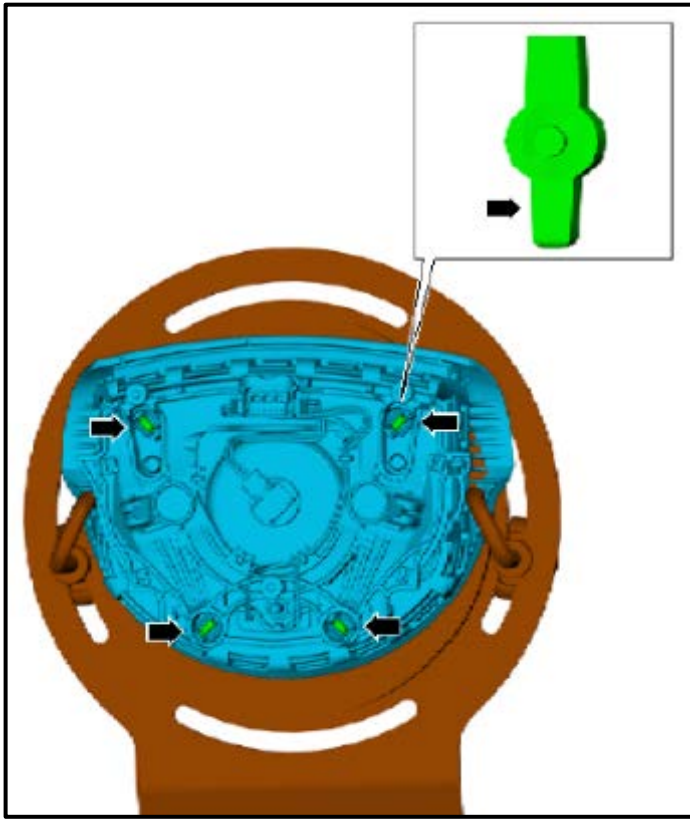
- Using long-nose pliers, insert four locking pins in retaining lugs with narrow side facing downwards <arrow in magnification>. Pins must engage audibly.

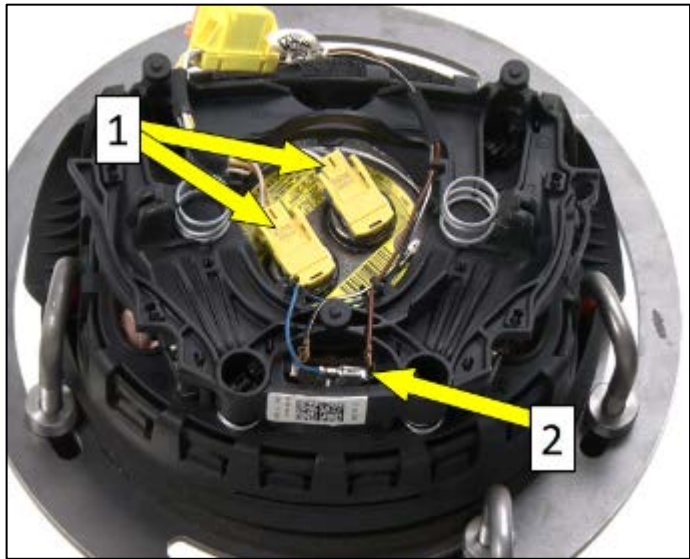
- Connect central connector(s) <1> on inflator.
- Press central connector lock(s) in until fully locked.
- Connect ground cable <2>.

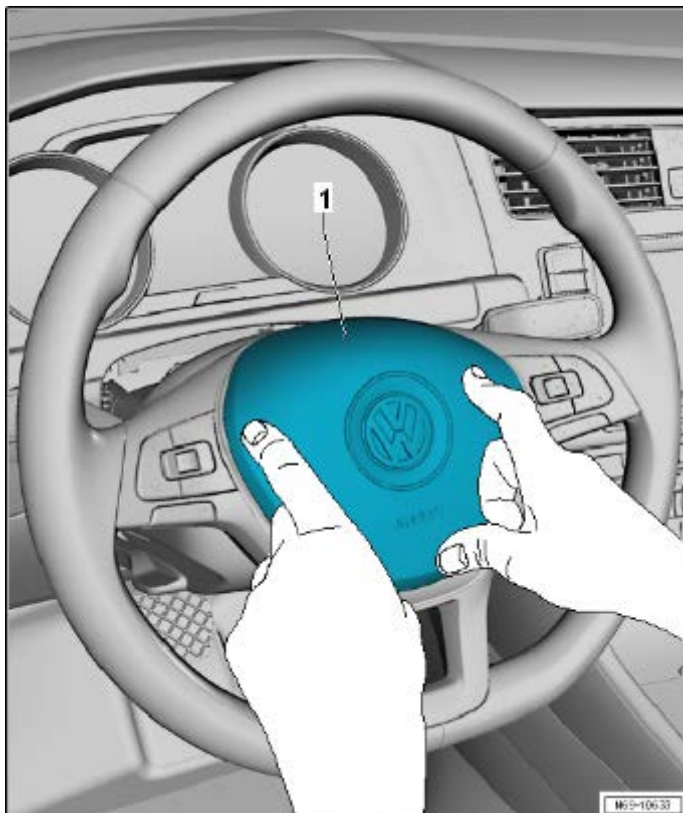
- Press on the edge of the airbag unit <1> with both hands until it locks into place.
- Gently pull on the airbag unit to make sure the airbag unit is secured correctly at all three attachment points in the steering wheel.
