Campaign No. 2019060004, June 2019

SUBJECT: **Model 164, 251, 212**  
**Model Years 2010 - 2012**  
**Replace Driver-Side Airbag**

Based on the defect decision of TK Holdings, Inc. ("Takata"), in certain front driver-side airbags produced by Takata used in certain Model Year 2010-2012 Mercedes-Benz vehicles, under specific circumstances, the front driver-side airbag inflator housing may explode during deployment due to excessive internal pressure. This condition is more likely to occur if the vehicle has been exposed to high levels of absolute humidity for extended periods of time. A front driver-side inflator explosion during deployment could result in metal fragments striking the passenger or other occupants, possibly causing serious injury or death. To remedy this concern, an authorized Mercedes-Benz Dealer will replace the front driver-side airbag on the affected vehicles.

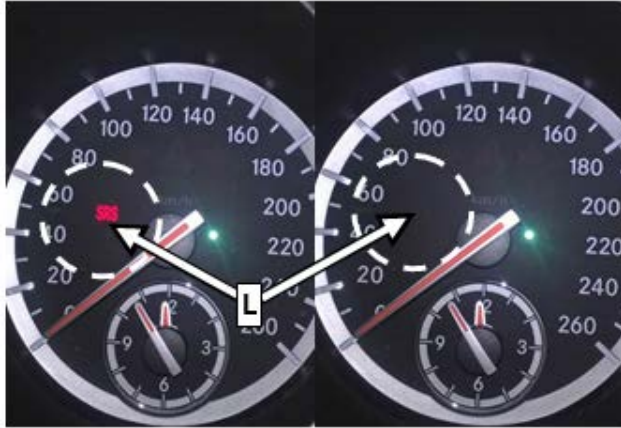
**Figure 1**

Start engine and check whether Supplemental Restraint System (SRS) indicator lamp (**Figure 1**) goes out after a few seconds.

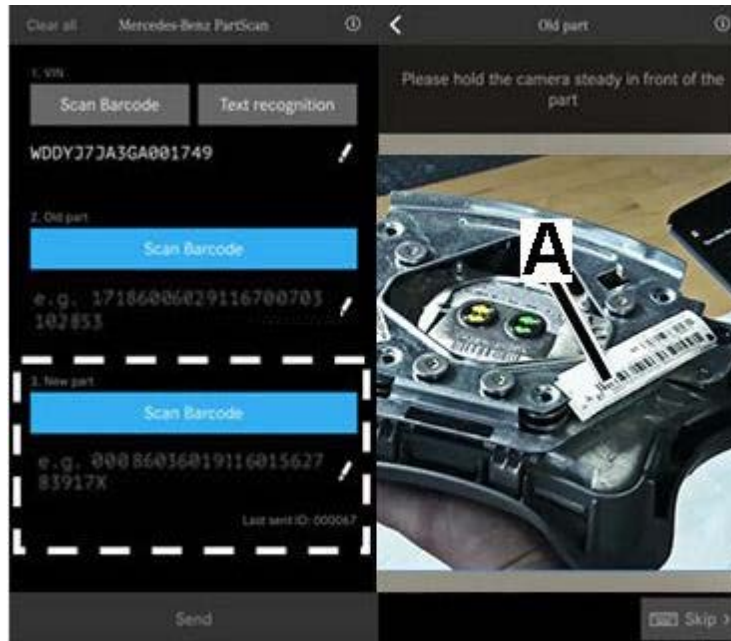
Figure 3

7. Scan bar code from "new" airbag immediately after packaging "old" airbag

- i** Please ensure that the lower barcode (**A, figure 5**) is scanned.
- i** All required data can also be entered manually if required.

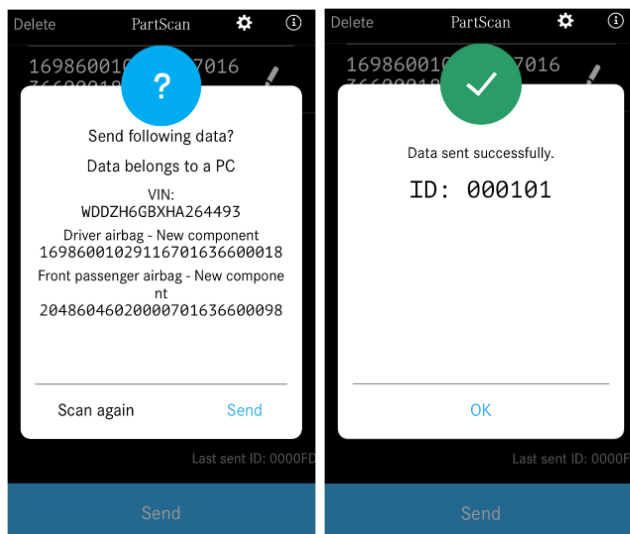
Figure 6

8. Create a scan ID via the "Send" button (figure 6).

**i** The generated scan ID (figure 7) must be recorded in writing on the work order.

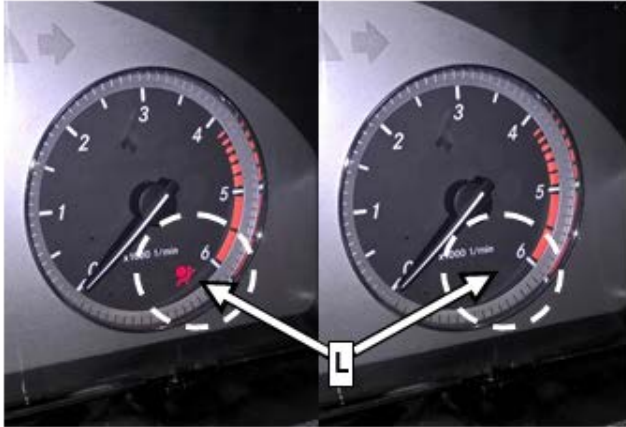
**Figure 8**

**11.** Start engine and check whether Supplemental Restraint System (SRS) indicator lamp (**Figure 8/9**) goes out after a few seconds.
