## RECALL REPAIR PROCEDURE

<b>SST Barrier Reinforcement</b>		<b>Recall 16V-085</b> Page - 1 - of 4	
<b>BY:</b> Timothy Downey	<b>DEPARTMENT:</b> Quality Control	<b>DATE:</b> 07/21/2016	<b>REVISION:</b> A

In the event of an accident, the barrier located behind the driver's seat may not deform according to the regulations listed within Code of Federal Regulations; Federal Motor Vehicle Safety Standard 571.222.

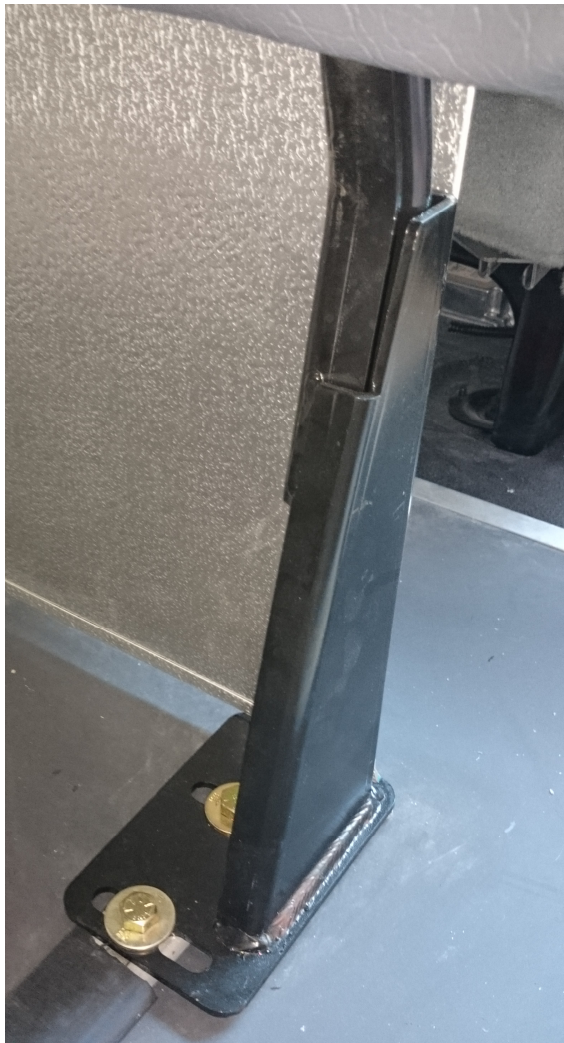
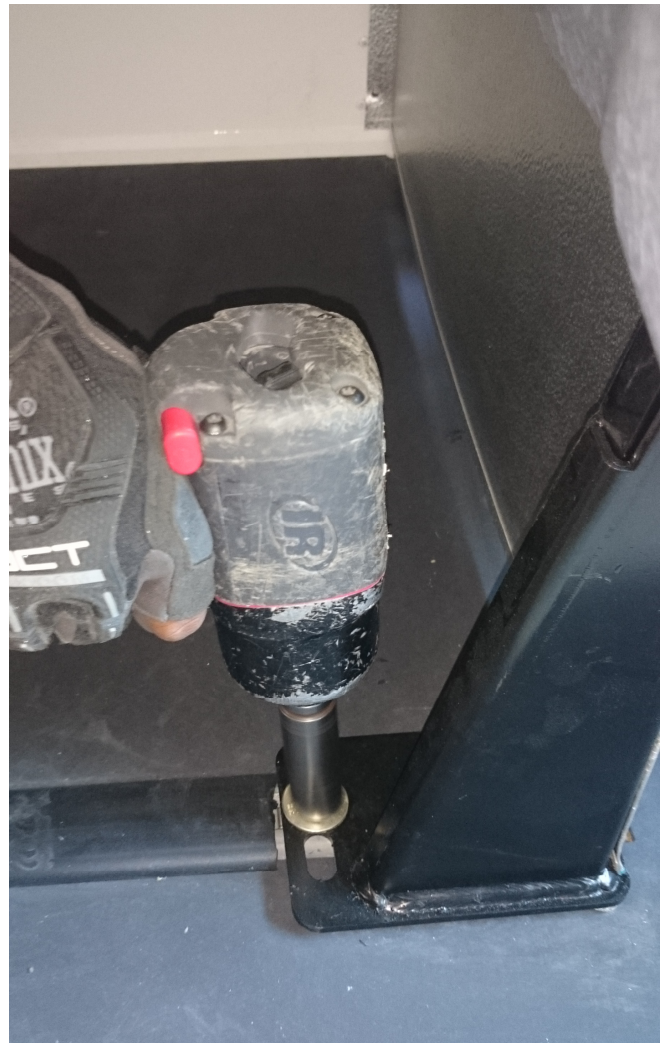
1. Begin by identifying the vehicle in need of the Recall.
2. Using the Impact gun and 5/8" socket, loosen the rear bolt in the barrier leg, and remove it. Save this component for reuse during the re-assembly stage.

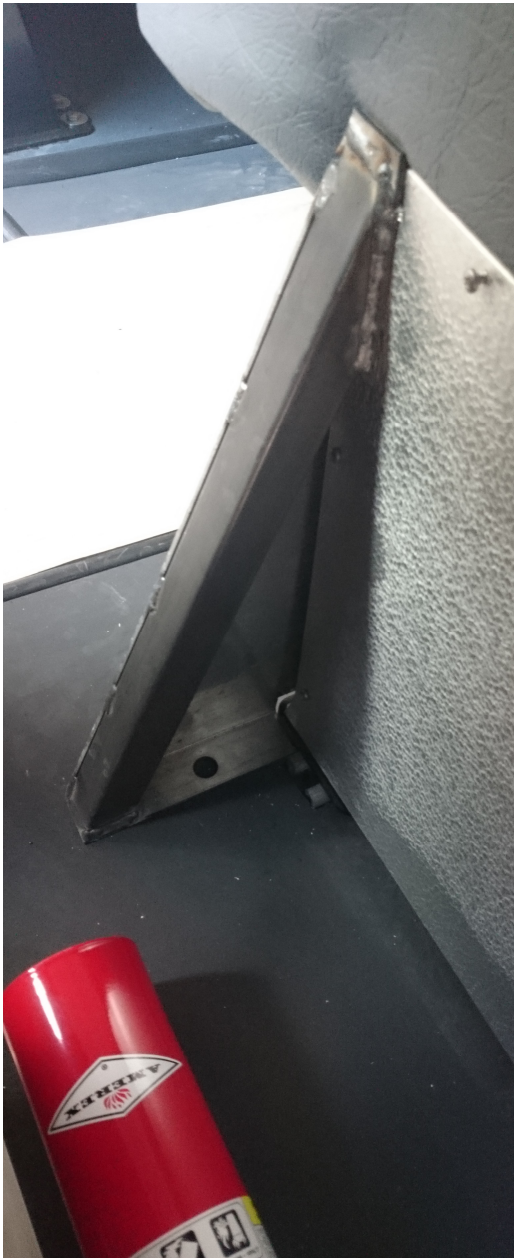
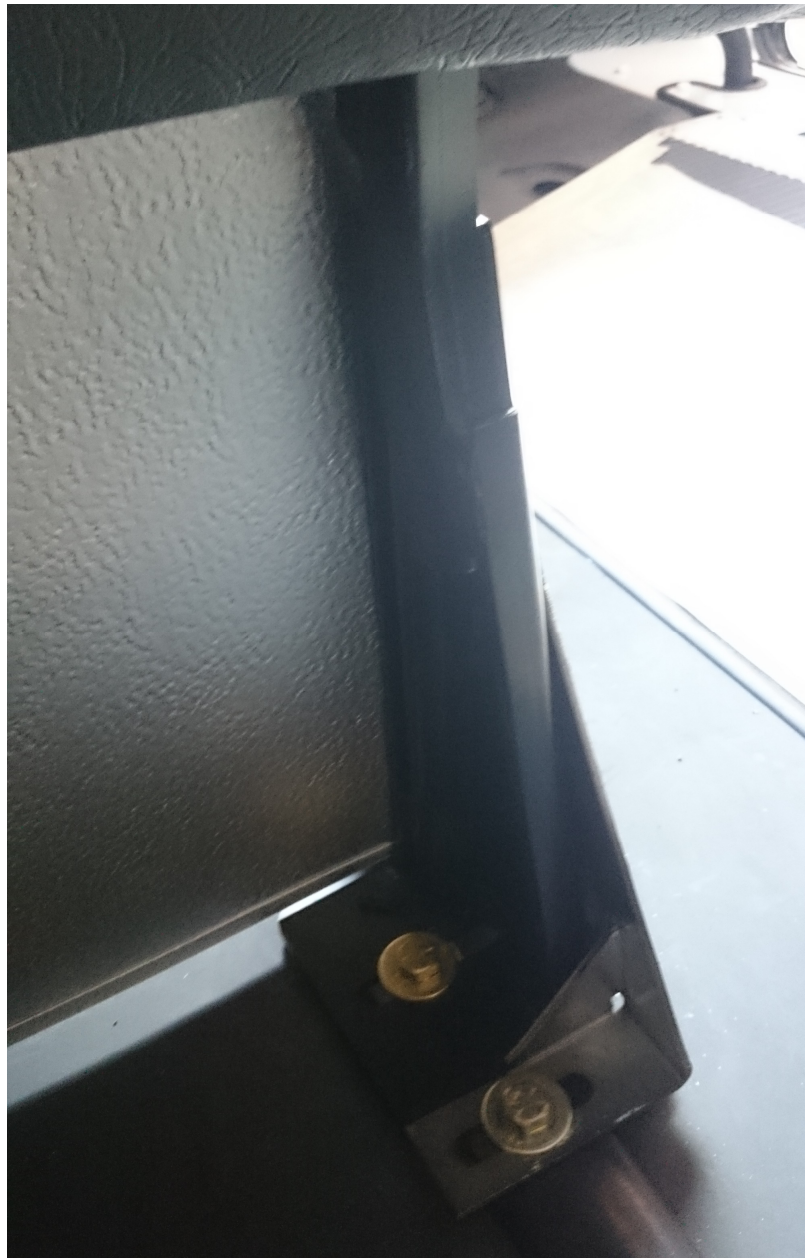
3. Take Trans Tech Bus provided reinforcement and lay the component over the exterior leg of the barrier. Use pictures below for visual reference.

4. The reinforcement may be a tight fit for some users because of a difference in padding thicknesses around the frame. The photos included in this procedure are shown to provide reference images from all angles of installation.

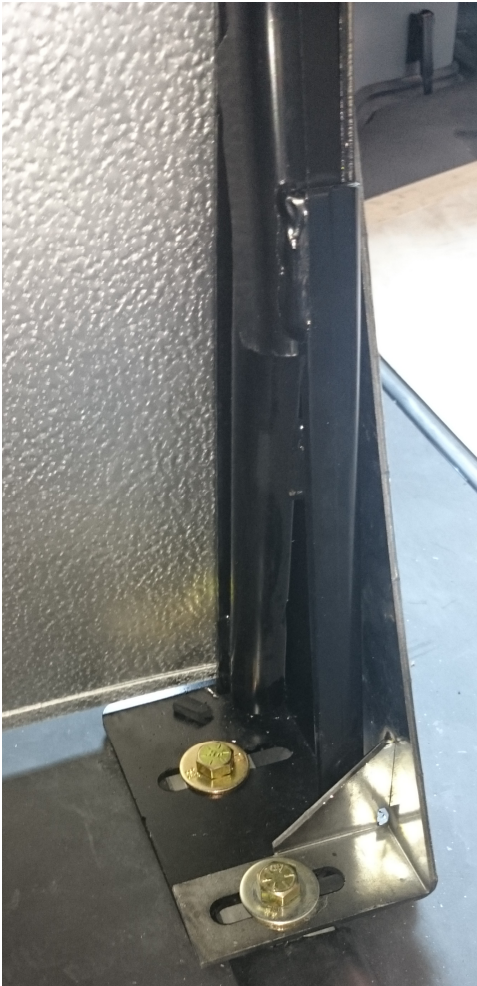
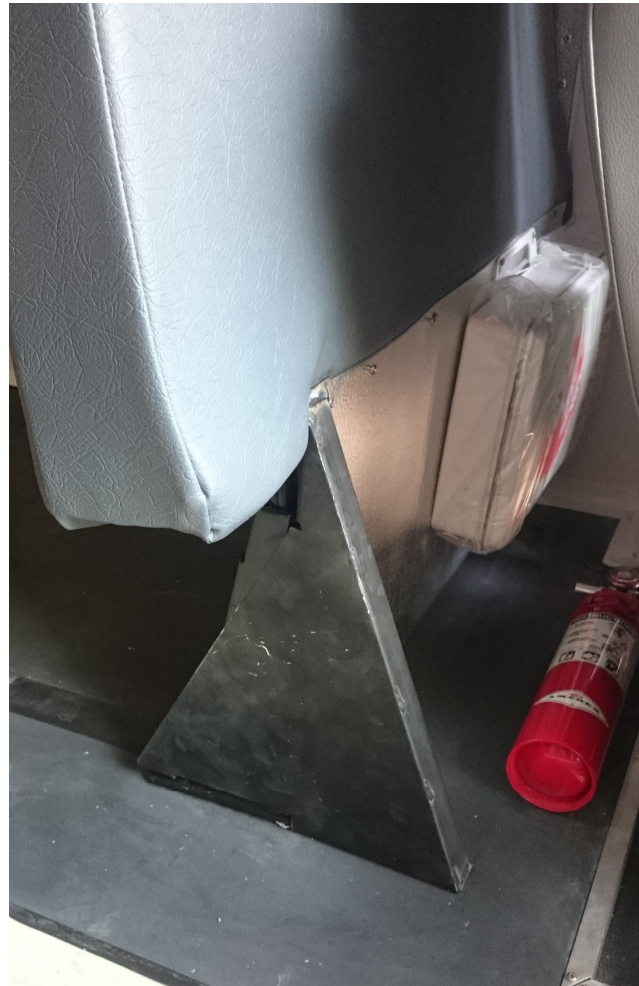
4. Using the Impact gun, and 5/8" Socket, reinstall the included bolt into the insert located in the slide-track. This is a critical stage of installation and must be performed and then tested with a dial torque.
5. Taking a dial torque wrench, set the instrument to 65 ft-lbs. and test the value at the bolt. If the bolt does not meet this minimum, take your impact gun and reapply the tightening process until this value is obtained.
6. Clear the area and ensure that all installation materials and tools are removed from the vehicle.
7. Return the vehicle to service.
