TECHNICAL INSTRUCTIONS

SAFETY RECALL DSF and E04

FRONT PASSENGER AIRBAG “MODULE” REPLACEMENT ONLY

CERTAIN 2003 – 2008 MODEL YEAR MATRIX

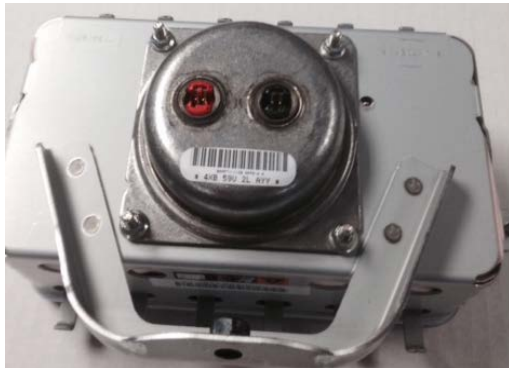
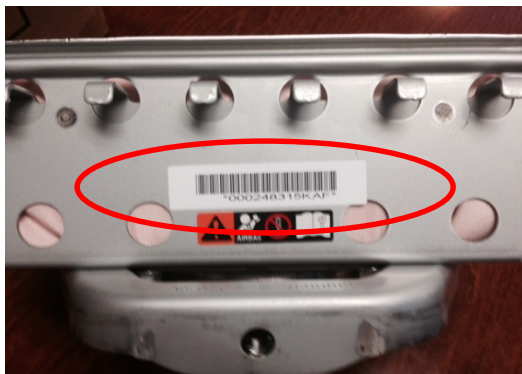
- Because this new part is a complete airbag assembly with a different style inflator installed, **you do not need to record the old or new inflator serial numbers.**

- The New 12 digit Airbag Serial number on the side of the assembly will need to be recorded
- To record the new Airbag Serial number, in the scanning application you will need to **check the box indicating the old Inflator serial number is not readable or missing.** This will take you to the screen that allows you to enter the new airbag serial number.
Go to step C on page 10

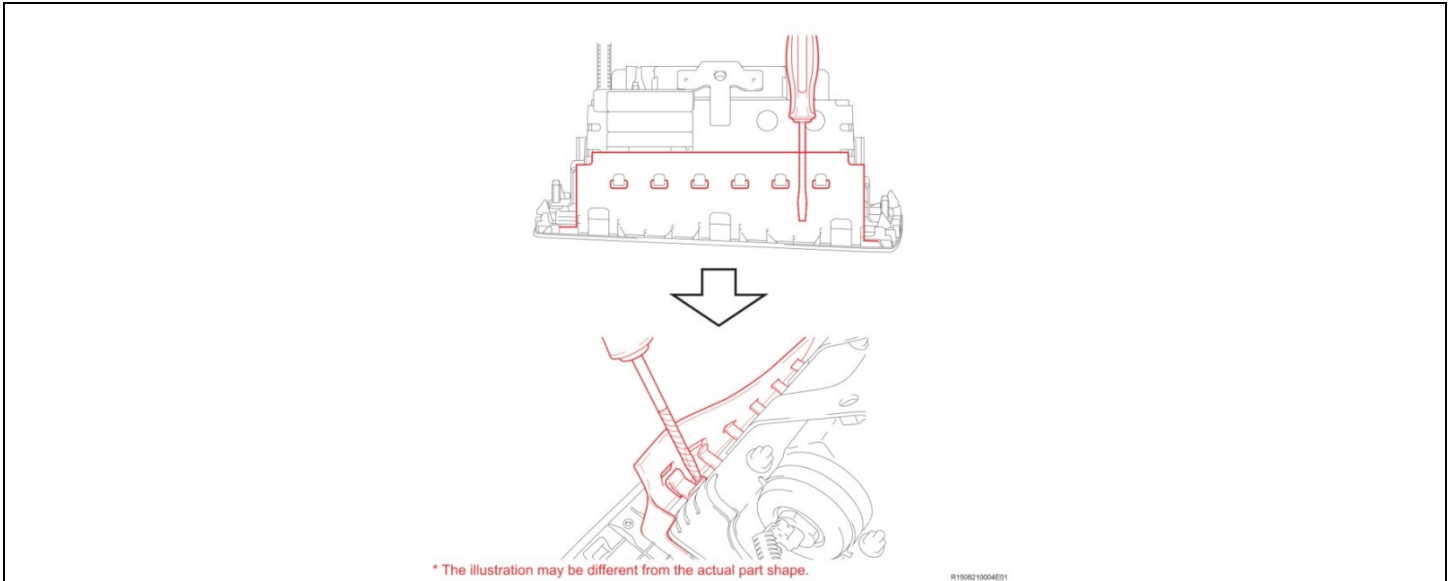
- a) Gently insert the screwdriver between the airbag door and module and disengage the claws holding the door to the module. Please refer to the video below.

- b) After all the claws have been disengaged separate the module from the door.
- c) Mark the old module so it is not reused.
- d) Inspect the door for damage to the mounting slots.
