## TECHNICAL INSTRUCTIONS

### SAFETY RECALL DSF and E04

### FRONT PASSENGER AIRBAG “MODULE” REPLACEMENT ONLY

### CERTAIN 2003 – 2008 MODEL YEAR MATRIX

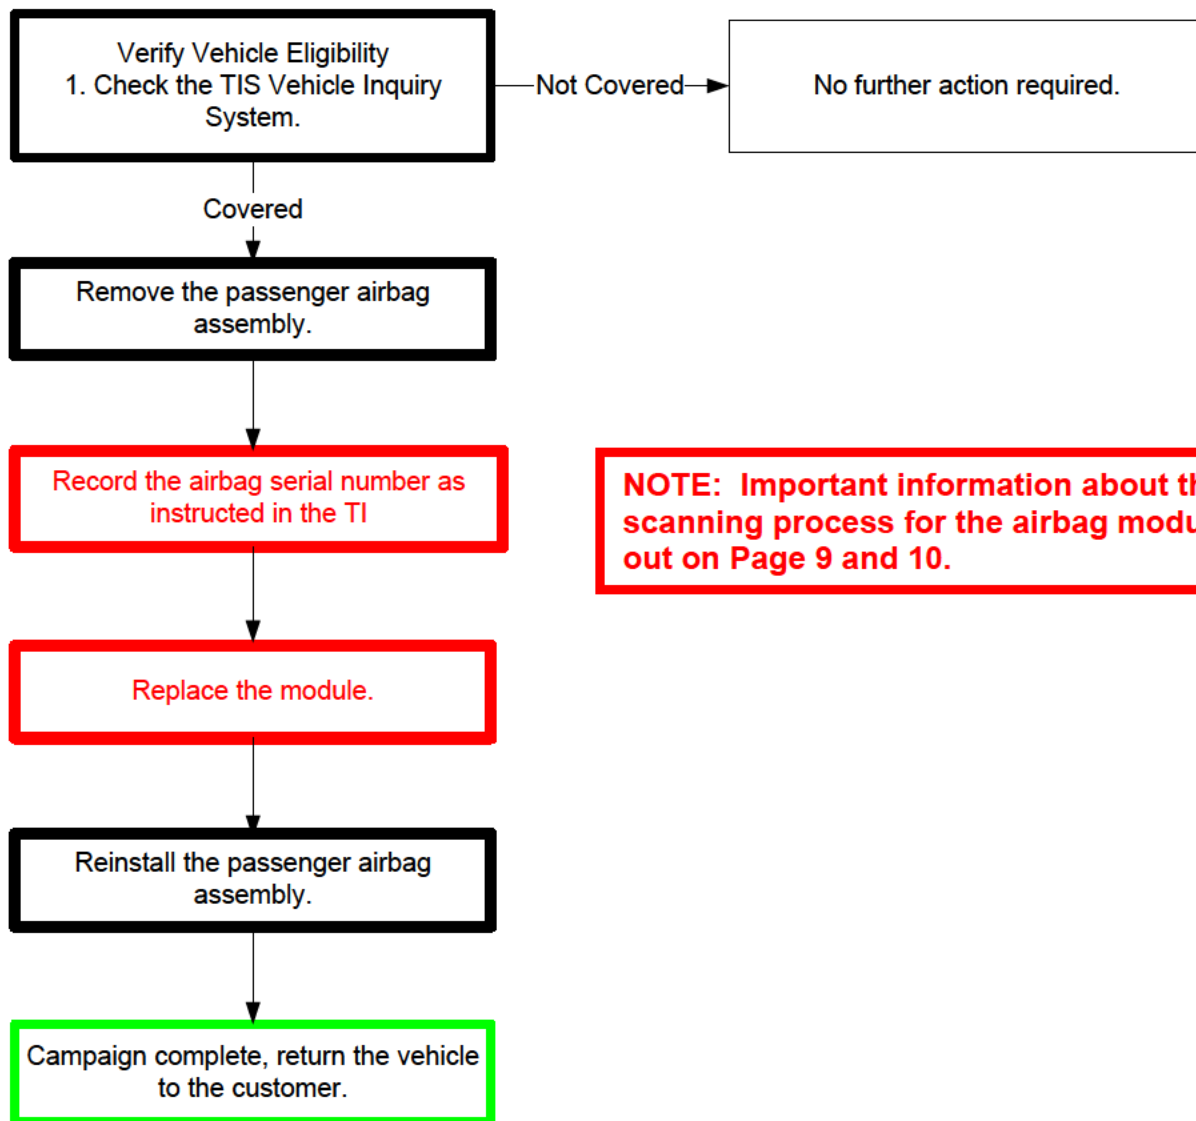
## I. OPERATION FLOW CHART

The flow chart is for reference only. **DO NOT** use it in place of the full technical instructions. Follow **ALL** steps as outlined in the full technical instructions to confirm the campaign is completed correctly.

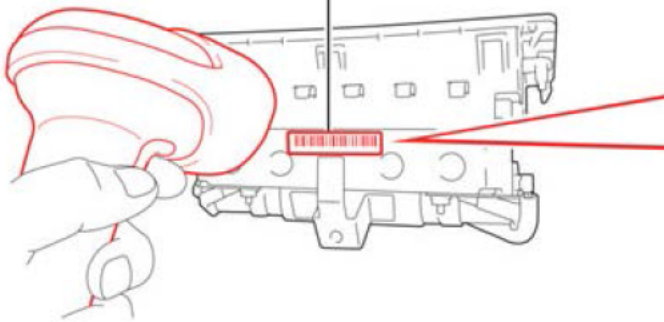
### Airbag Serial Number Label Example

### AIRBAG SERIAL NUMBER IDENTIFICATION

- The airbag serial number is **ALWAYS** the 12 **DIGITS** located between the asterisks.
- The 3 digits before the asterisk **ARE NOT** part of the serial number, and **SHOULD NOT** be entered or an inaccurate response may be returned.

The **AIRBAG ASSEMBLY** serial number **MUST** be recorded prior to replacement.
