SAFETY RECALL DSF and E04

FRONT PASSENGER AIRBAG “MODULE” REPLACEMENT ONLY

CERTAIN 2003 – 2008 MODEL YEAR MATRIX

Updated 03-10-16

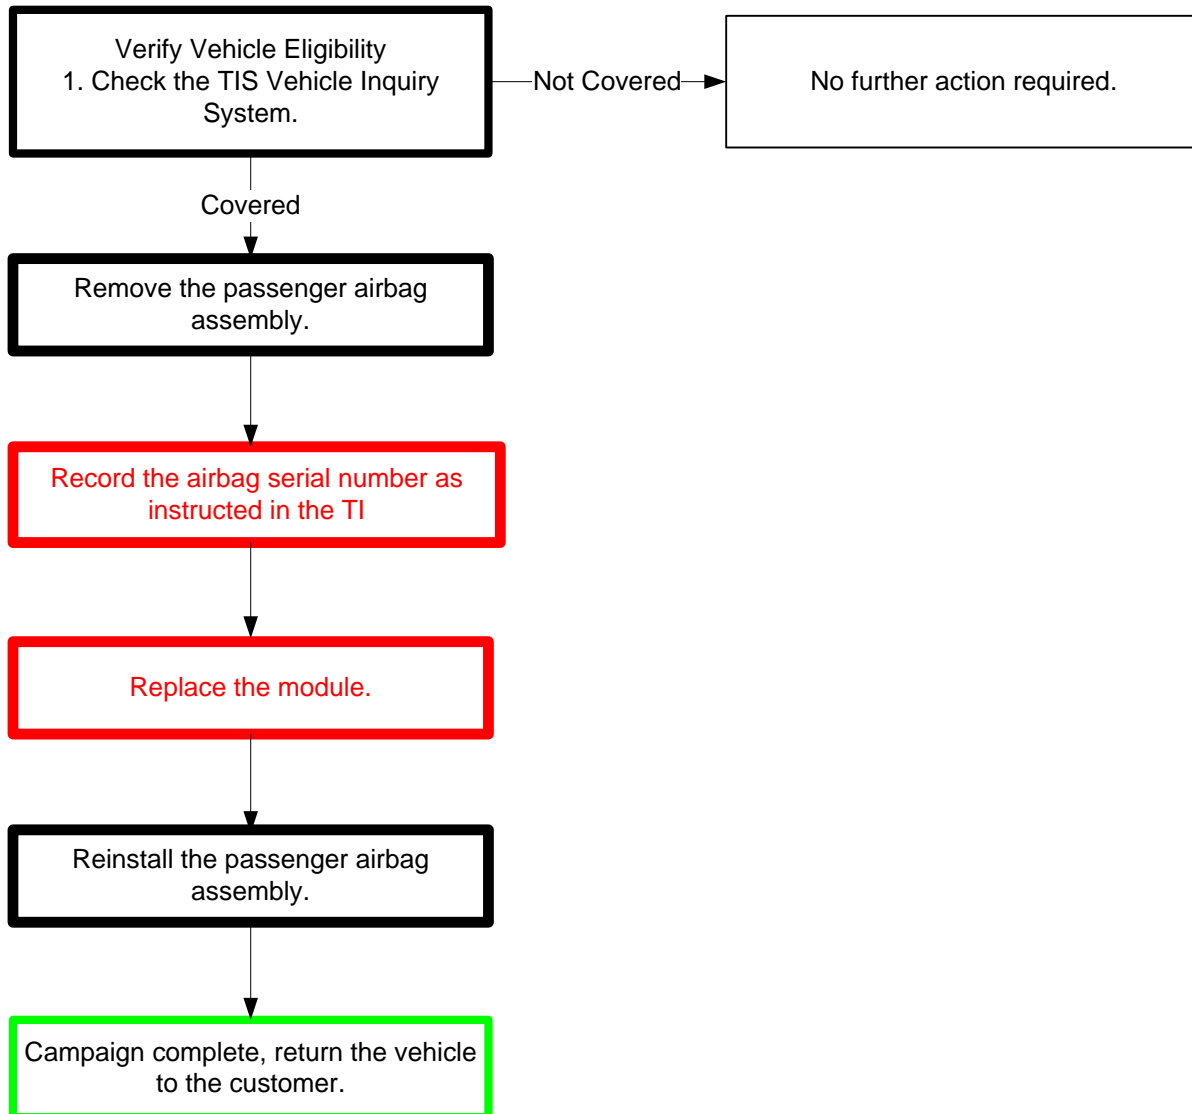
I. OPERATION FLOW CHART

The flow chart is for reference only. **DO NOT** use it in place of the full technical instructions. Follow **ALL** steps as outlined in the full technical instructions to confirm the campaign is completed correctly.

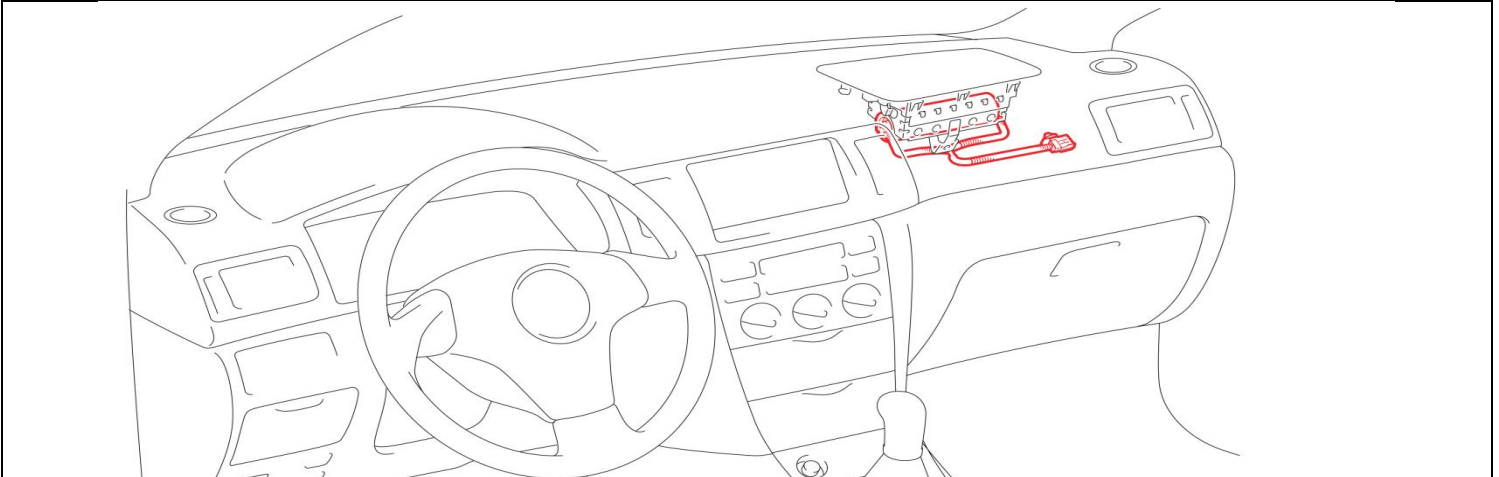
II. BACKGROUND

The subject vehicles are equipped with front passenger airbag inflators which may have been manufactured in such a way as to have a potential for the intrusion of moisture over time. Depending on the circumstances, this could create excessive internal pressure when the airbag is deployed and cause the inflator to rupture. In the event of an inflator rupture, metal fragments could pass through the airbag cushion material, striking the vehicle occupants and potentially resulting in serious injury or death.

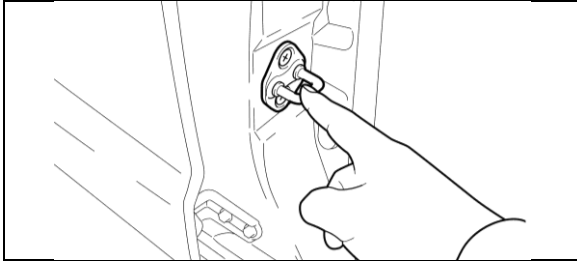
1. ELIMINATE STATIC ELECTRICITY

- Before starting work and periodically while working on the vehicle, touch a metallic part of the vehicle to discharge static electricity in the body.

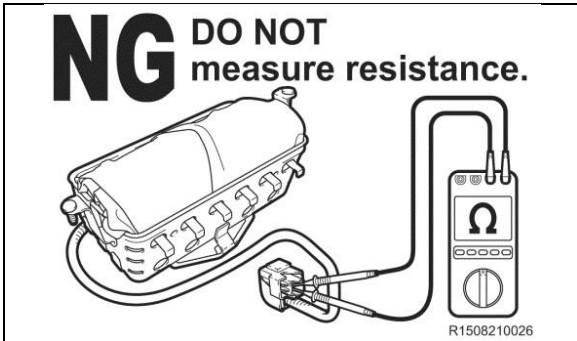
2. DO NOT MEASURE RESISTANCE

- DO NOT** measure resistance of airbag components, this may cause accidental activation.

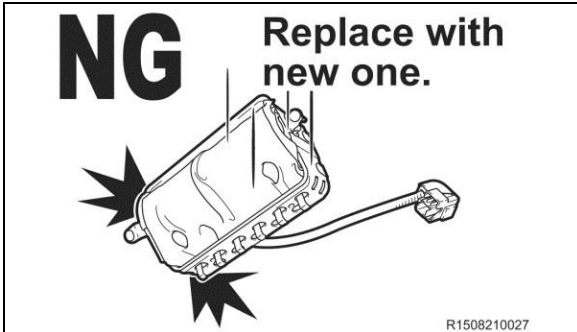
3. HANDLE THE AIRBAG CAREFULLY

- If an inflator is dropped, replace it with a **NEW** inflator.

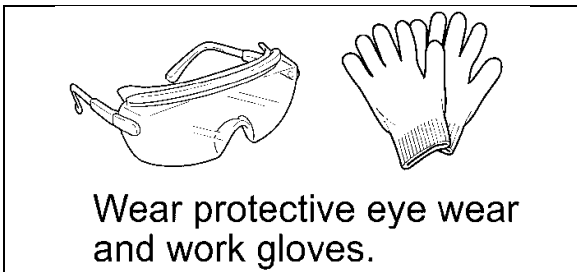
4. WEAR PROTECTIVE EQUIPMENT

- Always wear appropriate protective equipment when working on the SRS.

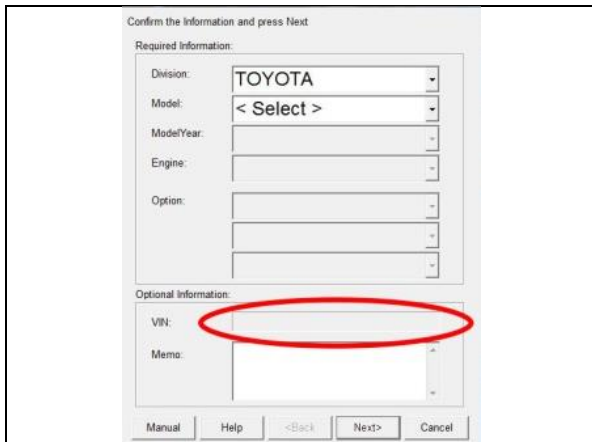
1. PERFORM A HEALTH CHECK

- Confirm the Techstream is connected to the dealership's internet.
- When launching the Techstream software the VIN **MUST** be entered manually.

NOTE: All letters of the VIN *MUST* be entered in ALL CAPS, or the VIN will need to be reentered when running the diagnostic report.

- Perform a health check.

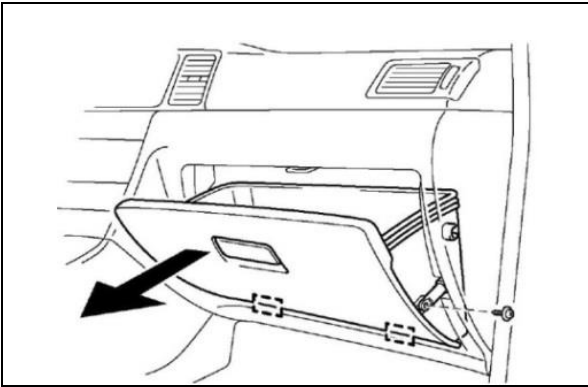
2. REMOVE THE GLOVE BOX

- Open the glove box door.
- Press in on both sides of the door and swing it down to remove it from the vehicle.

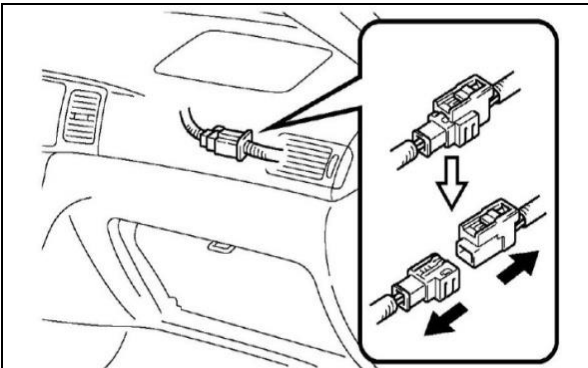
3. REMOVE THE AIRBAG ASSEMBLY

- Disconnect the negative battery cable.

- Wait at least 90 seconds after disconnecting the cable from the negative battery terminal to prevent airbag and seat belt pre-tensioner deployment.
- Follow all precautions as outlined on TIS before servicing the SRS system.

- Disconnect the airbag connector.

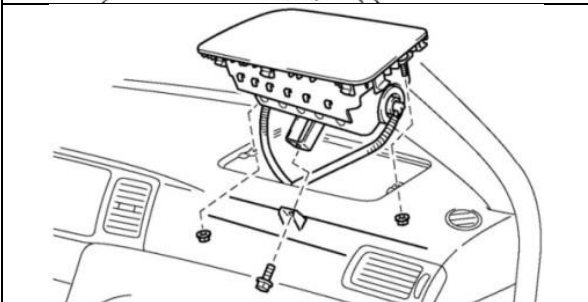
4. REMOVE THE FRONT PASSENGER AIRBAG

- Remove the 2 nuts and release the 6 clips.
- Remove the airbag assembly.

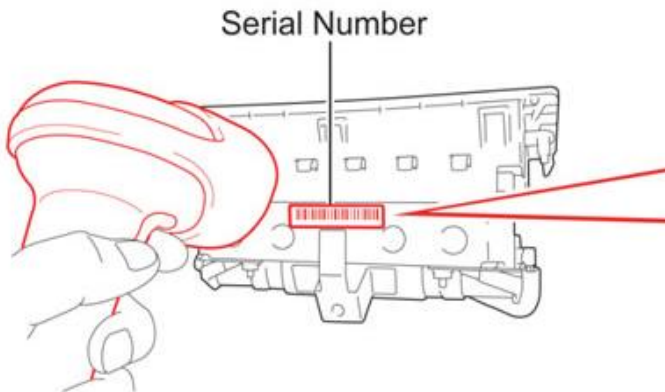
Airbag Serial Number Label Example

- The airbag serial number is **ALWAYS** the 12 **DIGITS** located between the asterisks.
- The 3 digits before the asterisk **ARE NOT** part of the serial number, and **SHOULD NOT** be entered or an inaccurate response may be returned.

The **AIRBAG ASSEMBLY** serial number **MUST** be recorded prior to replacement.

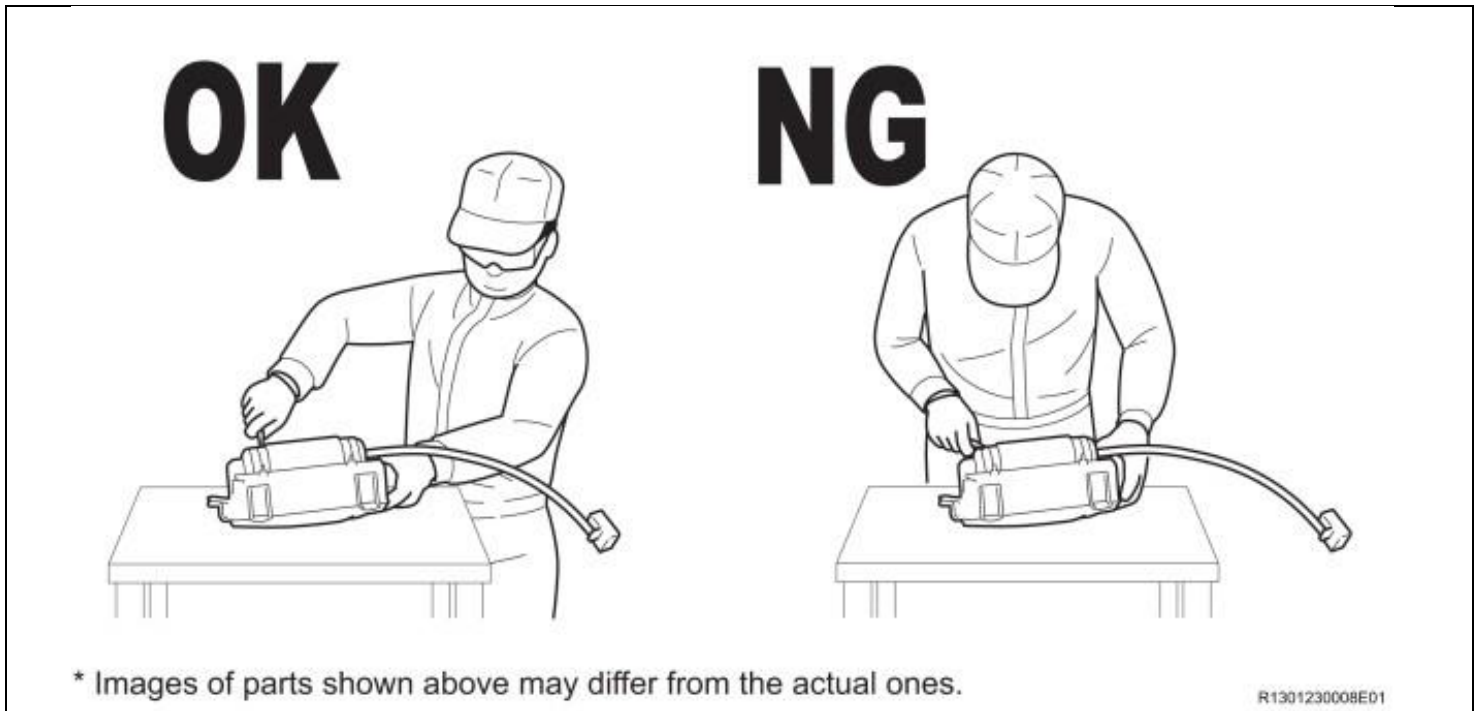
1. WORKING WITH AIRBAG

- a) Carefully place the airbag on the bench inflator side up.

NOTE: Place clean sheet(s) of paper on the bench to protect the airbag.

- b) Avoid standing directly over the inflator.

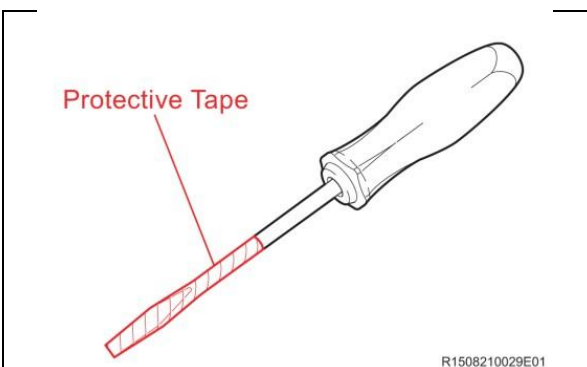
2. TOOL PREPARATION

- a) Wrap a screwdriver with tape.

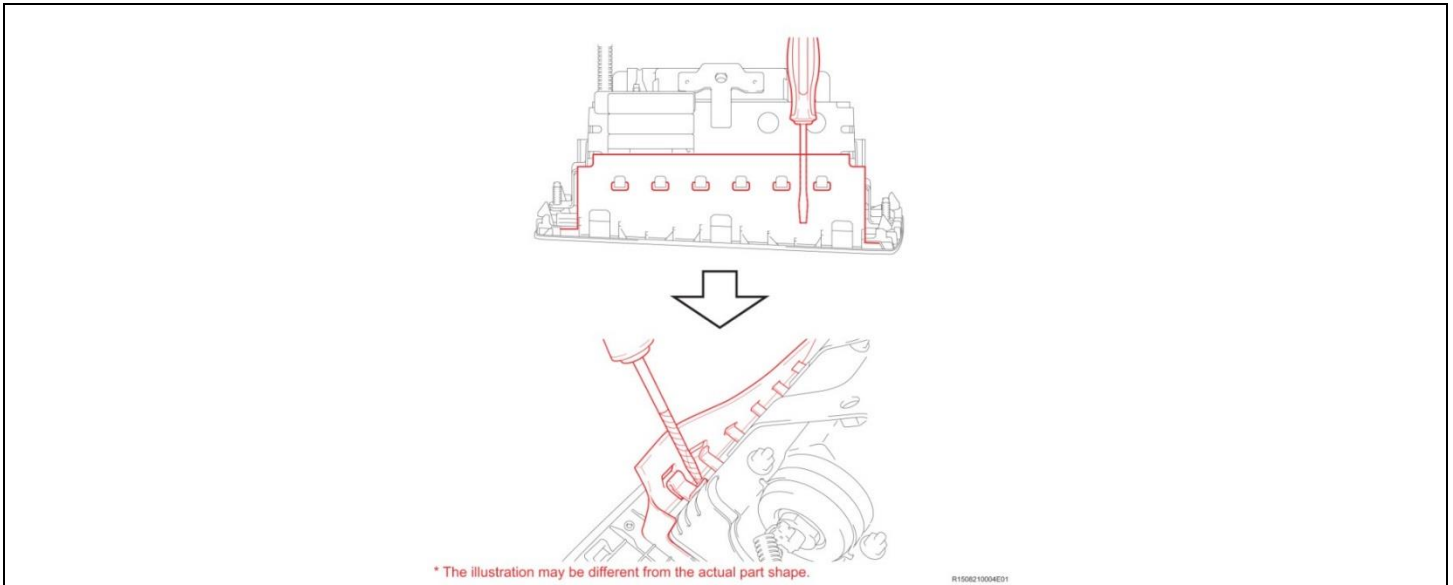
3. REMOVE THE COVER

- a) Gently insert the screwdriver between the airbag door and module and disengage the claws holding the door to the module. Please refer to the video below.

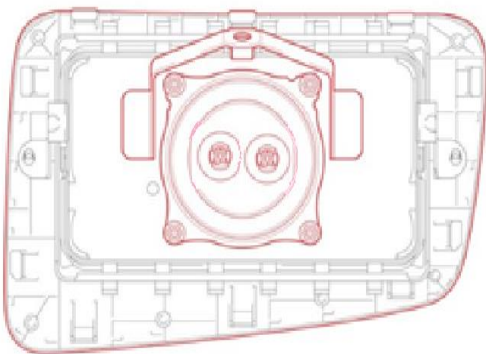
- b) After all the claws have been disengaged separate the module from the door.
- c) Mark the old module so it is not reused.
- d) Inspect the door for damage to the mounting slots.

Take care not to mistake the mounting direction.

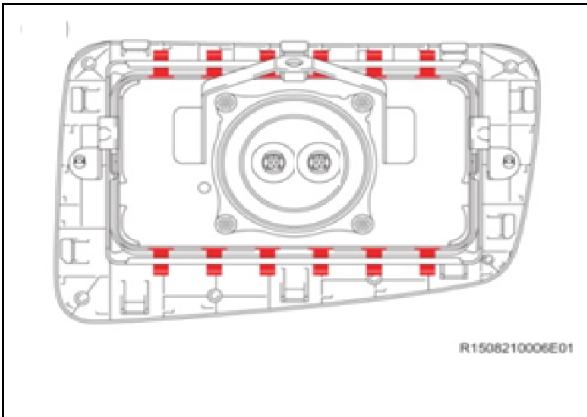
4. INSTALL THE NEW MODULE

- a) Carefully slide the new module into the airbag door.

NOTE: Mounting direction.

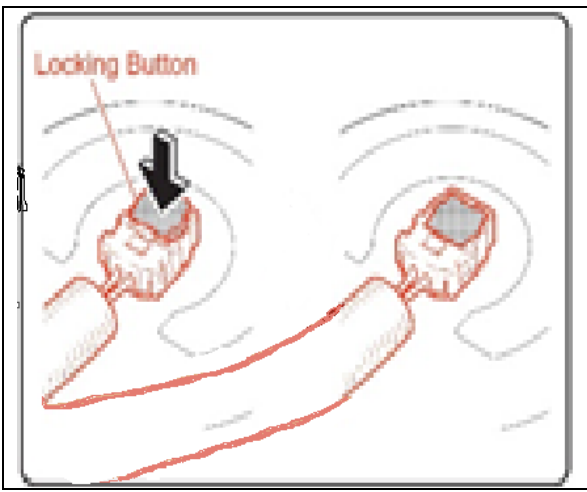
- b) Reengage the tangs of the module into the door using the screwdriver with the shaft wrapped in tape.
