Technical Service Bulletin

GROUP CAMPAIGN	NUMBER 16-01-013
DATE MARCH 2016	MODEL(S) SANTA FE SPORT (AN)

SUBJECT: SANTA FE SPORT DRIVER SEAT BELT BUCKLE HARNESS
(RECALL CAMPAIGN 141)

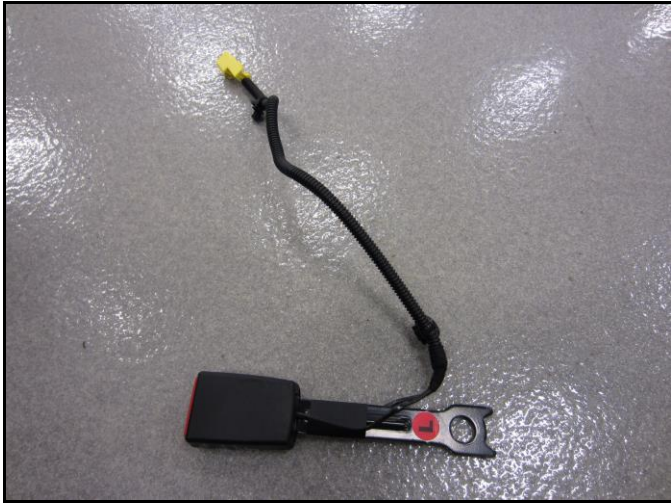
PART NAME	PART NUMBER	REMARKS
Driver seat belt buckle	88830-4Z500-RYNQH 88830-4Z500-NBCQH

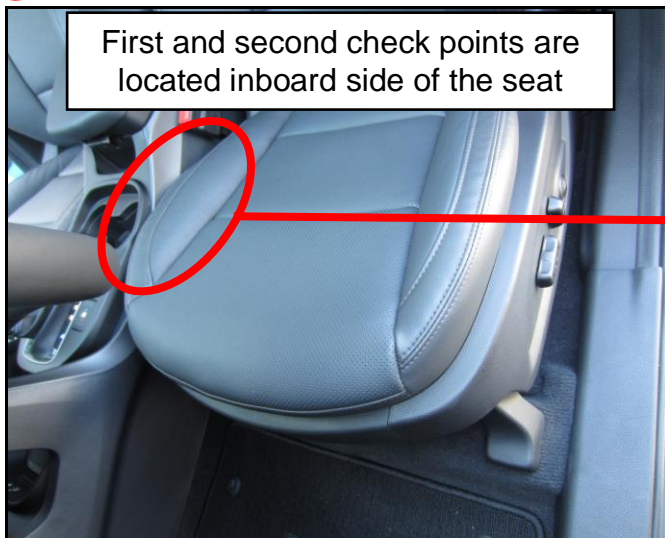
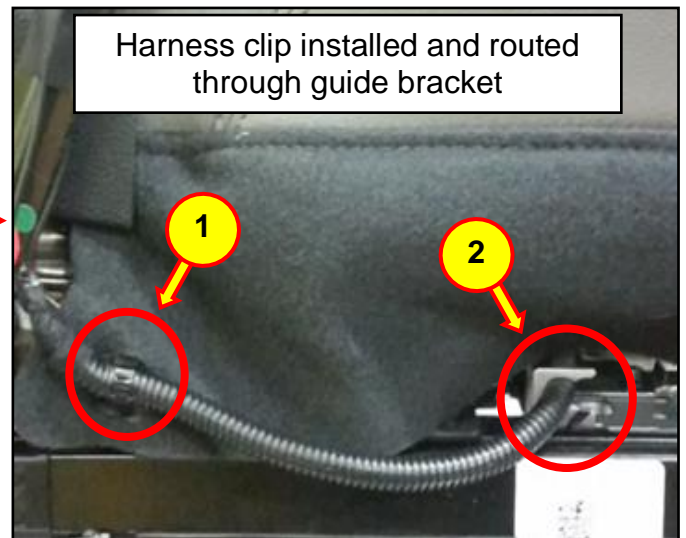
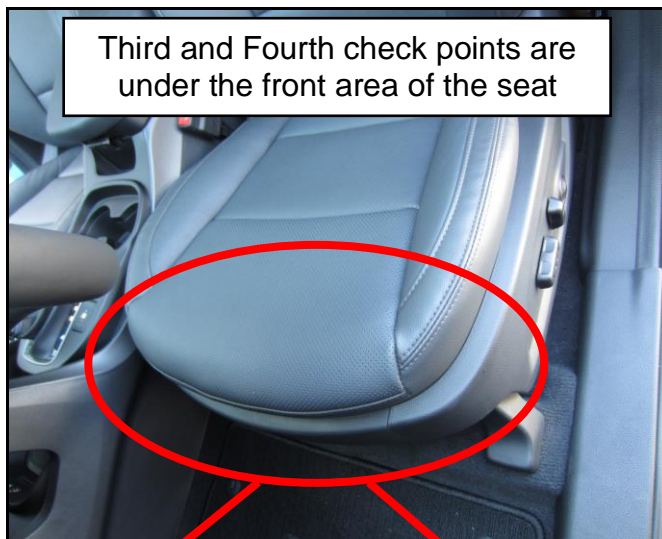
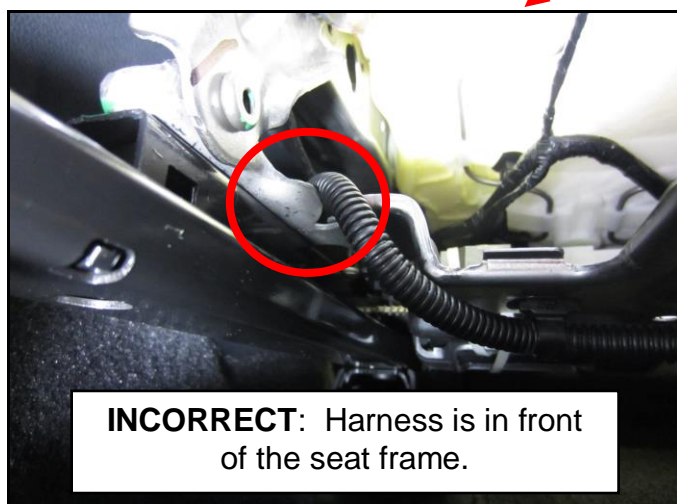
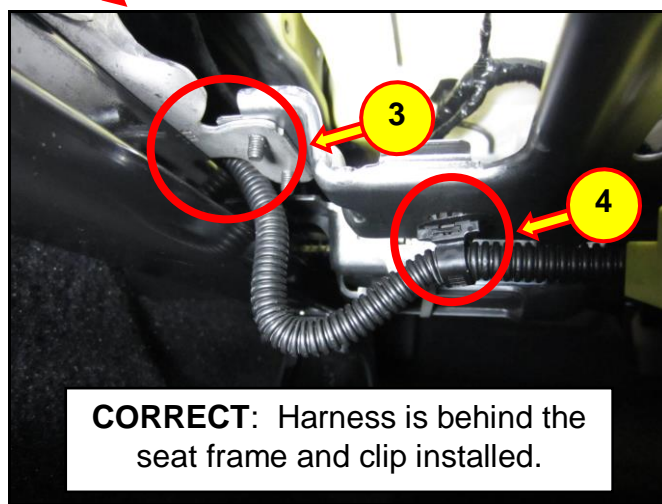
2. Check if the buckle wiring harness is correctly routed and clips are securely attached by inspecting the below positions. If the buckle harness routing is correctly routed, no further action is needed.

- 1 Harness clip installed to seat (inboard side of seat).
- 2 Harness routed through guide bracket (inboard side of seat).
- 3 Harness routed behind seat frame (under seat).
- 4 Harness clip installed (under seat).

- 3. If the buckle harness is not installed correctly, inspect for wire damage.

Confirm the buckle harness is not damaged/cut.

- 4. If harness is only misrouted and not damaged, follow the Rerouting Procedure on page 5 of this TSB.
- 5. If the harness wire is damaged, replace the buckle by following the Replacement Procedure on page 8 of this TSB.

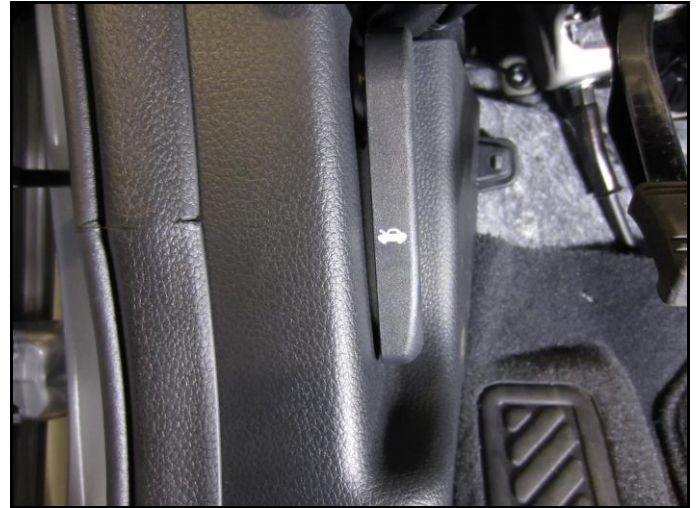
1. If applicable, record the customer's radio preset stations for AM/FM/XM.
2. Open the hood by pulling on the hood release to access the negative battery terminal.

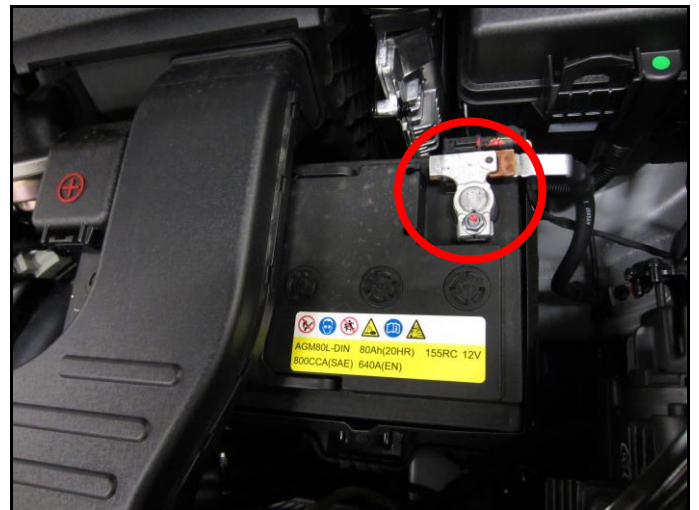
3. Disconnect the negative battery terminal.

***Negative battery terminal tightening torque:
4.0 ~ 6.0 N.m (0.4 ~ 0.6 kgf.m, 3.0 ~ 4.4 lb-ft)***

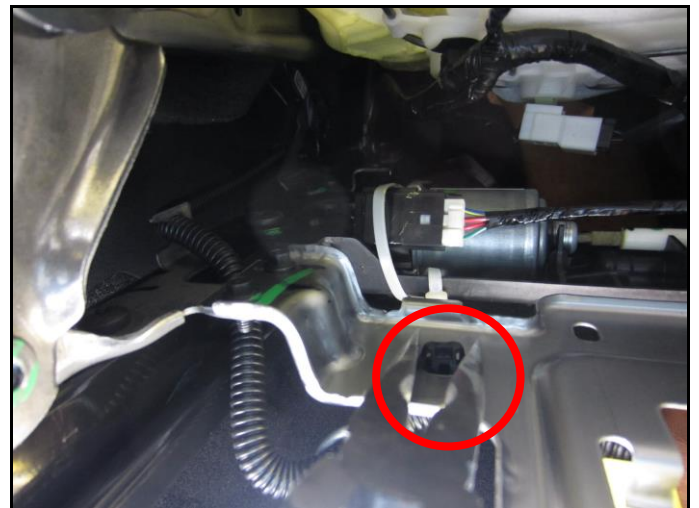
4. Use a needle nose plier to unlock the clip from the seat frame, by pinching the two locking tabs.

Remove the buckle harness clip from the seat frame.

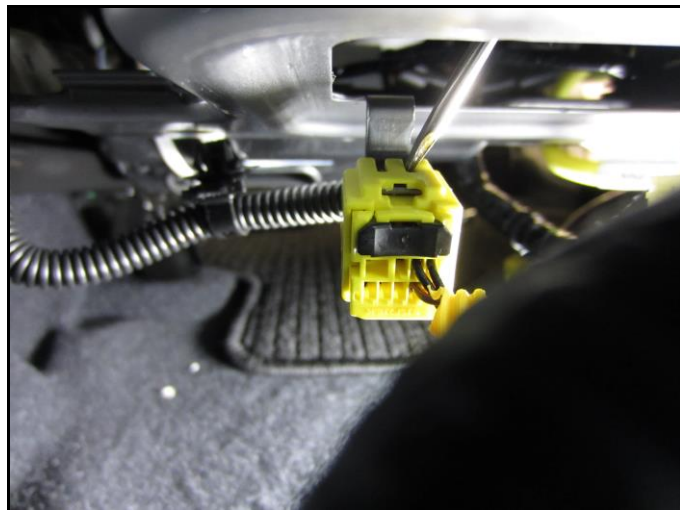
5. Use a small flathead screwdriver to gently lift the yellow locking tab, and pull it forward to remove the yellow buckle connector from the seat frame.

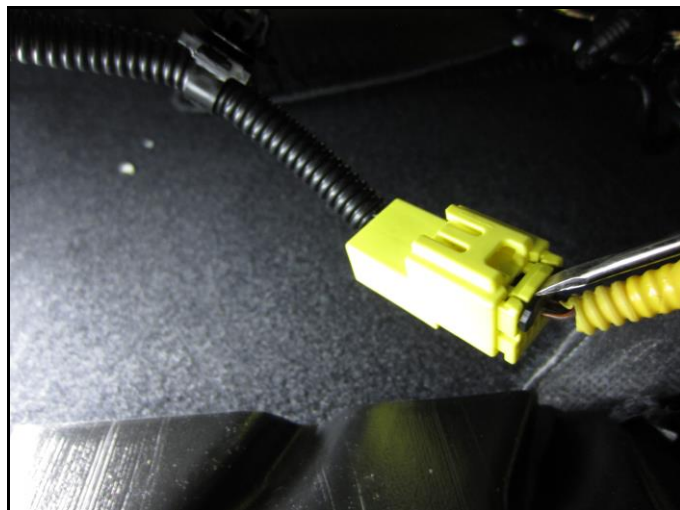
6. Use a flathead screwdriver and gently push the black secondary lock tab outward.

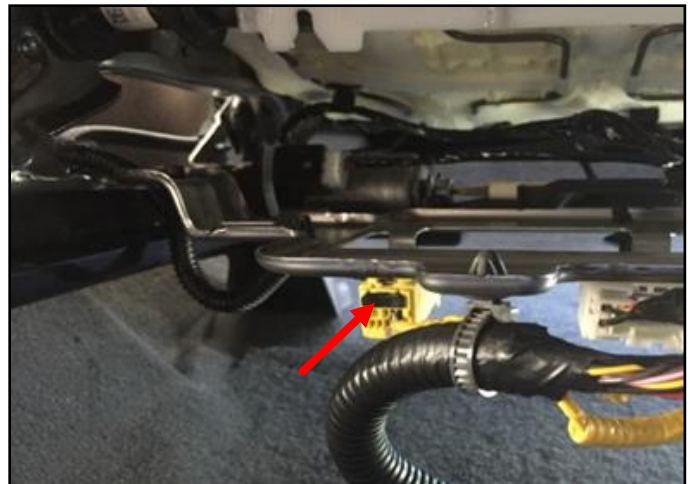
8. With the buckle wire harness free from the seat frame, examine the wire for any damage, especially in the potential pinch area. If no damage is found, confirm the harness is routed correctly as shown in the Inspection Procedure (Page 3 and Page 4).
9. Install the yellow floor harness connector to the seat belt buckle connector. Be sure to engage the black secondary lock.

Reattach the buckle harness clip to the seat frame.

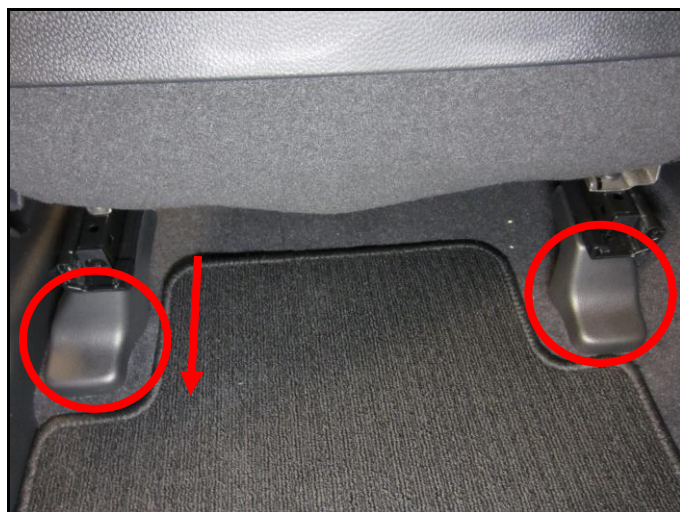
1. Repeat Reroute Procedure steps 1-7 on pages 5-7 of this TSB.
2. Remove the four driver seat bolt covers by gently pulling the cover outward away from the seat rail.

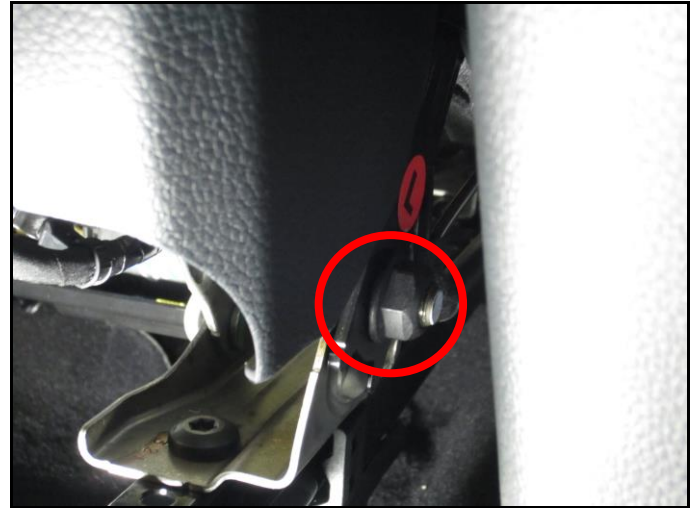
5. Remove the seat belt buckle nut using a 17mm socket and ratchet or crescent wrench.

Seat belt nut tightening torque:

39.2 ~ 53.9 N.m (4.0 ~ 5.5 kgf.m, 28.9 ~ 39.8 lb-ft)

6. Remove the seat belt buckle and harness and replace with a new part.

Ensure the seat belt buckle harness is routed properly as shown in the Inspection Procedure on Page 3 and Page 4 of this TSB.
