Safety Recall

Code: 46G4

Subject	Brake Pedal Clip
Release Date	April 5, 2016
Affected Vehicles	U.S.A. & CANADA: 2011-2016 Model Year Volkswagen Touareg Vehicles <i>Check Campaigns/Actions screen in Elsa on the day of repair to verify that a VIN qualifies for repair under this action. Elsa is the <u>only</u> valid campaign inquiry & verification source.</i> <ul style="list-style-type: none">ü Campaign status must show "open."ü If Elsa shows other open action(s), inform your customer so that the work can also be completed at the same time the vehicle is in the workshop for this campaign.
Problem Description	A securing clip at the brake pedal hinge may be missing. If the clip is missing, the pedal pivot pin could start to move and the pedal could lose guidance. If this remains undiscovered, the pedal hinge could fracture after continued operation, allowing the pedal to dislodge. The customer may not be able to properly actuate the brakes with a dislodged brake pedal. A non-functional brake or reduced braking power could lead to a crash.

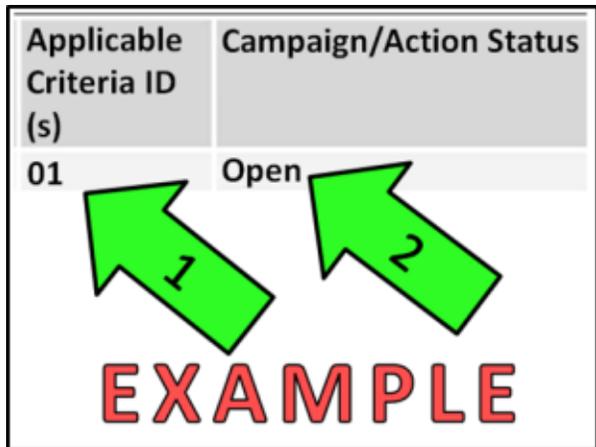
TIP
 If Campaign Completion label is present, no further work is required.

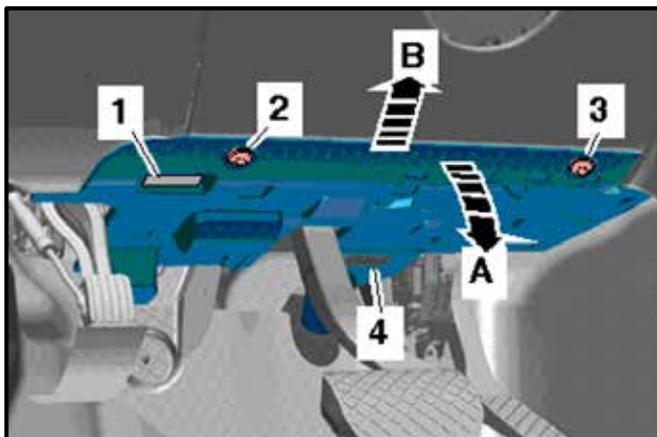
i TIP

Area of inspection will be found in location of <arrow>.

- Switch ignition off, set parking brake and remove key.
- Open driver door.
- Place a protective mat over the door entry area.
- Move driver seat as far back as it will go.

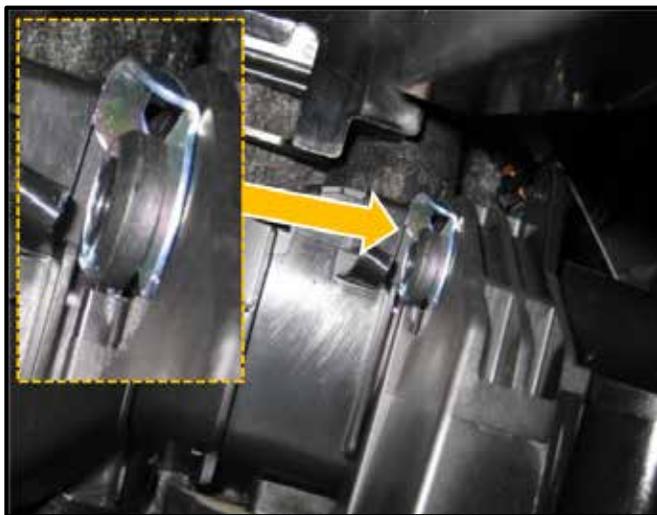
Inspection point <arrow>:

- Left-hand side of bearing bracket for brake pedal <1>.
- Fitted correctly on bearing pin <2>.

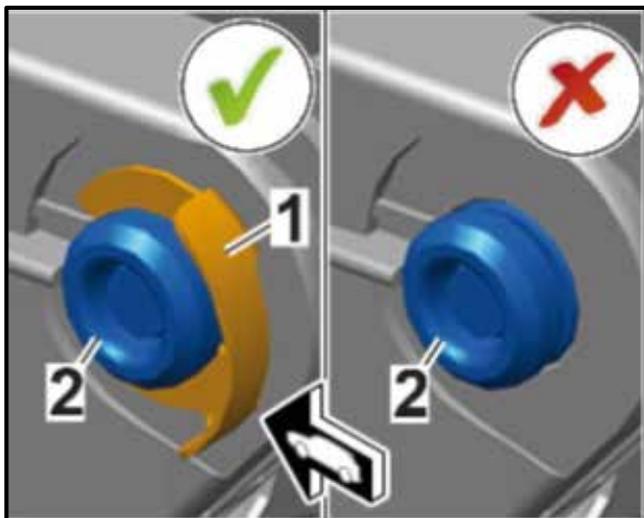
- Using a mirror and shop light, inspect for presence of silver-colored locking circlip <arrow> located at the left-hand side of the bearing bracket for the brake pedal and ensure it is fitted correctly on the bearing pin.

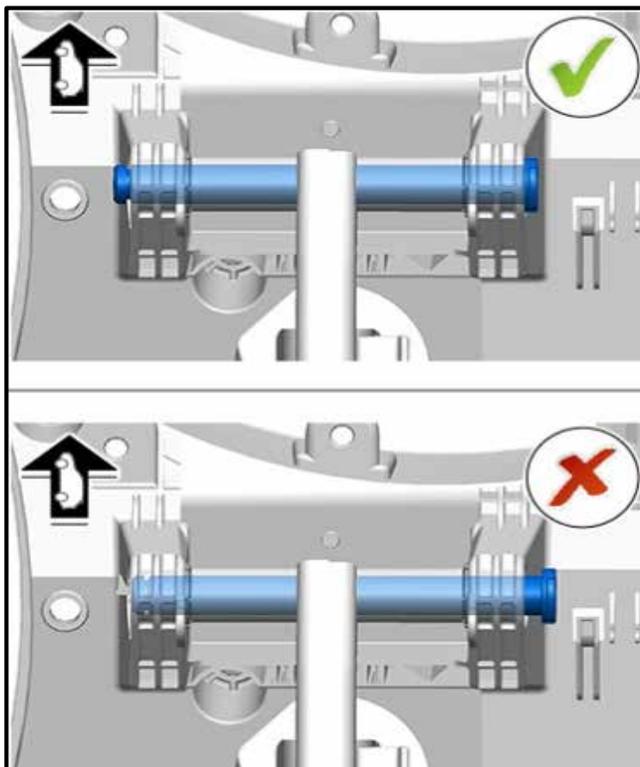
Section C – Inspect Bearing Pin and Bracket

The end collar of the bearing pin <1> (on the right-hand side of the bearing bracket for the brake pedal <4>) has a cut-out <2>. This means that the bearing pin can only be fitted correctly in one specific position.

- Inspect the bearing pin <1> to ensure pin is correctly fitted <as shown>.
 - If bearing pin <1> is correctly fitted, **CONTINUE to SECTION E** to install locking circlip.
 - If bearing pin is not correctly fitted, **CONTINUE to SECTION D** to inspect bracket for damage.

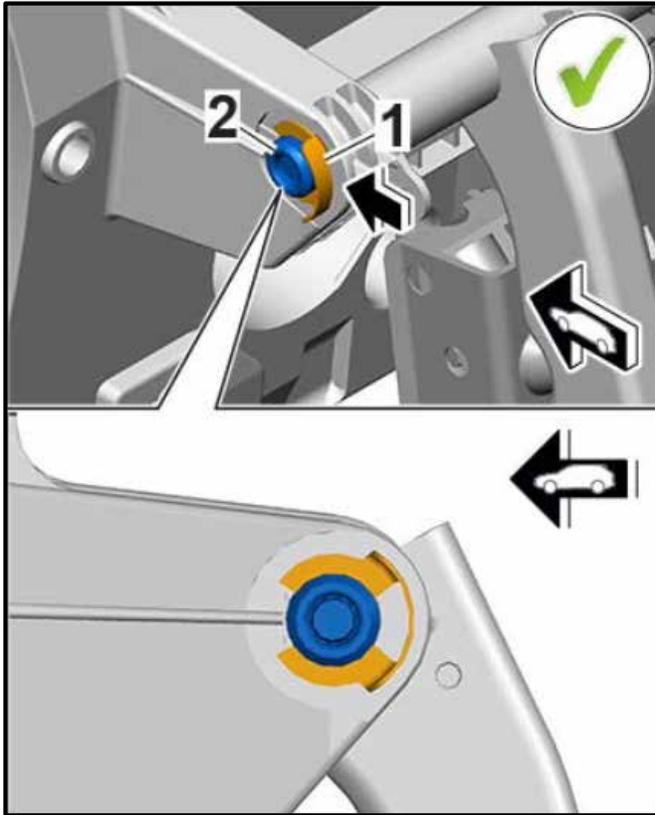
Section D – Inspect Bearing Bracket for Brake Pedal

- Push brake pedal from left-to-right toward the accelerator pedal.
 - If the brake pedal is no longer held in its installation position and can be tilted down at one side, the bearing pin has come **completely** out of the left bearing on the bracket. **STOP WORK IMMEDIATELY. Create a VTA ticket and contact the Technical Assistance Helpline.**
 - If the brake pedal is held in its installation position, **CONTINUE** work.
- Align the cut-out of the pin and push bearing pin back into its correct position.
