RECALL 16V-173: REPLACE “ELECTRONIC CONTROL UNIT” FOR THE AIR BAGS

G12 (7 Series)

Electronic Control Unit for the Air Bags (ACSM5) may not meet BMW specification.

Replace the Electronic Control Unit for the Air Bags (ACSM5) and update the vehicle software.

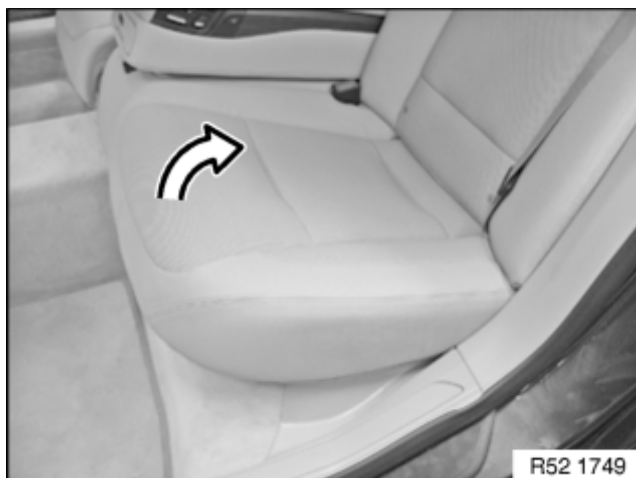
- Move seat angle all the way to the top.
- Set forward/back seat adjustment to maximum forward position.
- Unclip seat surface from latch mechanism from above.

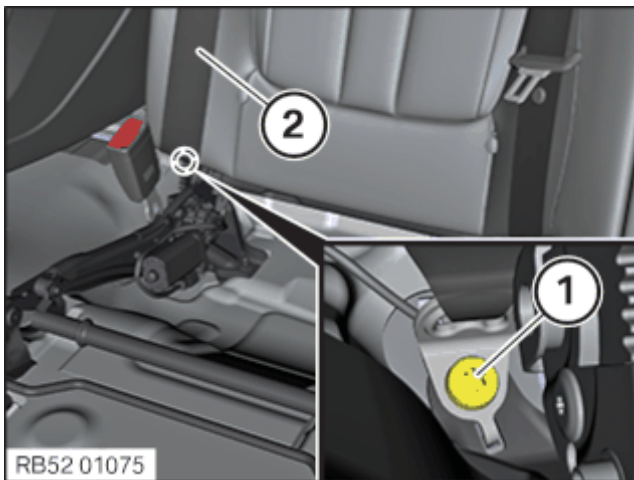
- Loosen screw (1).
- Guide out seat belt (2) and put to one side at top.

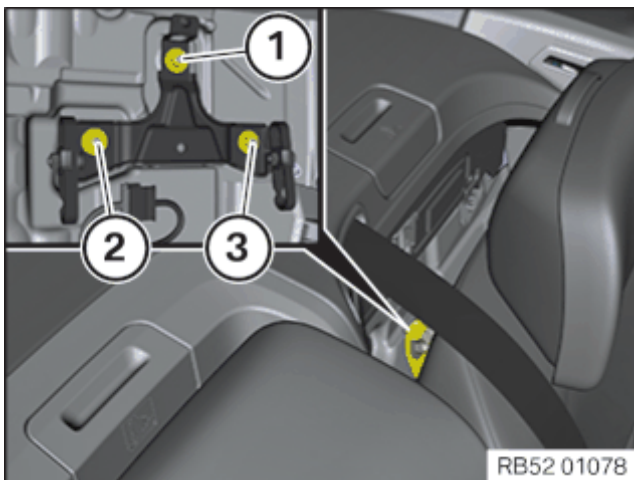
- Loosen nuts (1) to (3).

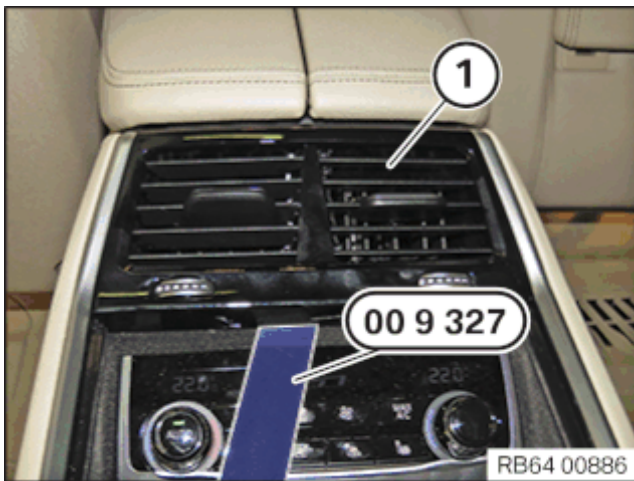
3–Remove fresh air grille in rear passenger compartment

- Unclip the fresh air grille (1) using special tool 0 496 571 (00 9 327).
- Disconnect the associated connector and remove the fresh air grille (1).

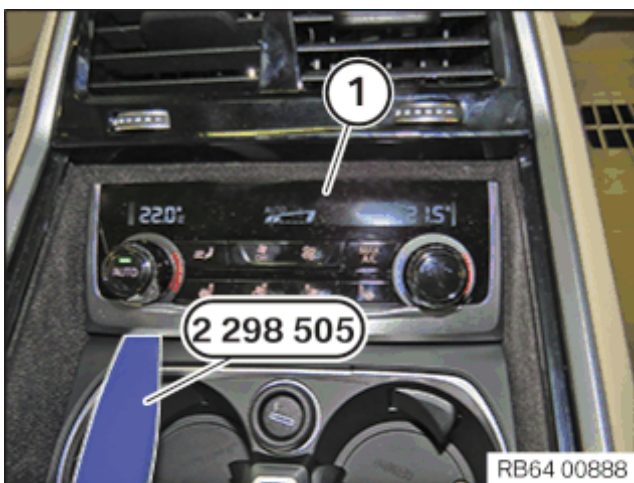
4–Removing the control panel of the rear passenger compartment air conditioning

- Unclip the control panel (1) using special tool 2 298 505.
- Disconnect the associated connector and remove the control panel (1).

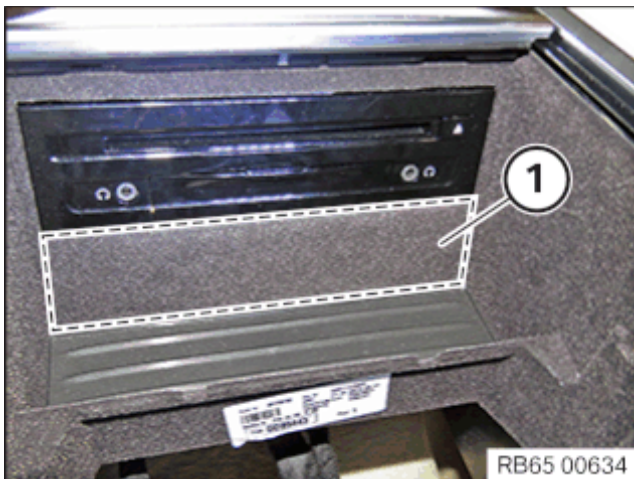
6-Removing the DVD player

- Disengage the cover (1).

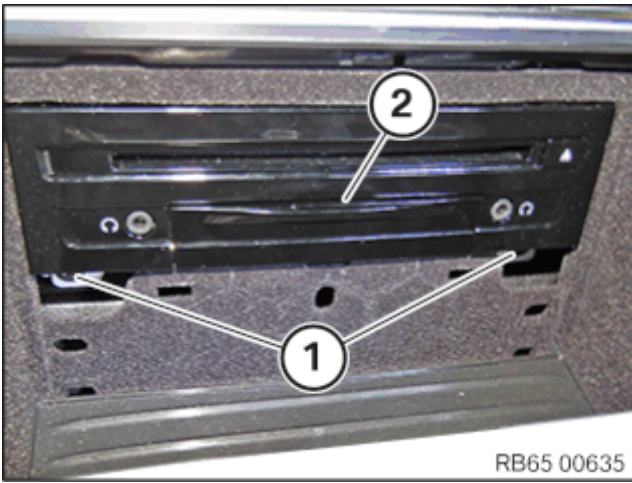
- Unlock and disconnect connector (1).
- Remove the DVD player (2).

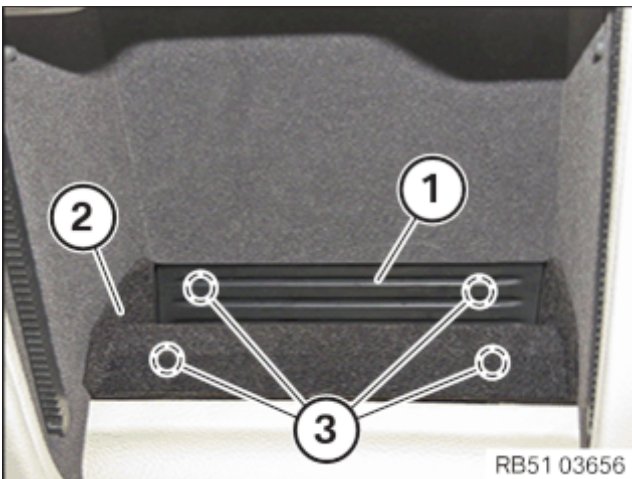
7-Removing the top rear console

- Remove the insert (1).
- Unclip the trim (2) from the clamps towards the top in this area (3).

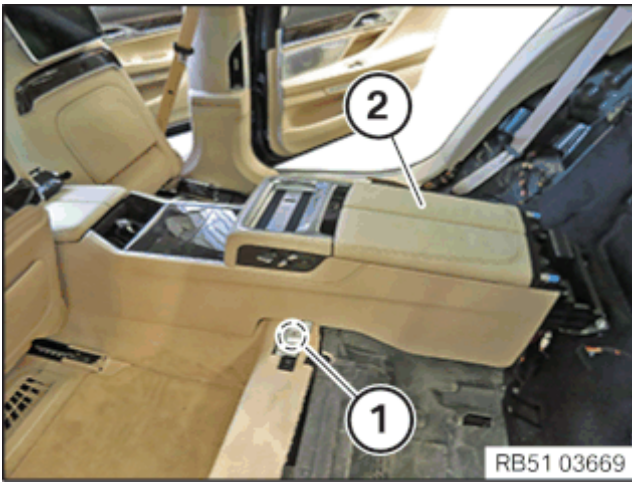
- Loosen left and right screw (1).
- Slightly lift the rear console (2) at the rear.
If necessary, unlock and disconnect additional plug connections.
- Remove the rear console (2) with an additional person.

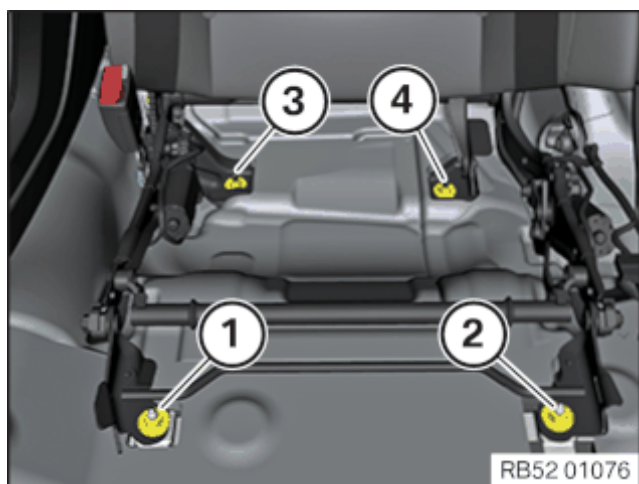
- Tighten nuts in the sequence (1), (2), (3) and (4).

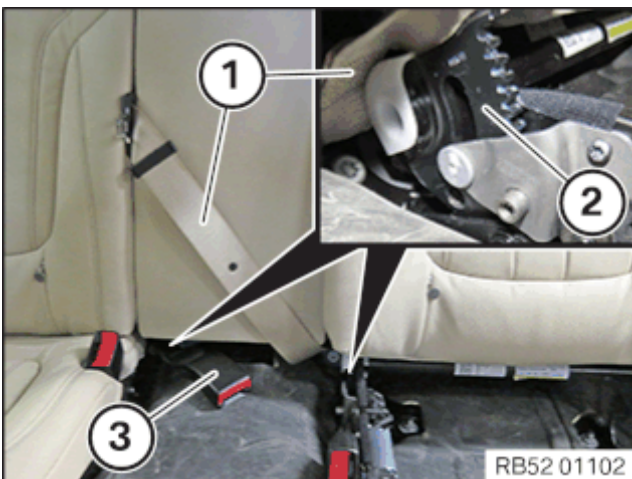
- Check seat belt (1) and lower strap (3).

Seat belt (1) and lower strap (3) must not be trapped by the seat mechanism (2).

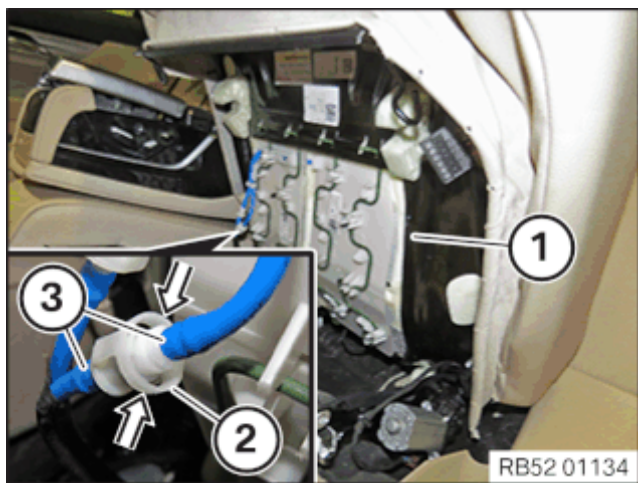
Position seat surface (1) as illustrated.

Coupling (2) must not be damaged.

Connect lines (3) together and ensure correct latch mechanism of the coupling (2).

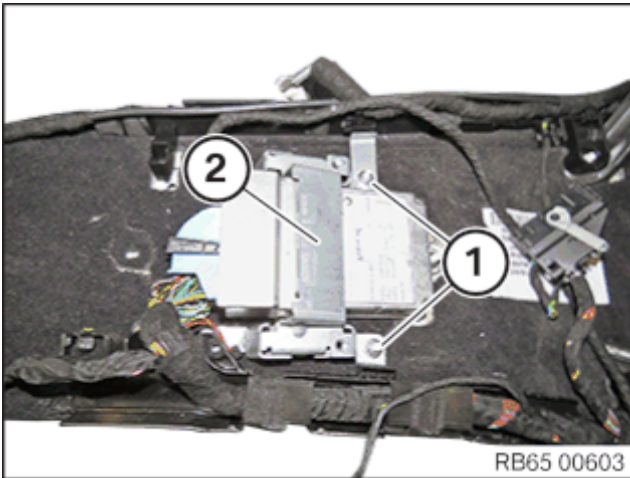
10-Removing the airbag control unit

- Loosen nuts (1).
- Remove the holder (2).

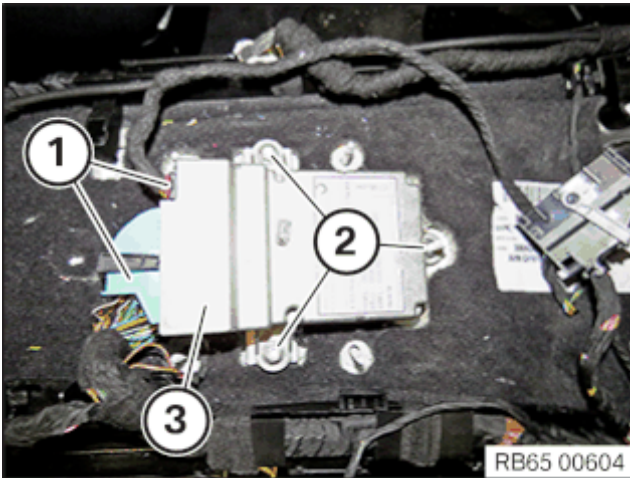
- Unlock and disconnect connector (1).
- Loosen nuts (2).
- Remove airbag control unit (3).

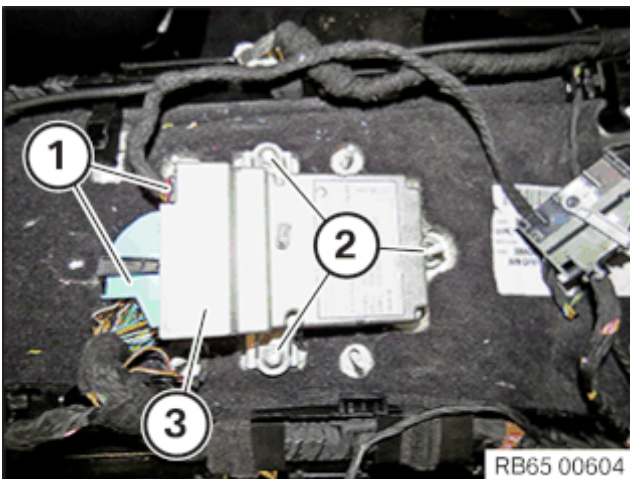
11-Installing the airbag control unit

- Position airbag control unit (3) correctly.
- Tighten nuts (2).
- Connect connectors (1) and lock.

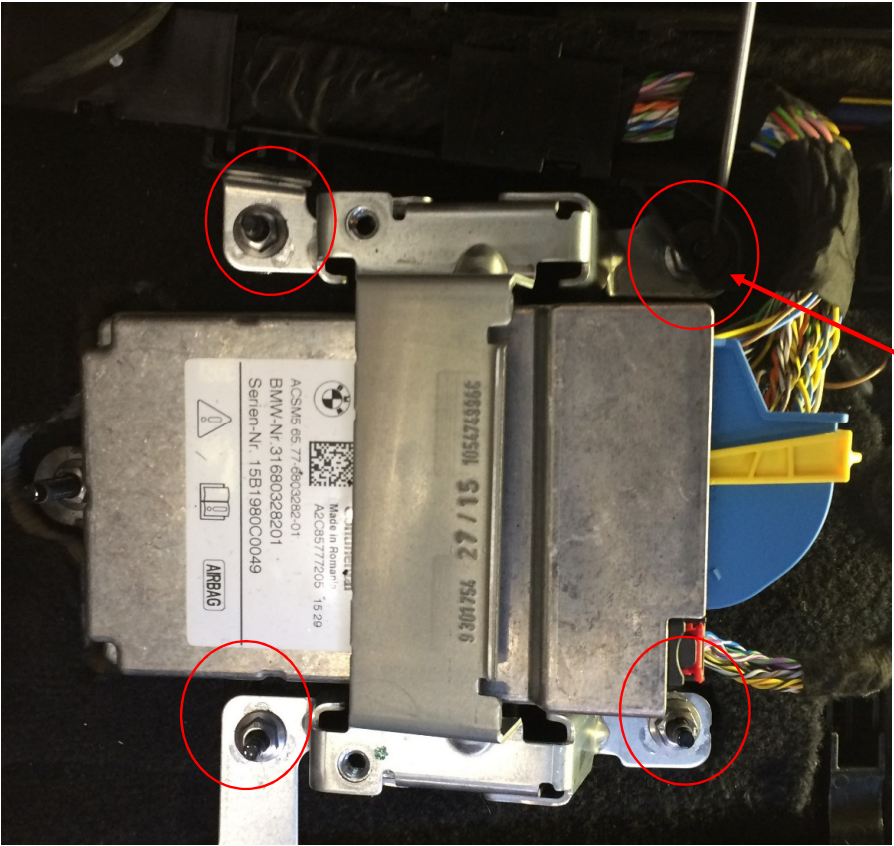
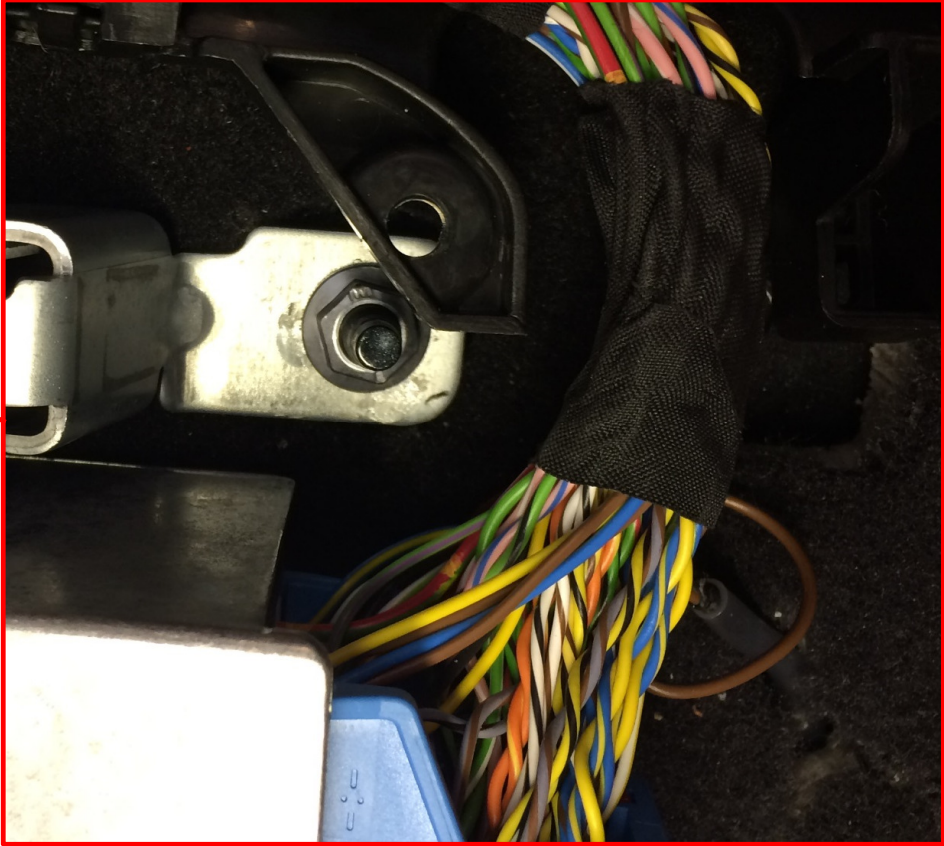
ACSM 4 Mounting Nuts – Step 10 REP 6577018

1. Replace the air bag control unit ACSM5, see Repair Instructions **RA 65 77 018** . Copy of RA attached.
 - Reference the attachment on this SIB for tips on ACSM5 removal.
 - All four ACSM5 mounting nuts are to be reused and tightened to 8 Nm of torque.
 - On G12 vehicles with option 4F5 "Executive Lounge rear console", the rear console must be removed, see "Remove and refit the rear console" Repair Instructions **RA 52 25 350** . Copy of RA attached.
 - The front and rear consoles have sharp edges that can cut into the dashboard or rear seat during removal. Take precautions to prevent contact that can damage the interior.
2. After ACSM5 replacement program the vehicle with ISTA/P.
 - **Always connect a BMW approved battery charger / power supply ([SI B04 23 10](#)).**
