REPAIR PROCEDURE

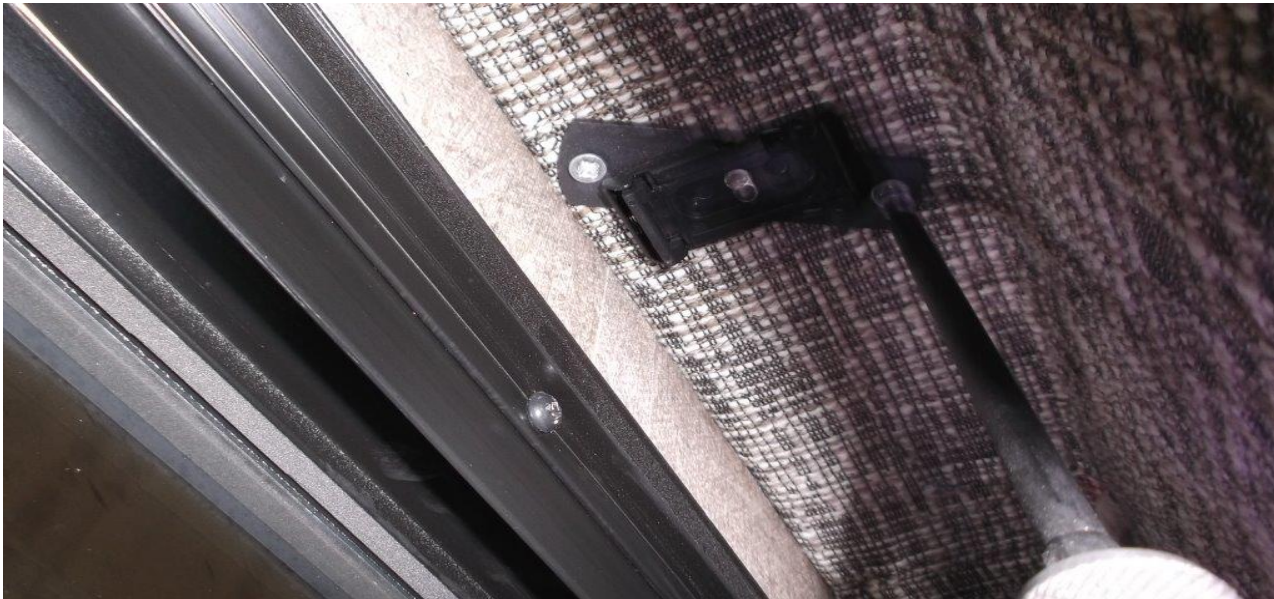
- Remove the roller shade from the brackets and also the brackets from the valance as shown in figure 1 below.

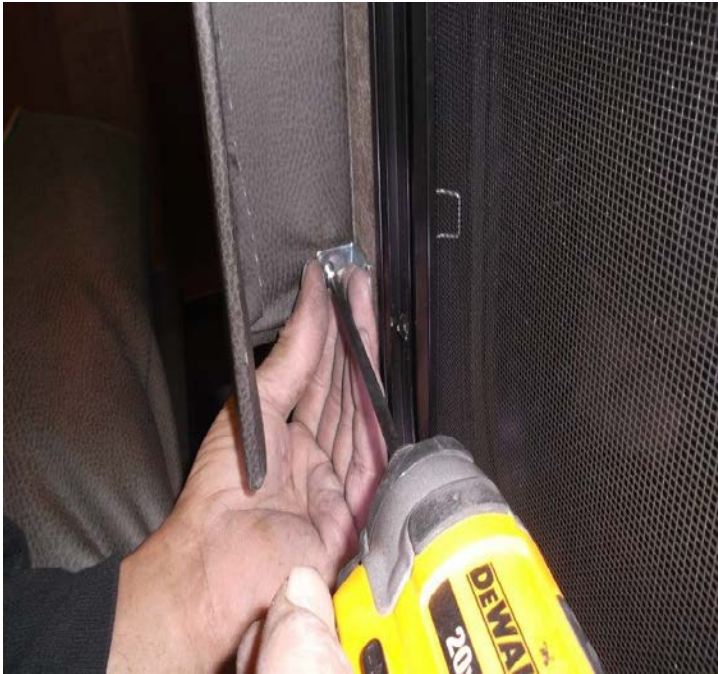
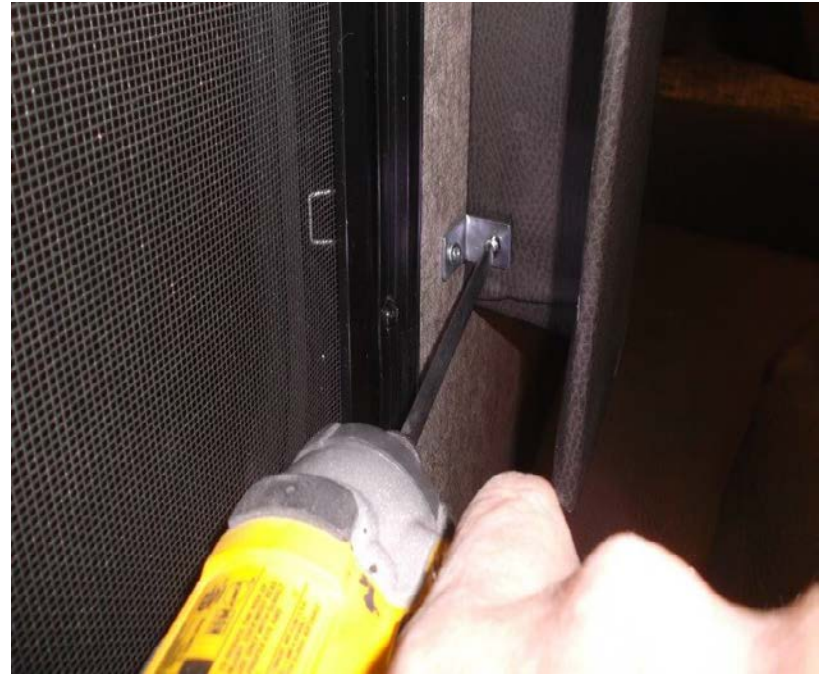
- Remove side legs as shown in figure 2 below.

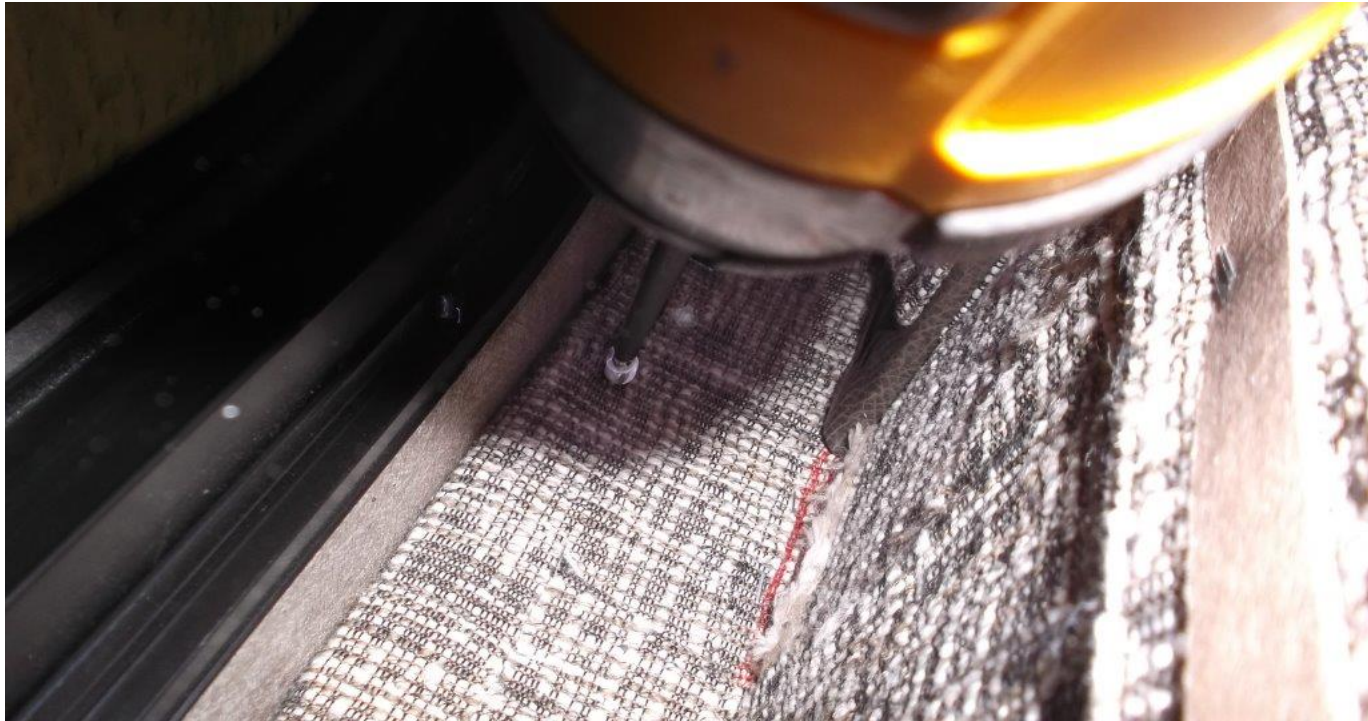
VALANCE REMOVAL

- Remove valance as shown in figure 3 below.

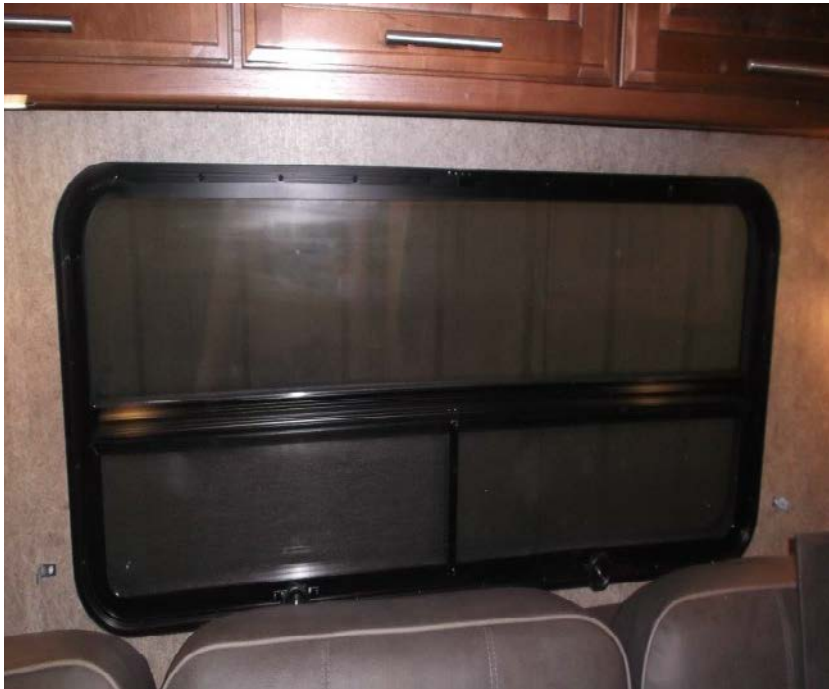
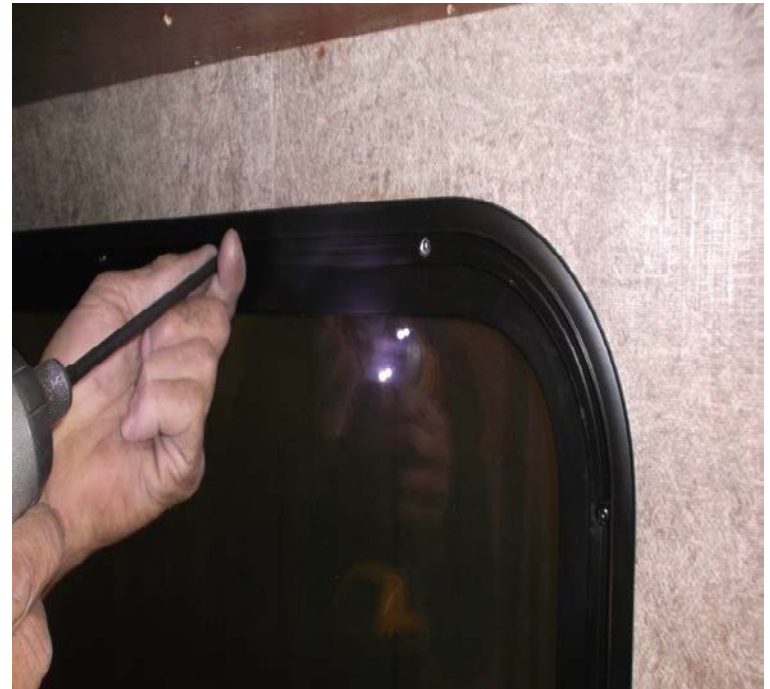
WINDOW REMOVAL

- Remove window trim ring from inside as shown in figure 4 below.

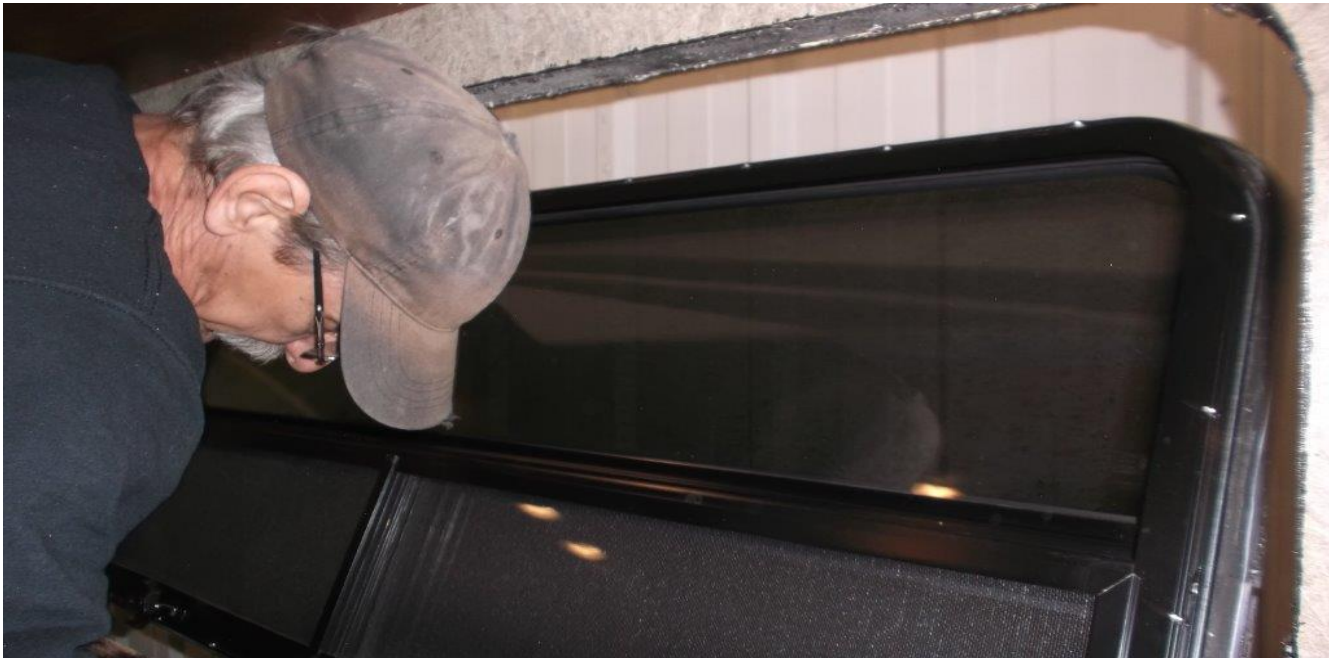
REMOVE WINDOW

- Carefully remove window from opening as shown in figure 5 below.

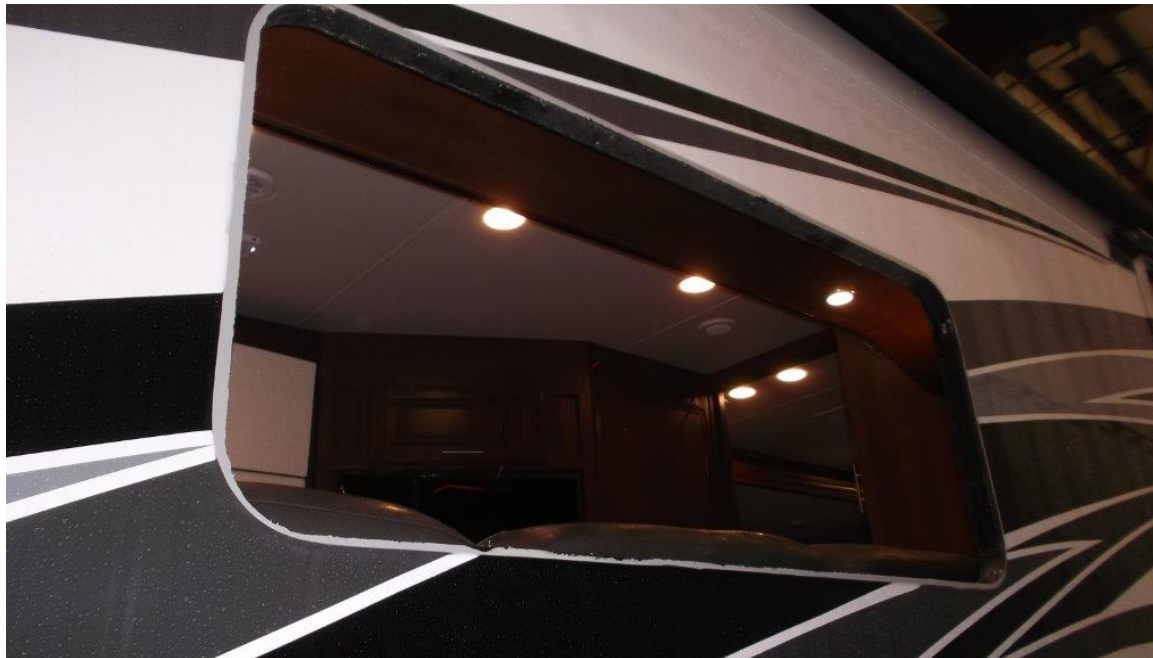
CLEAN SEALANT FROM WALL

- Carefully clean sealant from exterior window opening on exterior if any present as shown in figure 6 below.

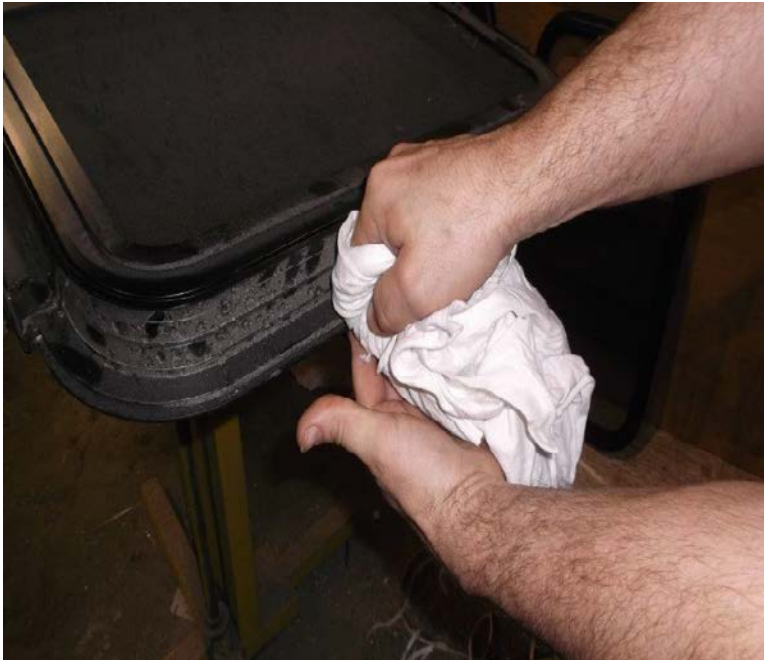
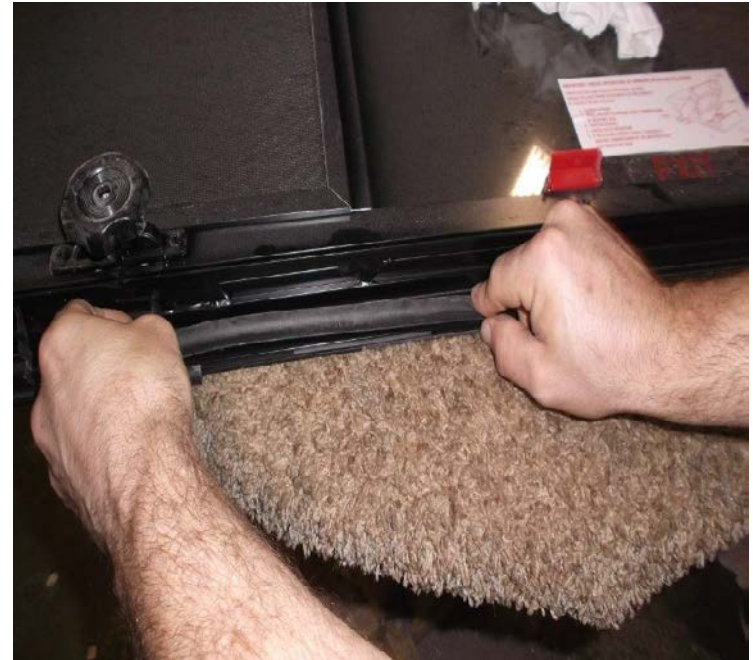
PREPAIR NEW WINDOW

- Add supplied rubber “ D “ seal to flange of new window as shown in figure 7 below.

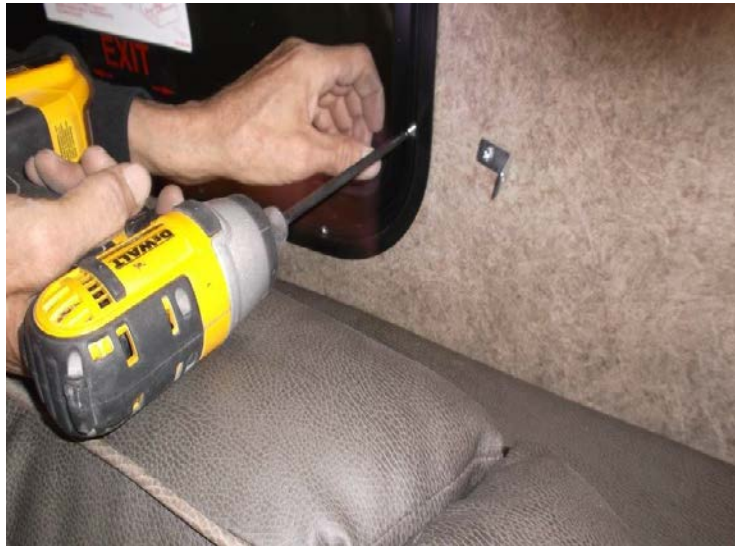
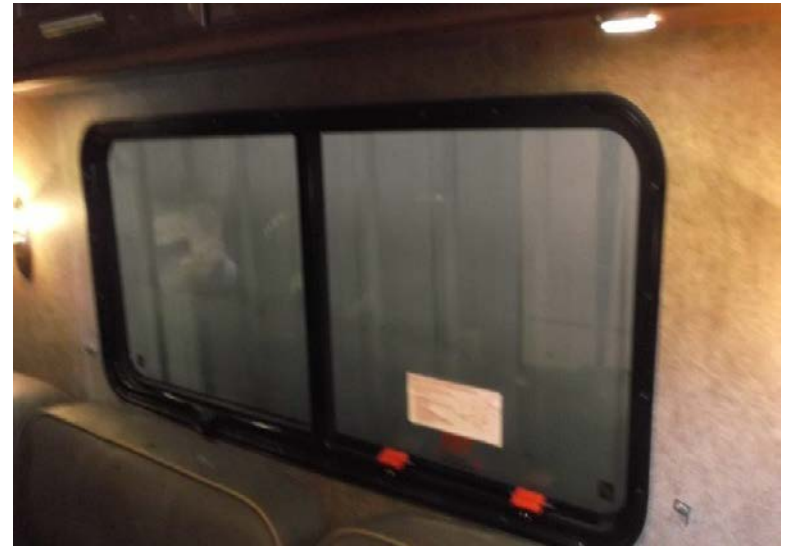
INSTALL NEW WINDOW

- Place new window in opening and install interior trim ring. You may need an assistant to hold the window while you set a few interior screws shown in figure 8 below.

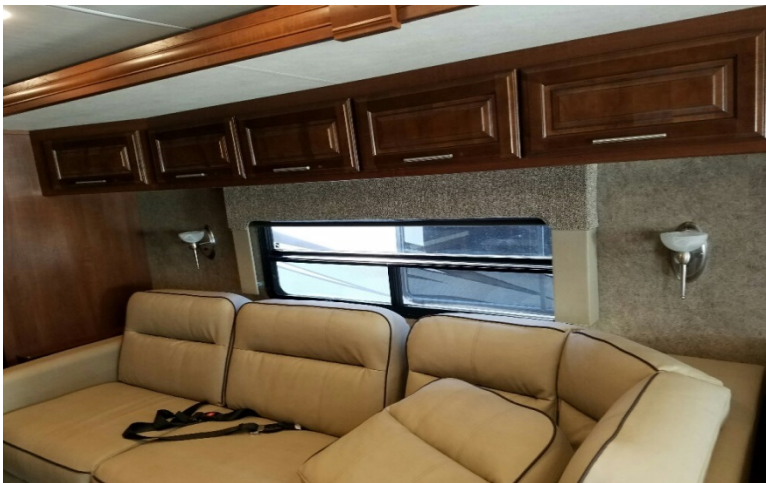
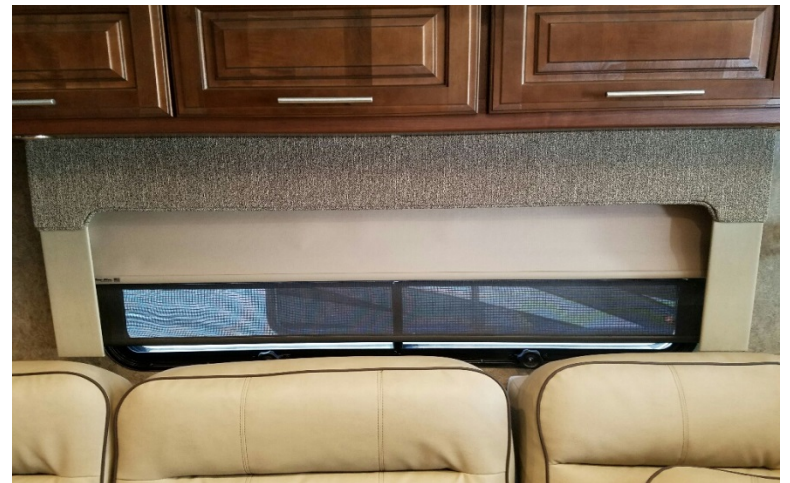
VALANCE INSTALLATION

- In some cases, the valance over the window is too large for the escape window as shown in figure 9 below.

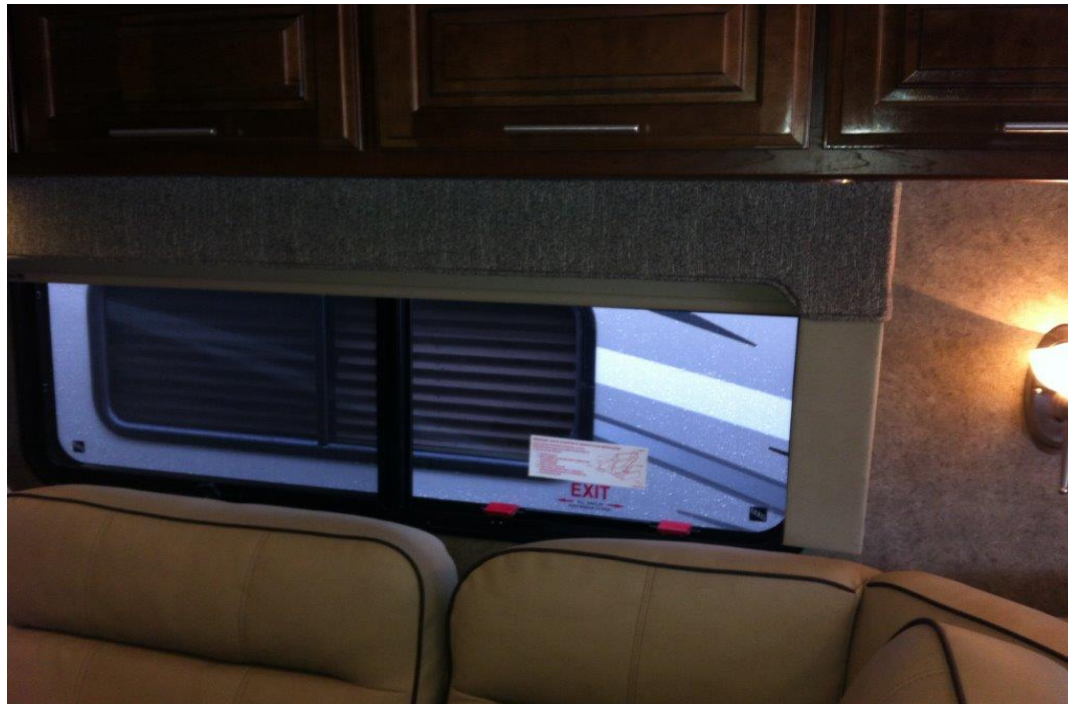
VALANCE CONTINUED

- In this situation, Forest River, Inc. has supplied a new valance that covers less of the escape window as shown in figure 10 below.

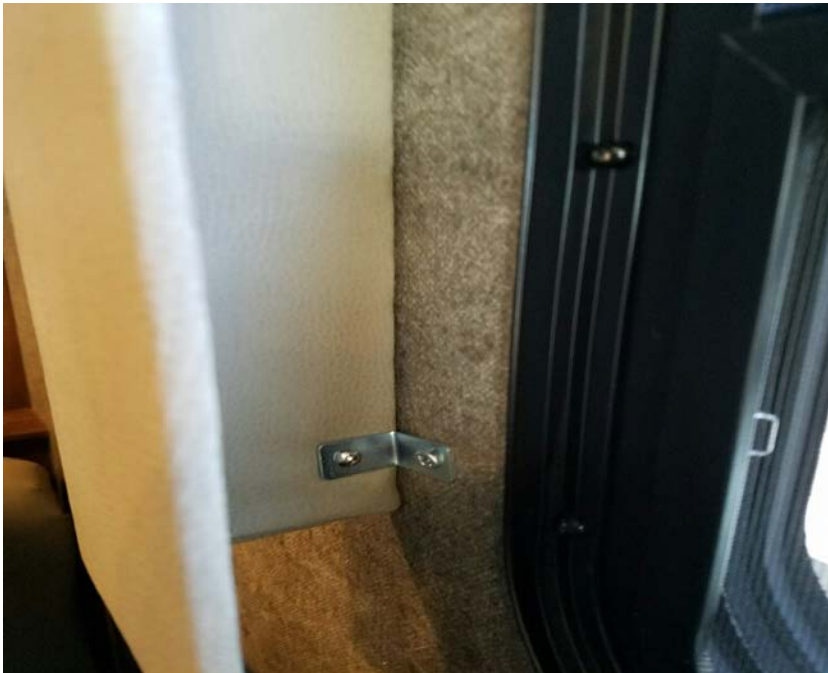
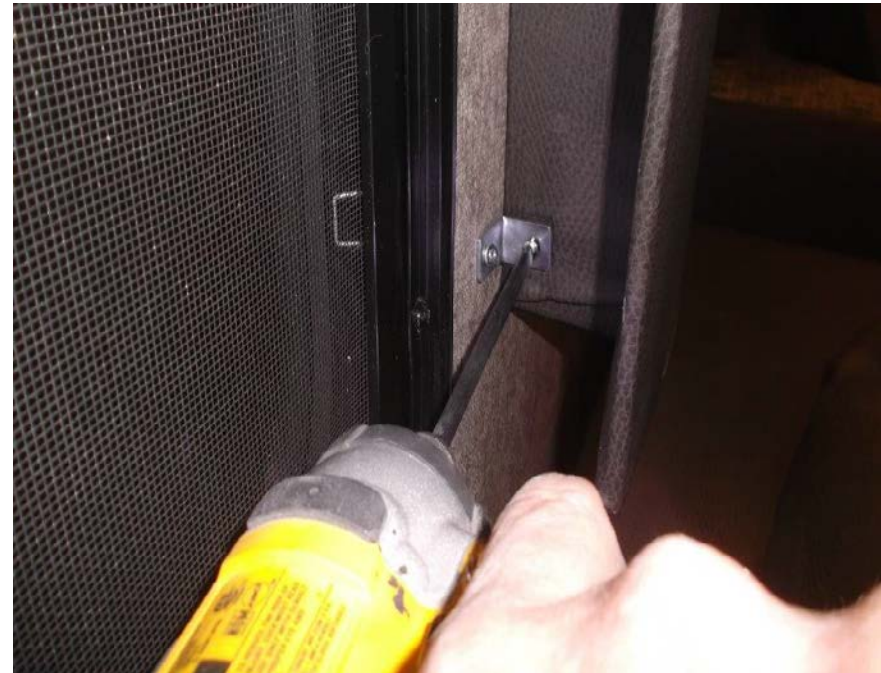
VALANCE LEGS

- Re-install the valance side legs as shown below in figure 11.

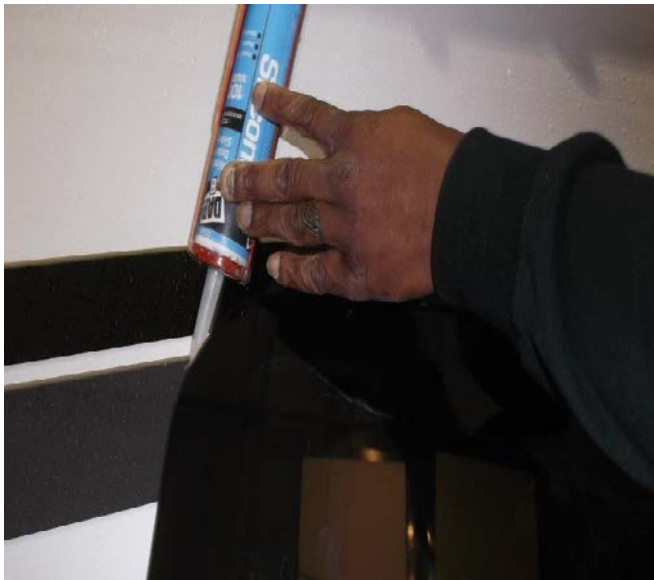
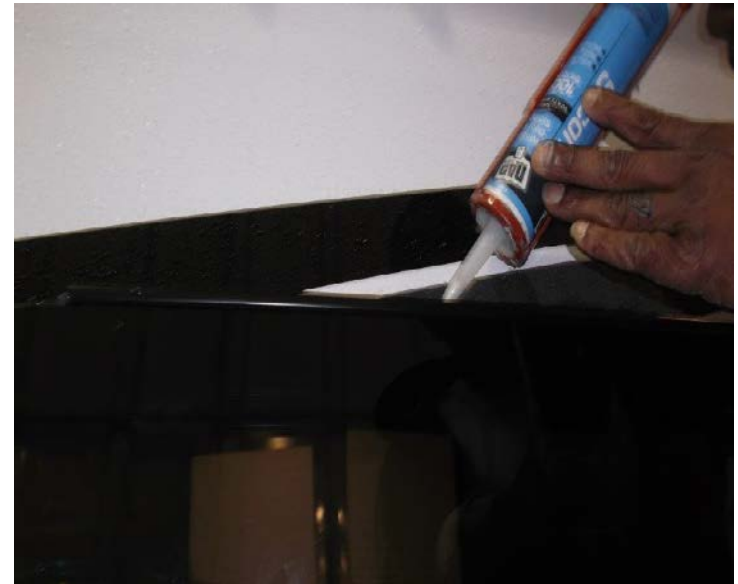
TOP SEAL WINDOW EXTERIOR

- Top seal the exterior of the window with a good clear exterior caulk as shown in figure 12 below.
