Service Bulletin

16-033

Noncompliance Recall: 2004-07 Accord Front Passenger Airbag

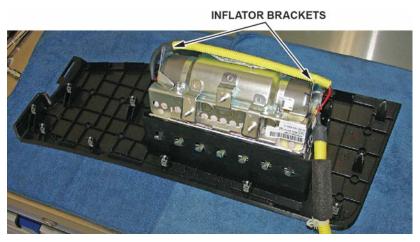
1. Remove the harness from both ends of the inflator brackets.

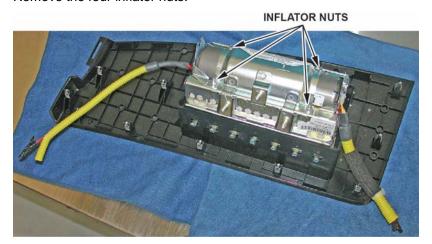
- Tape the twisted ends with electrical tape.
- 4. Remove the four inflator nuts.
