REFERENCE:	Nova Bus Manuals
SECTION:	12: Driver's seat Recaro
RS N°:	N/A
EFFECTIVE IN PROD.:	L931 (2015NO)
TC RECALL N°:	2016-144
NHTSA RECALL N°:	16V-191

SUBJECT:	Recaro driver's seat
JUSTIFICATION:	Welds might be missing on right and/or left-hand seat belt anchor J-brackets.

RECARO						
Work Instruction						
Operation #	SAP Line #	Operation Description	Level	Date	Author	
M0999507	N/A	Service Instruction Inspect and Repair J-brackets	05	Released	10/21/2015	Chris Perkins
	Page 1 / 8			Revised	10/30/2015	Chris Perkins

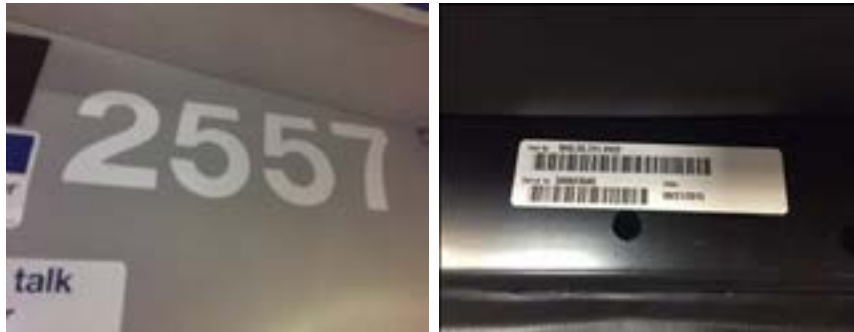
1. Position the seat to “full forward” and “full up” to obtain the serial number on the seat. The serial number decal is located on the back of the seat on the top of the suspension between the seat tracks, shown above. Record the bus number and serial number of the seat.
