**TECHNICAL INSTRUCTIONS**  
**FOR**  
**SAFETY RECALL GLC**  
**BRAKE ACTUATOR ASSEMBLY INSPECTION/REPLACEMENT**  
**CERTAIN 2016 MODEL YEAR ES 350 AND RX 350 (TMMC ONLY) VEHICLES**

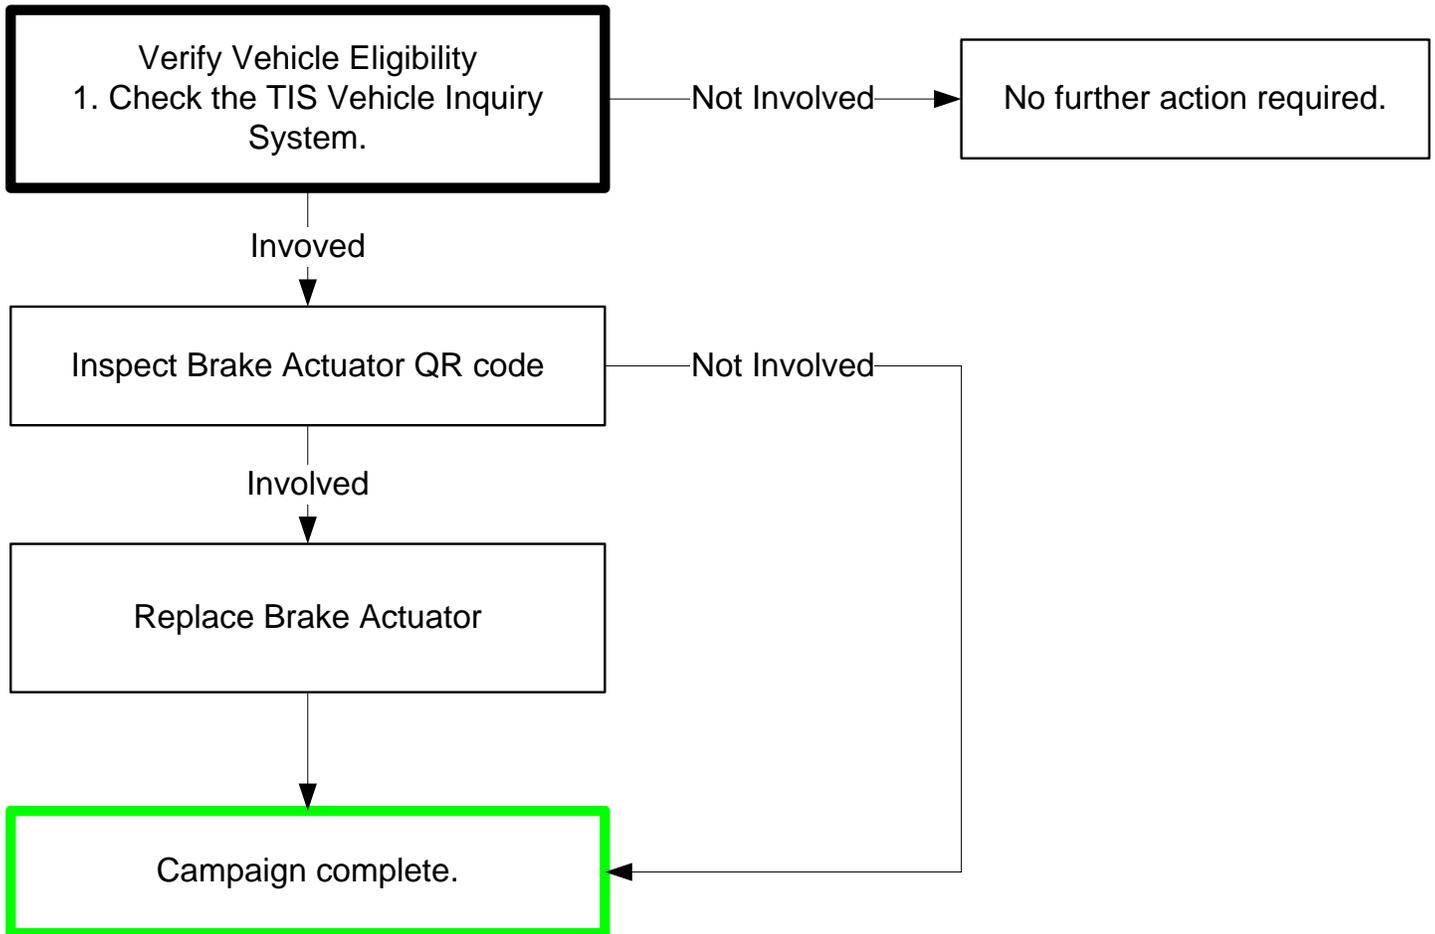
## I. OPERATION FLOW CHART

The flow chart is for reference only. **DO NOT** use it in place of the full technical instructions. Follow **ALL** steps as outlined in the full technical instructions to confirm the campaign is completed correctly.

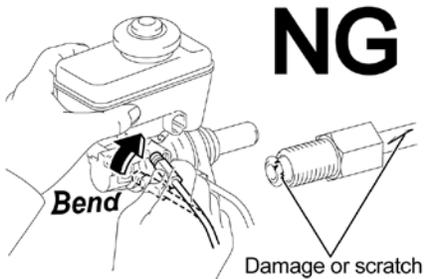
S11203aS

#### 3. HANDLE THE BRAKE TUBES CAREFULLY

- DO NOT** deform or damage the brake tubes during removal or installation.

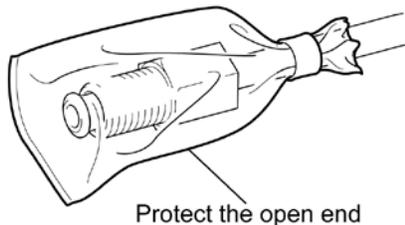
S11204aS

Protect the open end

#### 4. PROTECT THE BRAKE SYSTEM

- Clean components prior to disassembly to avoid contamination.
- Cover open components to avoid contamination.

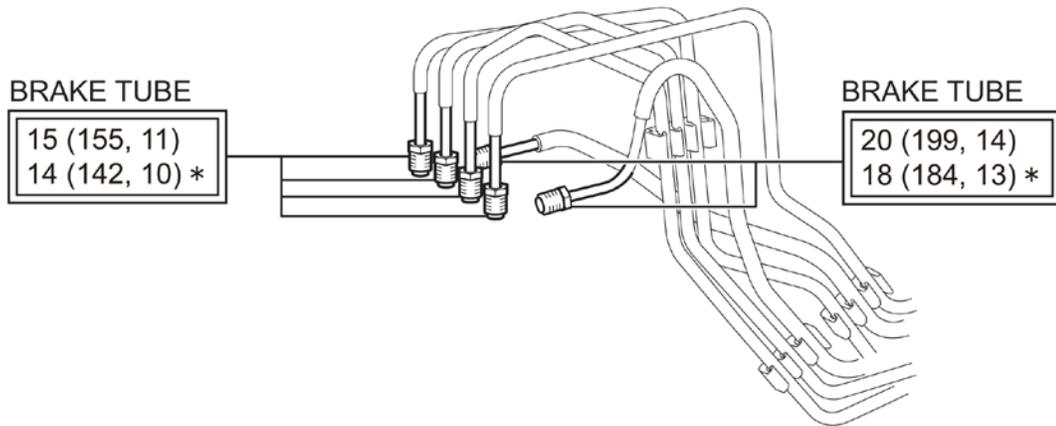
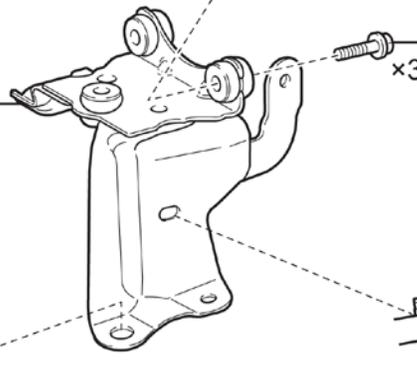
R1603030003

● BRAKE ACTUATOR ASSEMBLY

BRAKE ACTUATOR BRACKET ASSEMBLY

19 (194, 14) x3

6.5 (66, 58 in.\*lbf)

SUCTION PIPE CLAMP

● : Component to be replaced

**[N\*m (kgf\*cm, ft.\*lbf)]** : Tightening torque for "Major areas involving basic vehicle performance such as moving/turning/stopping"

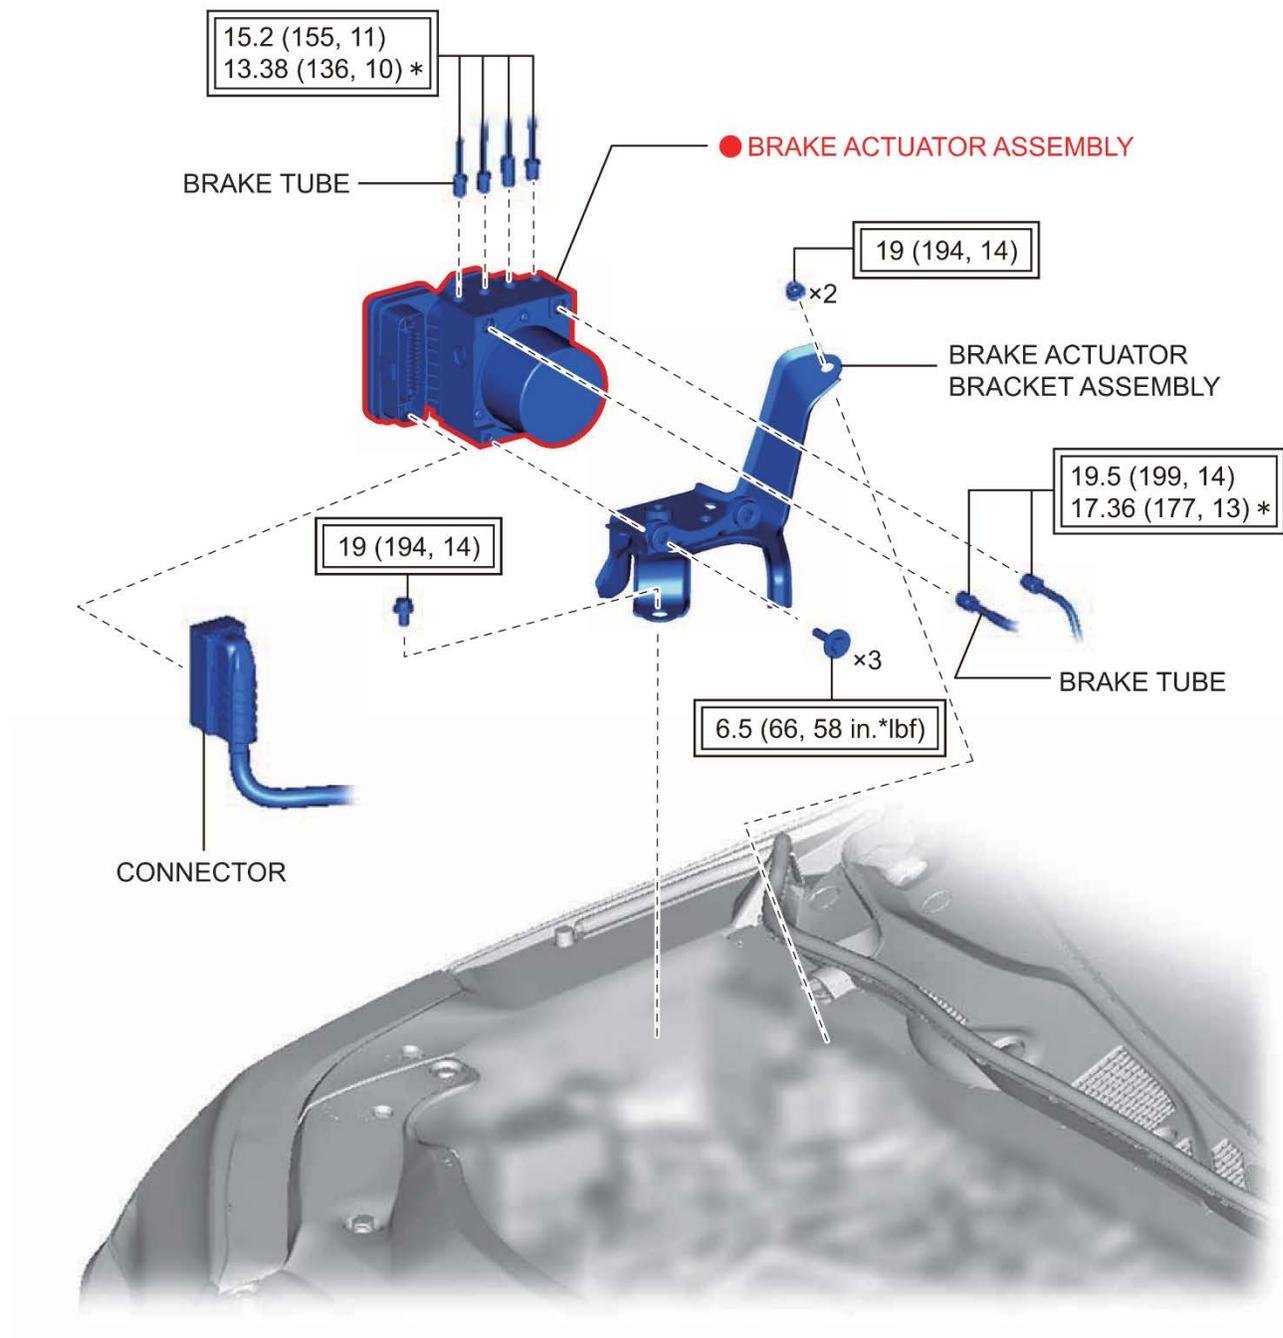
C336173AE

● : Component to be replaced

**N\*m (kgf\*cm, ft.\*lbf)** : Tightening torque for "Major areas involving basic vehicle performance such as moving/turning/stopping"

\* : For use with a union nut wrench

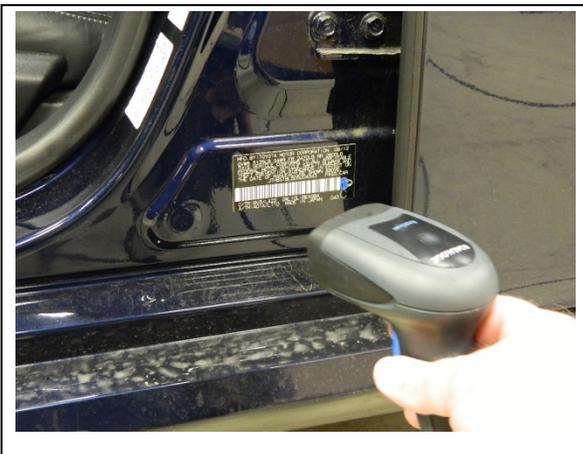
- a) Using Techstream, perform a health check to confirm if there are any brake DTCs present (current, history or pending).

- Ensure that the Techstream software is 11.00.017 or higher.
- On the “connect to vehicle” screen, enter the VIN number to ensure that the vehicle information is uploaded to TIS.

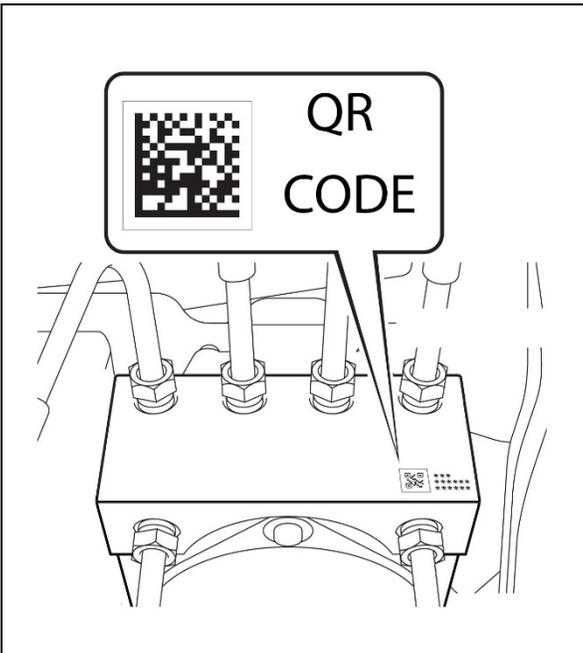
- b) Go to <https://g0i-glc-brake-actuator-validation.imagespm.info>  
c) Scan the VIN on the certification label located in the left front door jam.

**Ensure that Datalogic scanner model # 2430 is used for this recall.**

**DO NOT touch or place anything on the keyboard while scanning as this will cause the scanner to read incorrectly.**

- d) Scan the QR code on the brake actuator.  
e) Follow the prompts on the web site to determine if the brake actuator needs to be replaced.
