## **Safety Recall S24 / NHTSA 16V-202 CAN-C Bus Connector**

**2015-2016 (VM) RAM ProMaster City**

The CAN-C bus communication connector on about 23,900 of the above vehicles may develop internal connector pin corrosion due to moisture.

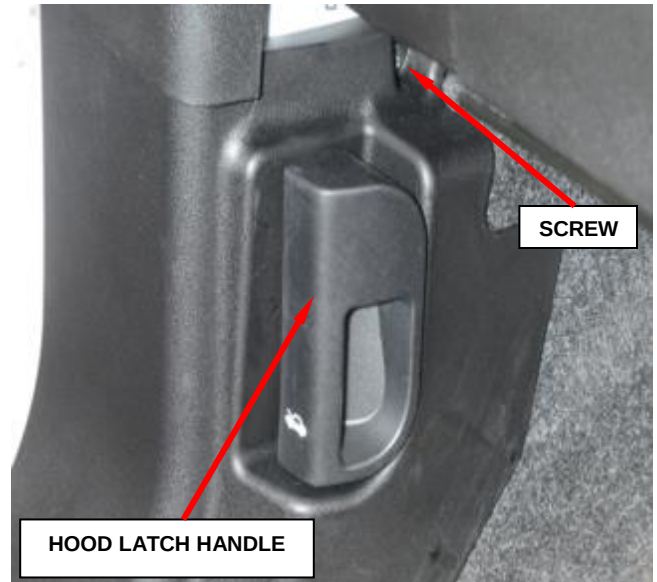
Figure 1 – Hood Latch Screw

3. Remove and save the screw located behind the hood latch handle (Figure 1).
4. Remove the hood latch handle (Figure 2).

10. Position the carpet or rubber flooring back into the original position.
11. Install the seat track bolt and tighten to 29 ft. lbs. (39 N·m) (Figure 3).
12. Install the door sill scuff plate (Figure 3).
13. Install the hood latch handle (Figure 2).
14. Install the screw located behind the hood latch and tighten securely (Figure 1).
15. Install the drive's side floor mat.
16. Connect the negative battery cable.
17. Using wiTech scan tool, erase all stored DTC data.
18. Return the vehicle to the customer.

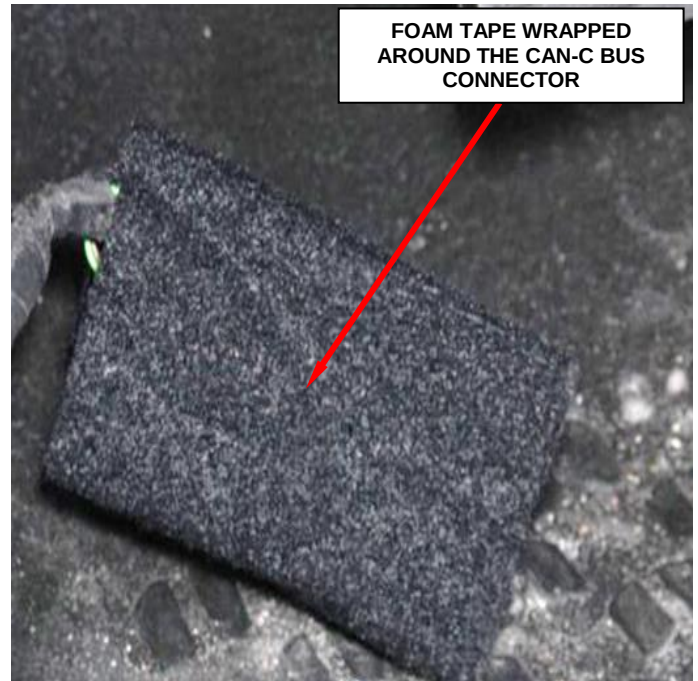
**Figure 6 – Foam Tape**

1. Apply supplied foam tape on the CAN-C Bus Connector (Figure 6).

**CAUTION:** While wrapping the CAN-C Bus Connector in foam tape do not disrupt the wire dress orientation.
